Thunder Valley PUD

Traffic Impact Study

Weld County, Colorado

April 23, 2018

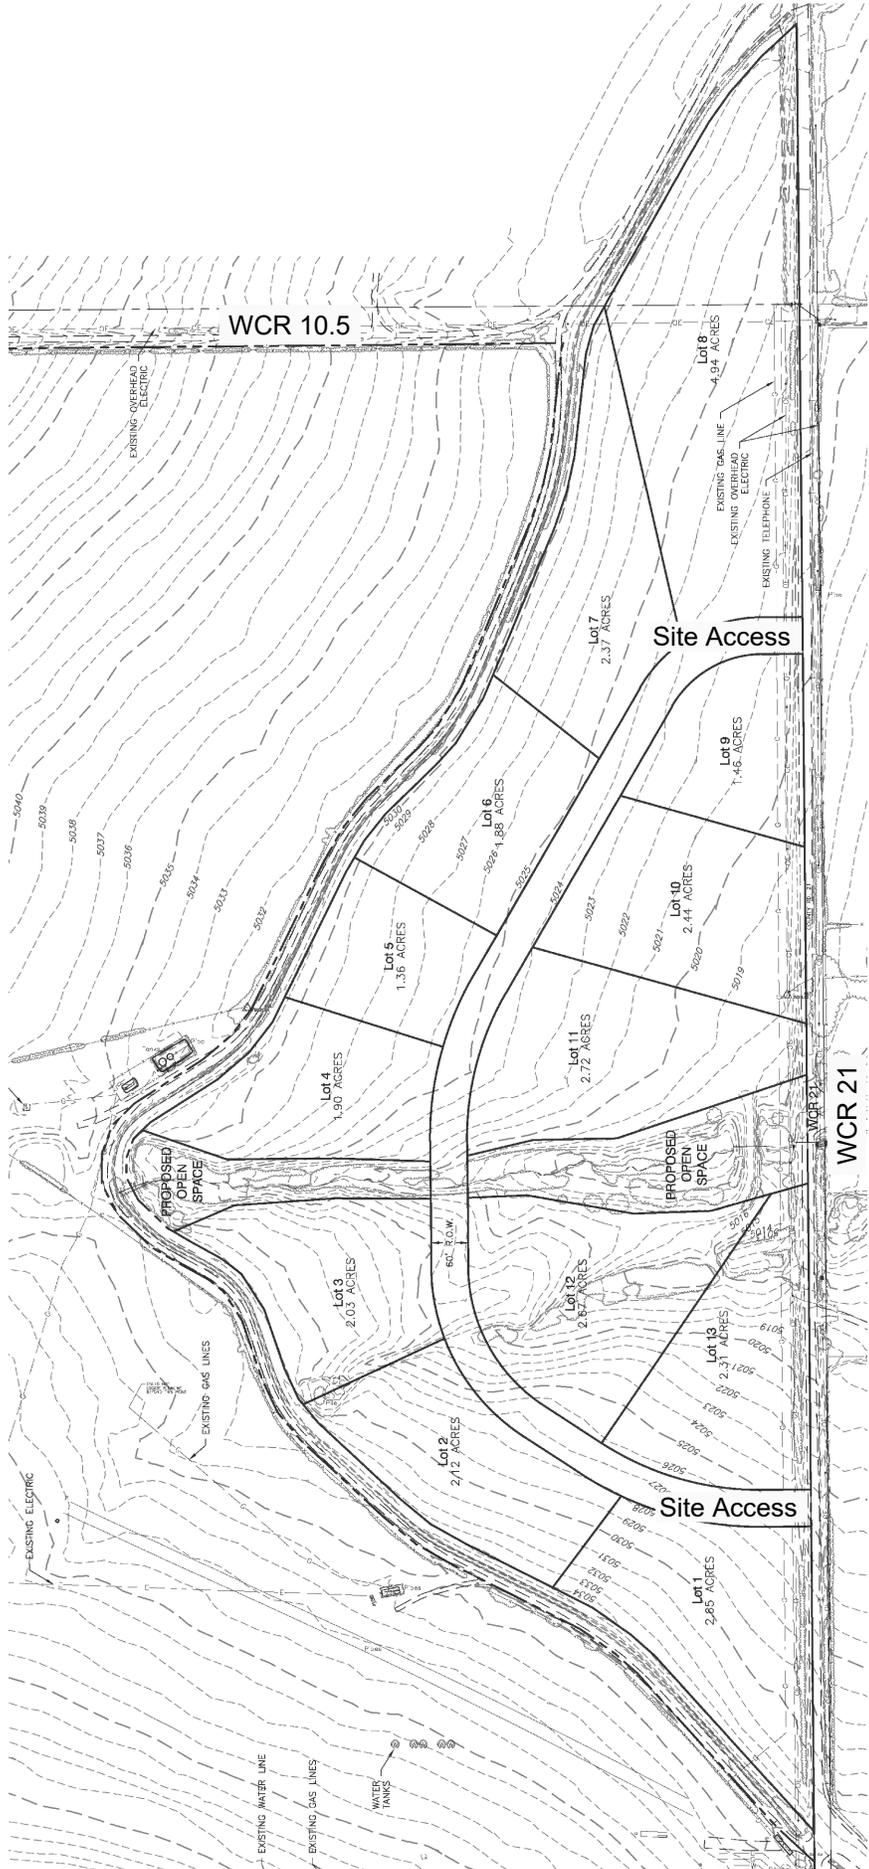
Thunder Valley PUD Traffic Impact Study
SITE PLAN

The Thunder Valley PUD is proposed as a residential development with 13 single family dwelling units. It will be west of WCR 21 between WCR 10 and WCR 10.5. The vicinity map is contained in Figure 1 and the site plan is contained in Figure 2.

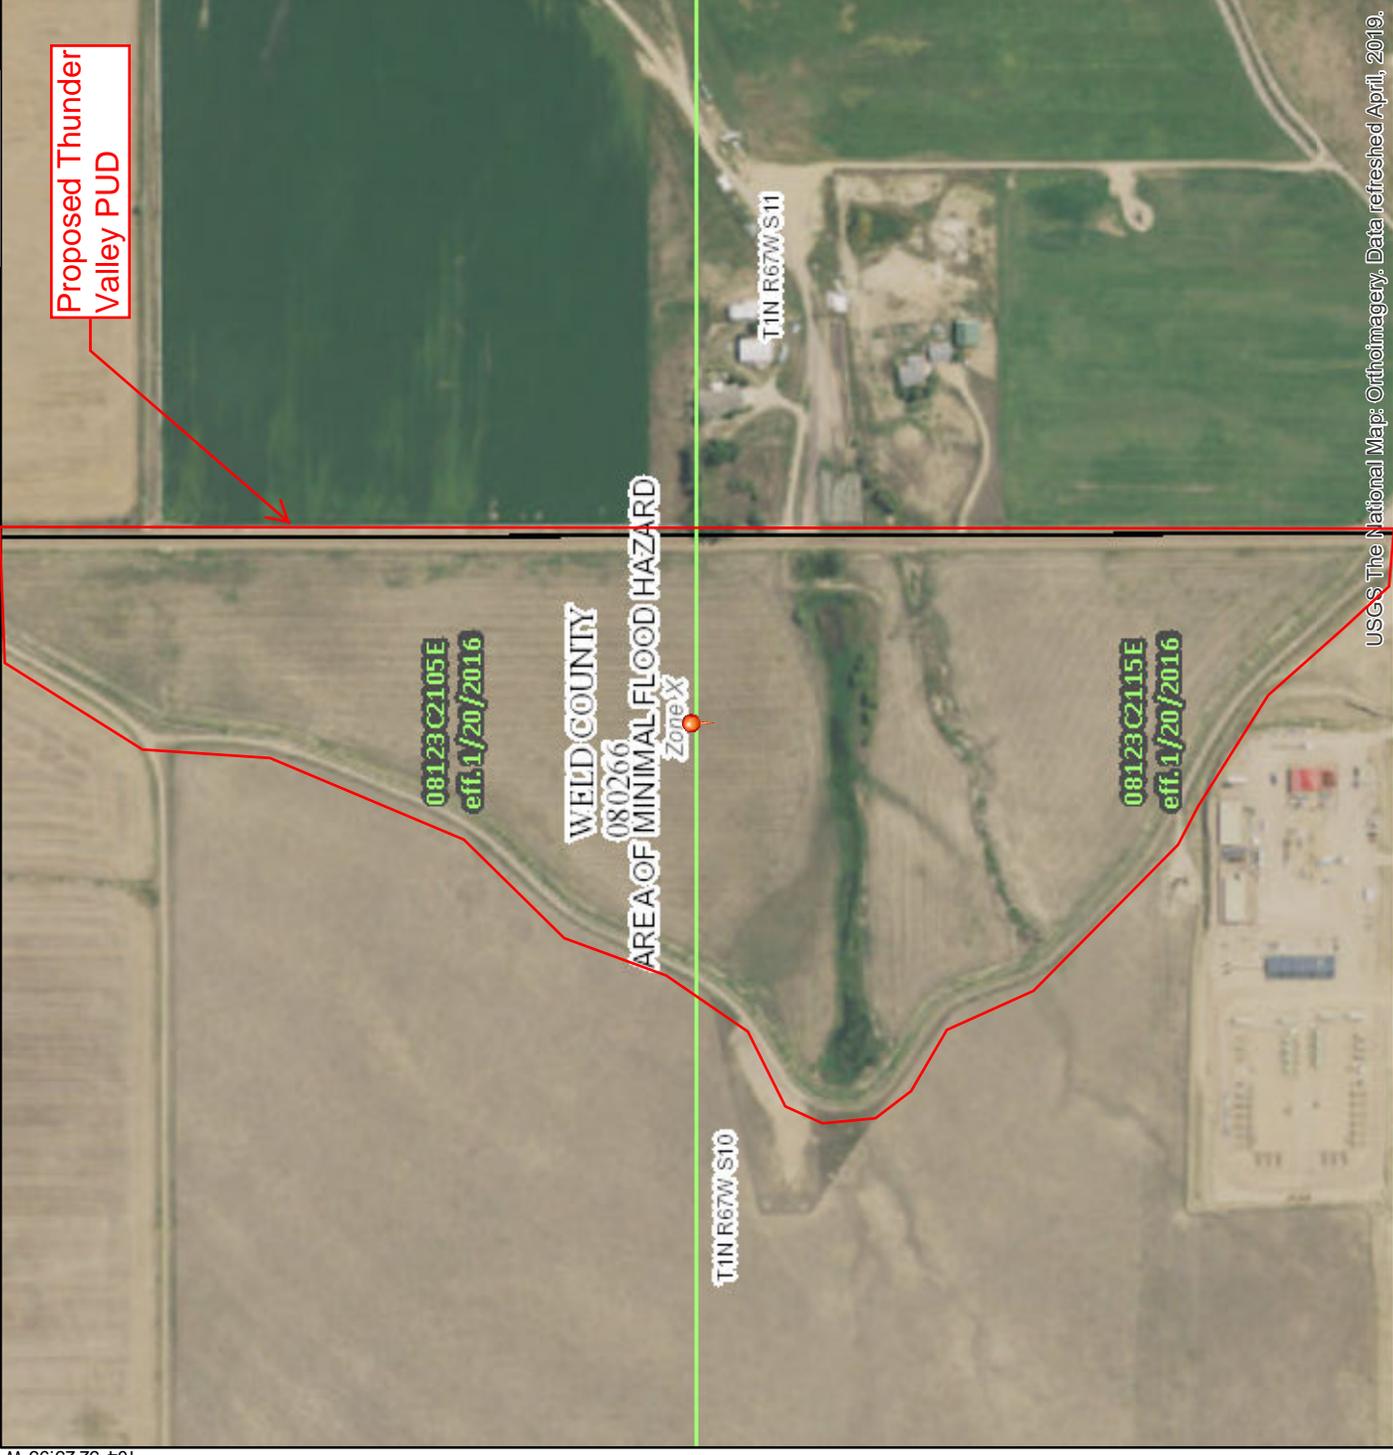
National Flood Hazard Layer FIRMette

There are no existing major drainageway planning studies for the area .The FEMA Flood Insurance Rate Maps (FIRM) show that the PUD is an Area of Minimal Flood Hazard. The proposed

development is located on Community Panels No. 08123C2105E and No. 08123C2115E, updated January 28, 2016. See FIRMettes National Flood Hazard Map included in Appendix A.

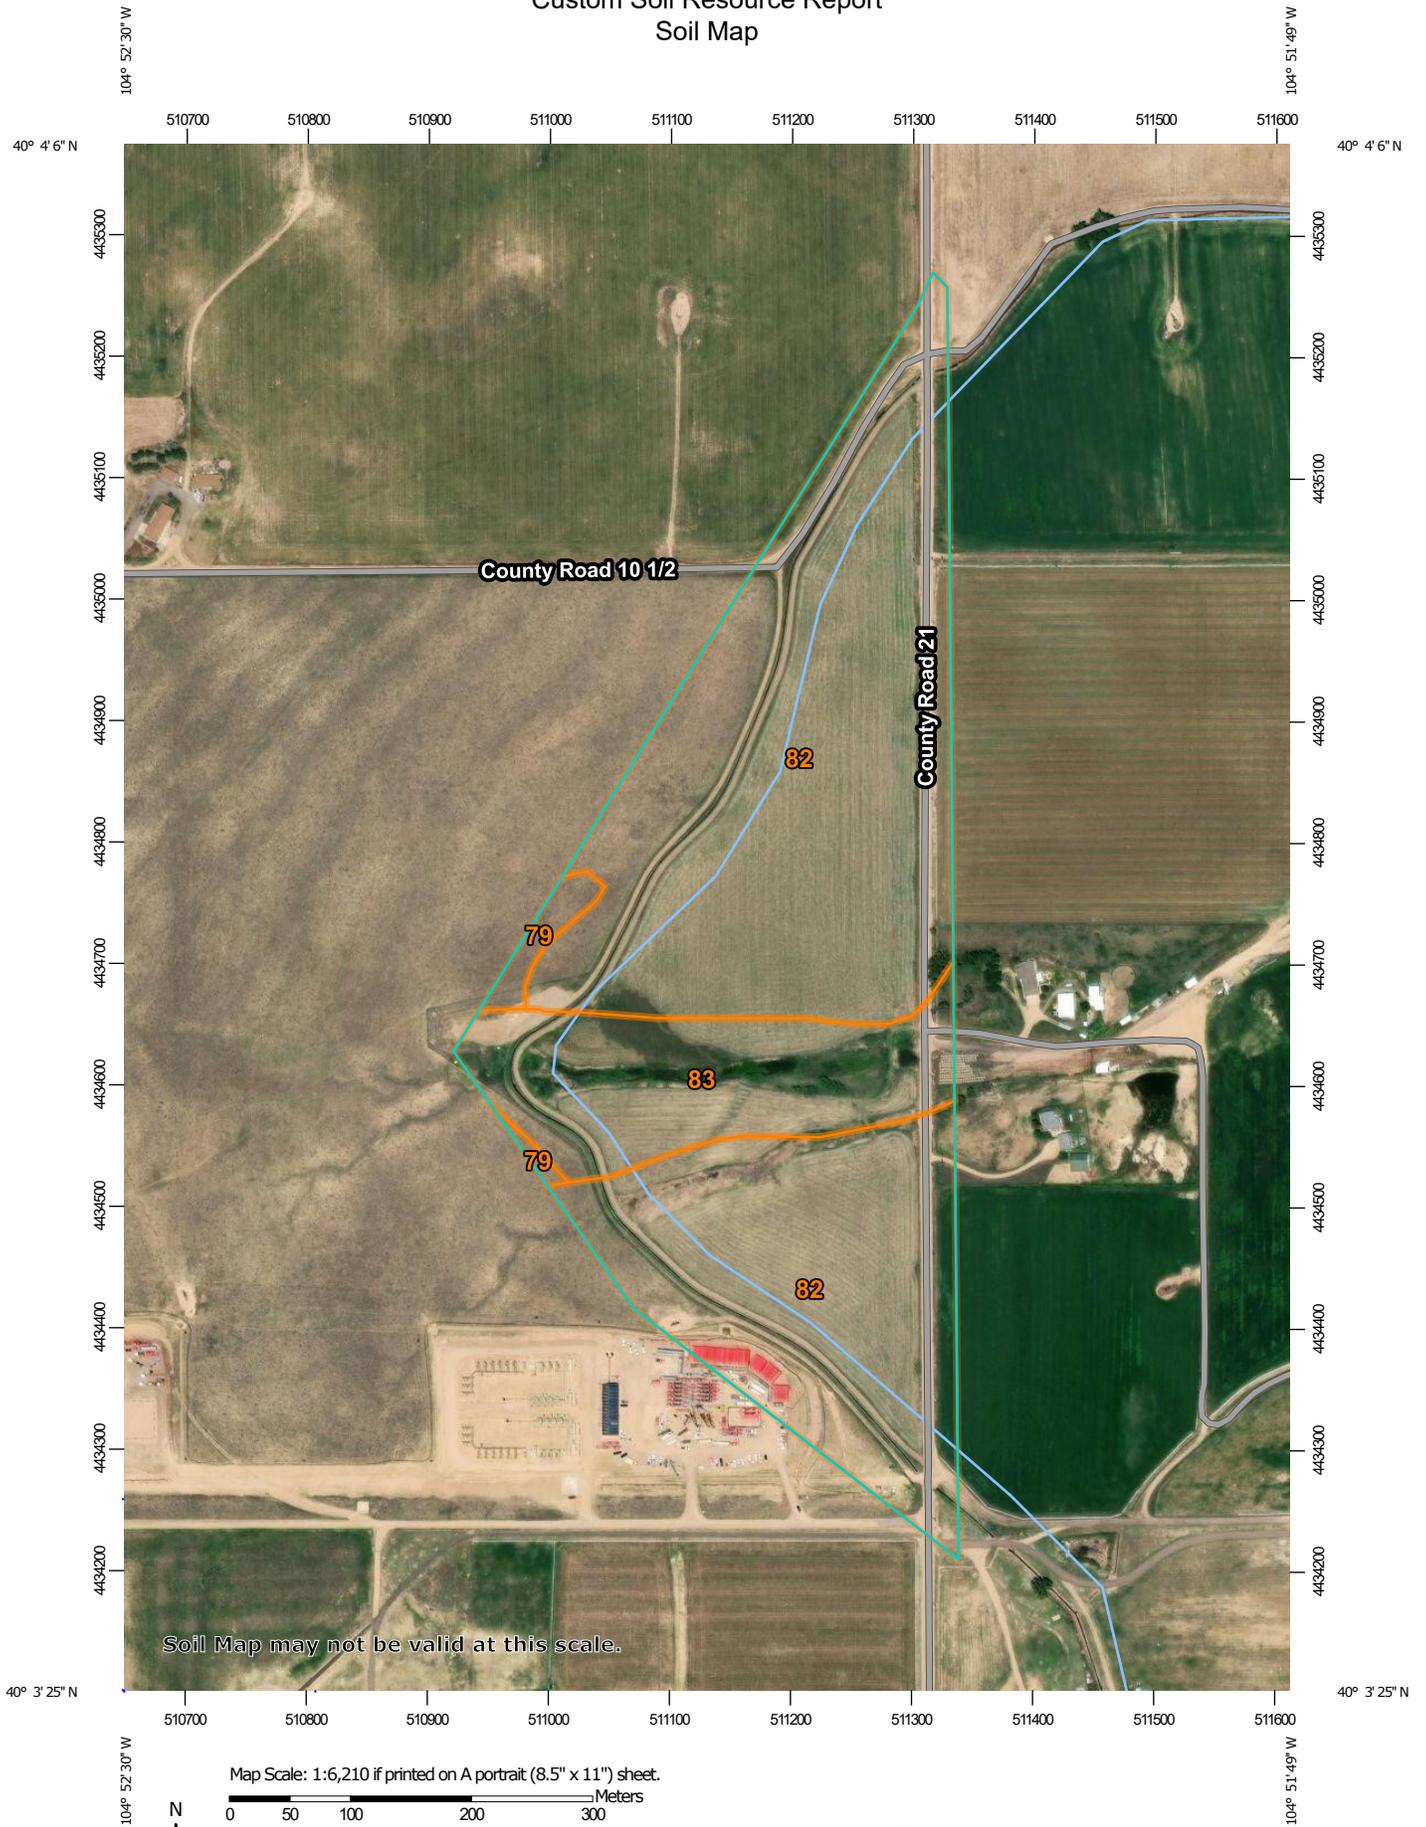
Custom Soil Resource Report Soil Map

Hydrologic soil groups are based on estimates of runoff potential. Soils are assigned to one of four groups according to the rate of water infiltration when the soils are not protected by vegetation, are thoroughly wet, and receive precipitation from long-duration storms.

Group B. Soils having a moderate infiltration rate when thoroughly wet. These consist chiefly of moderately deep or deep, moderately well drained or well drained soils that have moderately fine texture to moderately coarse texture. These soils have a moderate rate of water transmission.

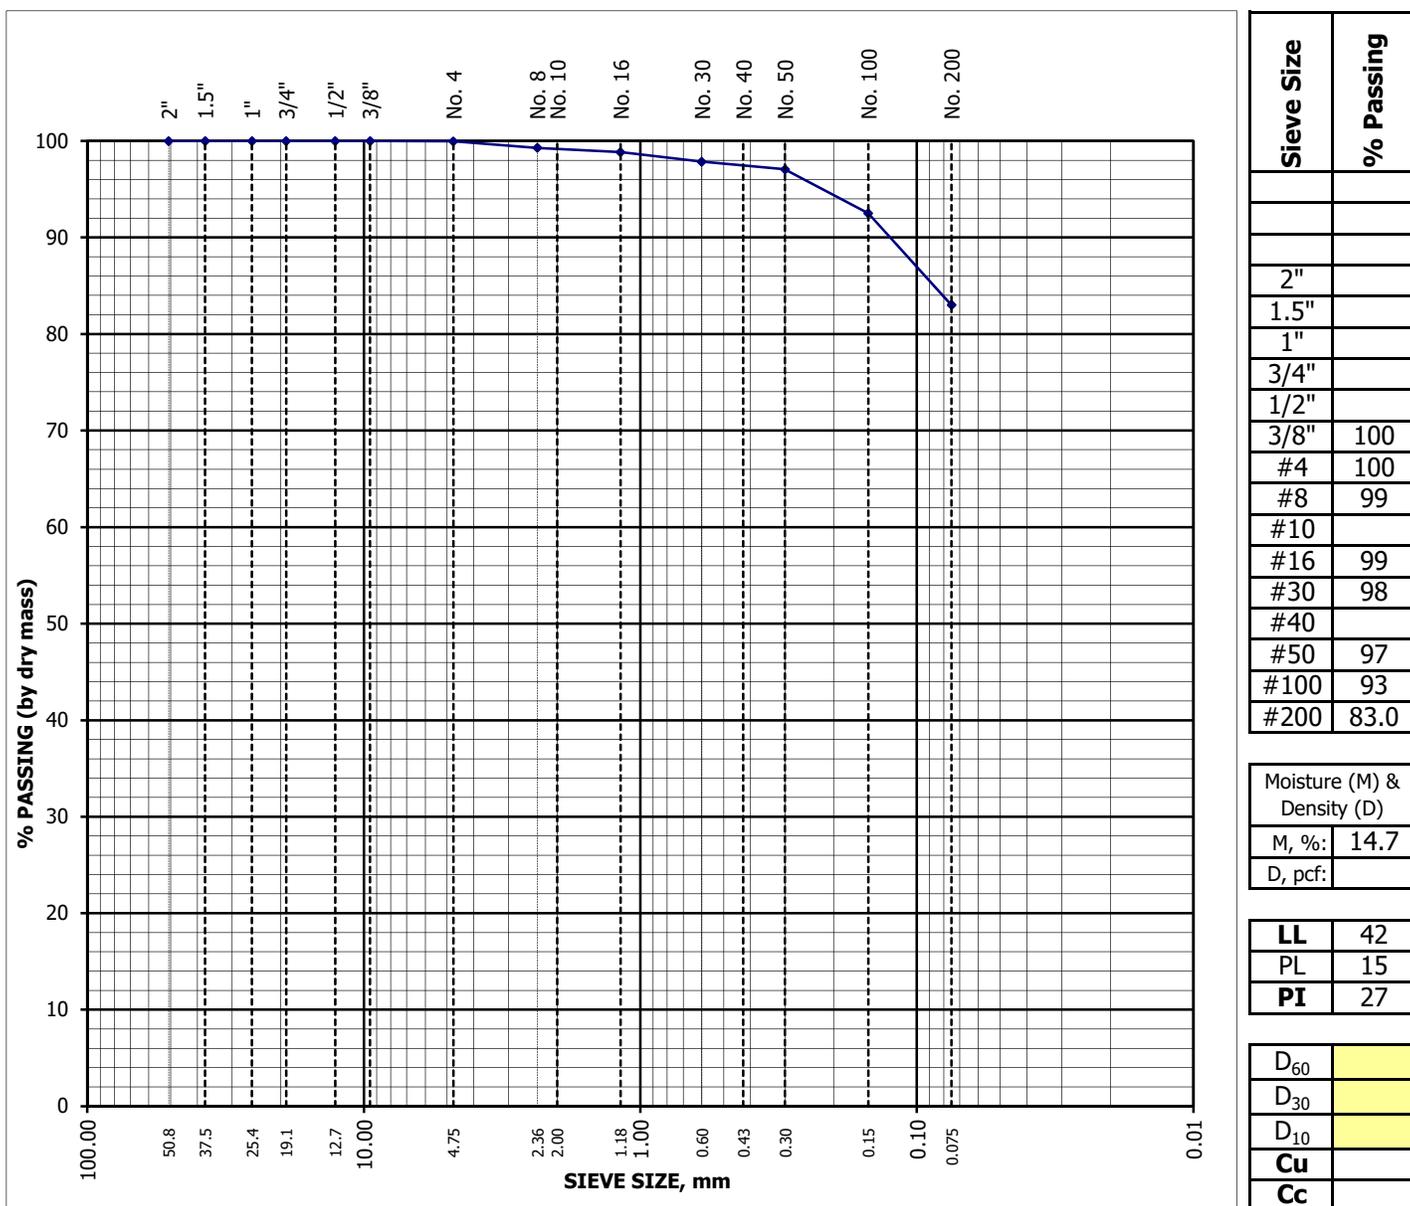
GRADATION PLOT - SOIL & AGGREGATE

AASHTO M 145 Classification: A-7-6 **Group Index:** 22
Unified Soil Classification System
(ASTM D 2487): (CL) **Lean clay with sand**

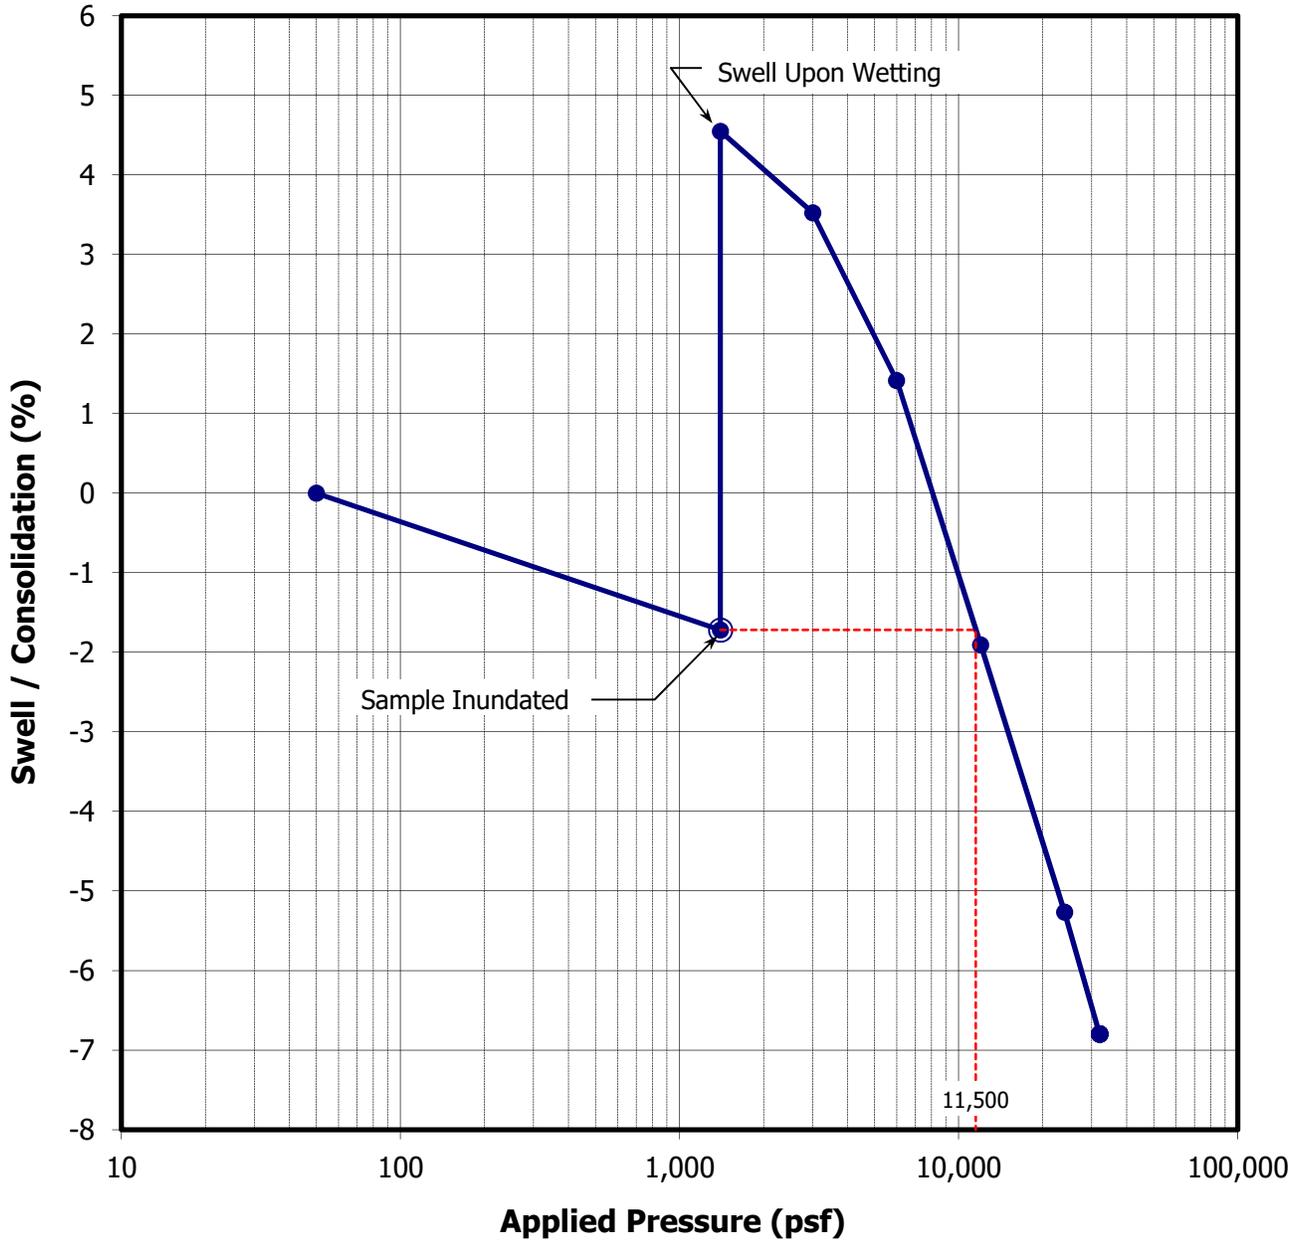
SWELL/CONSOLIDATION PLOT

Sample Location	Sample Depth (feet)	Lab ID Number:	Dry Density (pcf)	Moisture Content (%)	Inundation Pressure (psf)	Volume Change (%)	Swell Pressure (psf)
		182936					
		Visual Description of Sample					
B-1	14	CLAYSTONE, sandy, mottled, gray brown	100.9	23.4	1,400	6.3	11,500

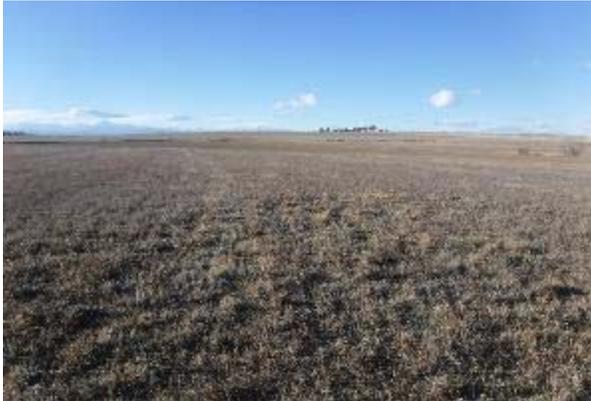
Photo 1. Example of the Cultivated Cropland vegetation community which is currently used as hay field in the southern portion of the survey area.

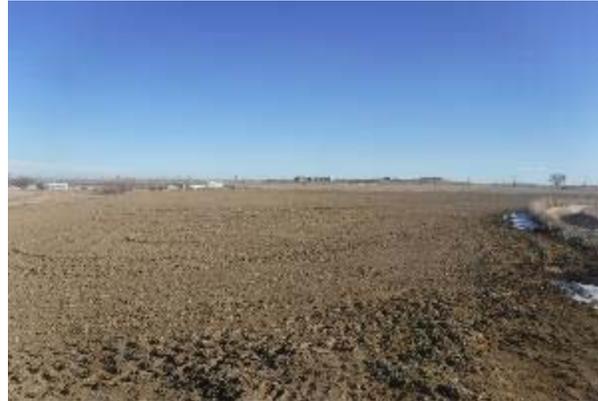
Photo 2. View southeast of the southern portion of the survey area where it has been recently plowed/tilled and is completely devoid of vegetation.

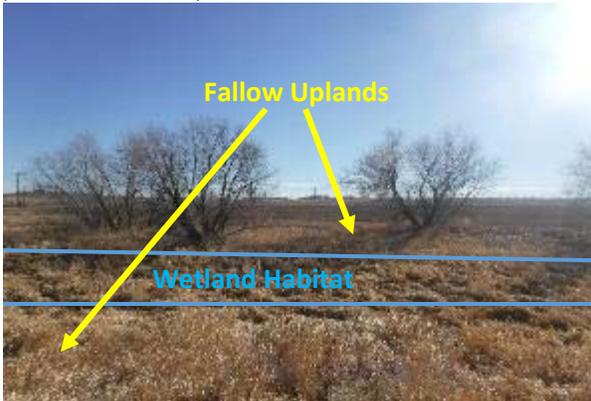
Photo 3. View south of the eastern portion of the Ruderal Wetland community (blue lines above) and adjacent fallow uplands. Few mid succession trees can be seen in the background.

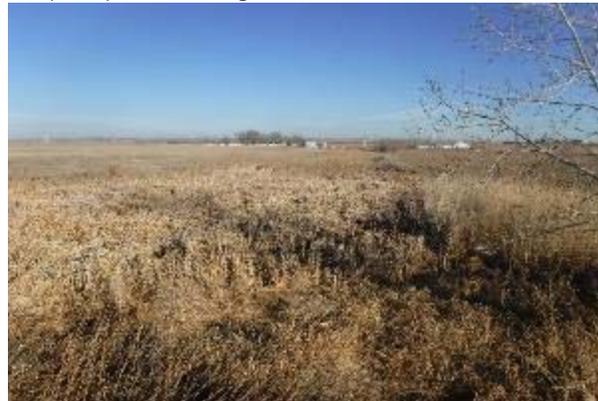
Photo 4. View east from the western boundary of the Ruderal Wetland community within the survey area. The wetland is largely dominated by broadleaf cattail herbaceous vegetation.

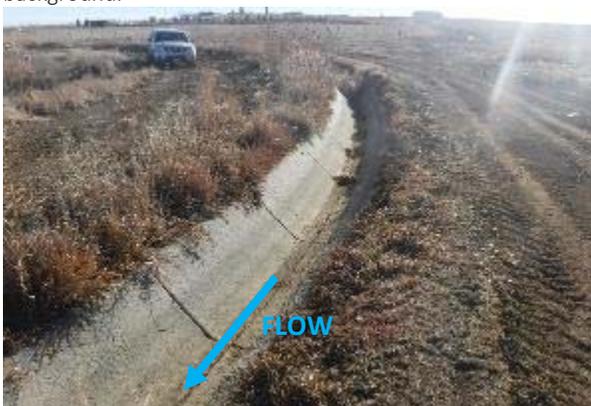
Photo 5. View southwest at the man-made, concrete lined irrigation ditch along the western perimeter of the survey area. Unmowed herbaceous vegetated fallow lands along the ditch is evident in this photo.

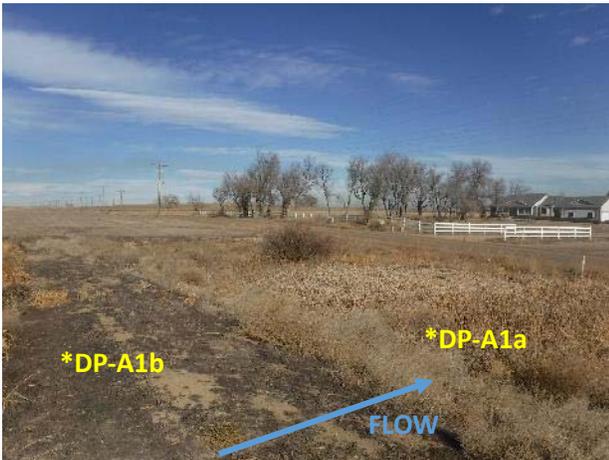
Photo 1. Overview northeast of the eastern portion of Aquatic Resource A within the survey area. The upland berm which bisects the aquatic resource is evident at the left of the photo, and a depression dominated by cattail is evident at the right. Approximate location of wetland data point DP-A1a and paired upland data point DP-A1b shown above.

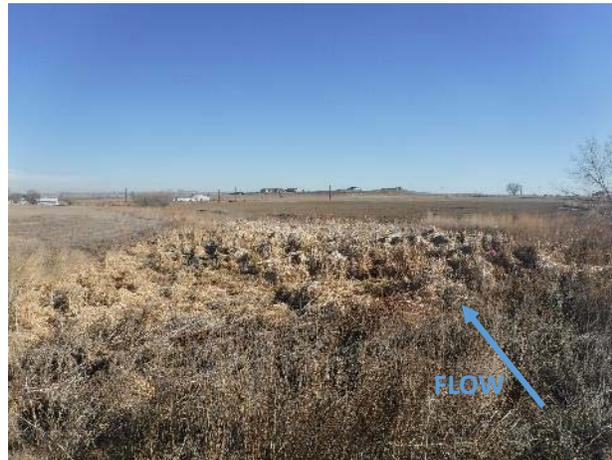
Photo 2. Overview east from the western boundary of Aquatic Resource A. The culvert that outlets into Aquatic Resource A from the diversion headgate on Bull Ditch 2, Lateral 3 is located in the general area of the flow arrow shown above.

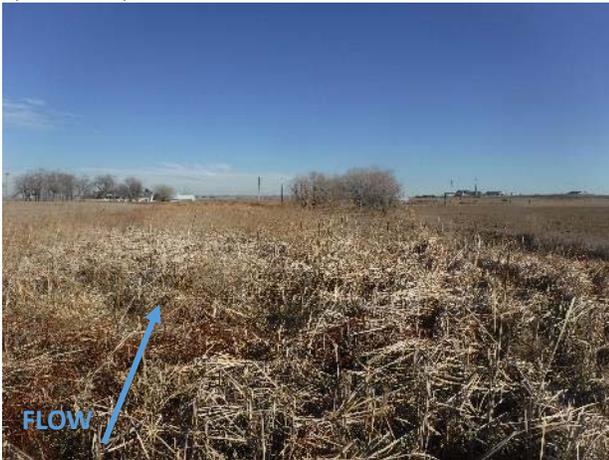
Photo 3. Overview facing east of the central portion of Aquatic Resource A dominated by cattail and dock-leaf smartweed herbaceous vegetation.

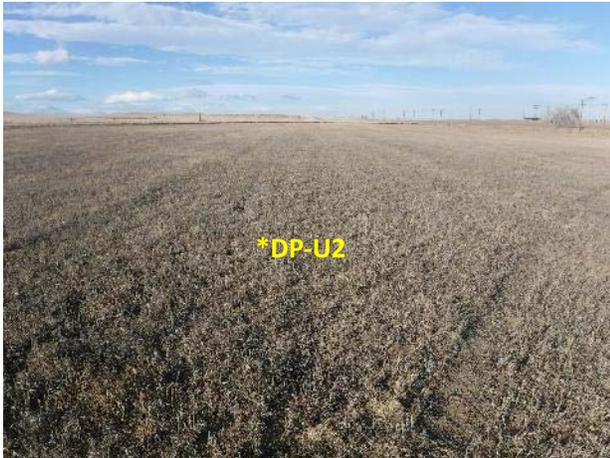
Photo 5. View north across the northern portion of the survey area comprising mowed hay field. This photo is representative of the entire northern portion of the survey area. Approximate location of upland data point DP-U2 shown above.

Refer to **Photos 5-8** below for characteristics of upland habitat identified within the survey area.

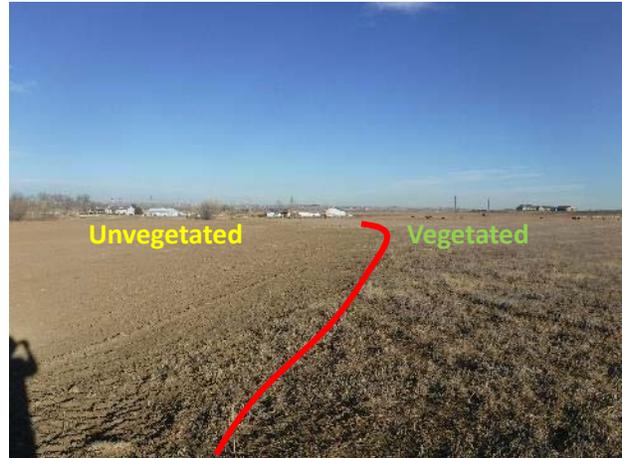
Photo 6. View east across the southern portion of survey area showing the divide between vegetated mowed hay field (right) and a recently plowed/tilled area that is currently unvegetated (left).

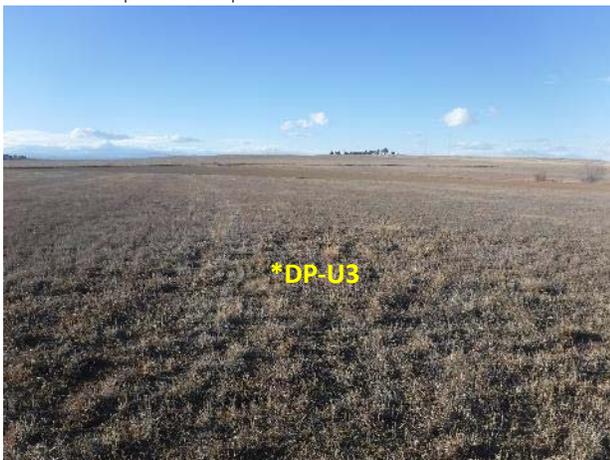
Photo 7. View northwest across the southern portion of the survey comprising mowed hay field. Approximate location of upland data point DP-U3 shown above.

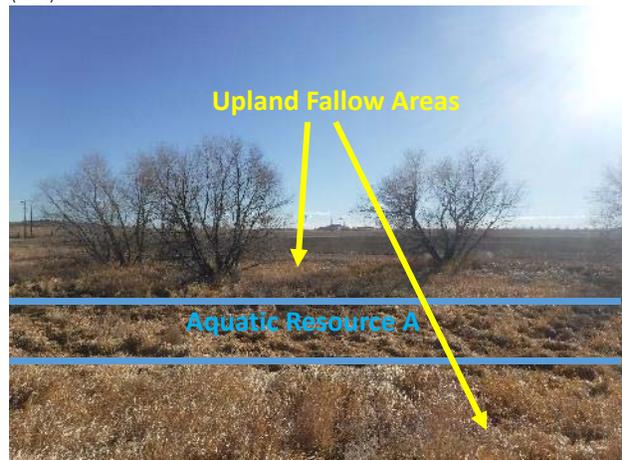
Photo 8. View south at upland fallow areas vegetated with grasses and ruderal herbaceous species along the perimeter of Aquatic Resource A (blue line). Few mid succession crack willow trees are evident in the background of this photo.

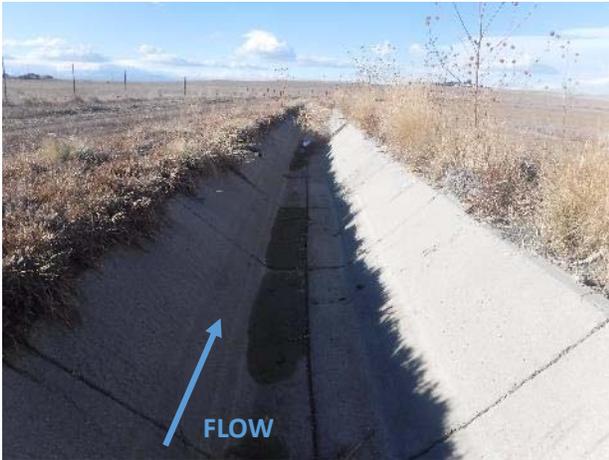
Photo 9. Overview northwest of Bull Ditch 2, Lateral 3 within the southern portion of the survey area. A man-made, concrete lined channel and no flow is evident in this photo.
