## **Reynolds Addition and Reynolds Second Addition Intensive Survey**

**Historic Residential Intensive-Level Survey – Phase II  
Certified Local Government Grant No. CO-19-10005  
Fort Lupton, Colorado**

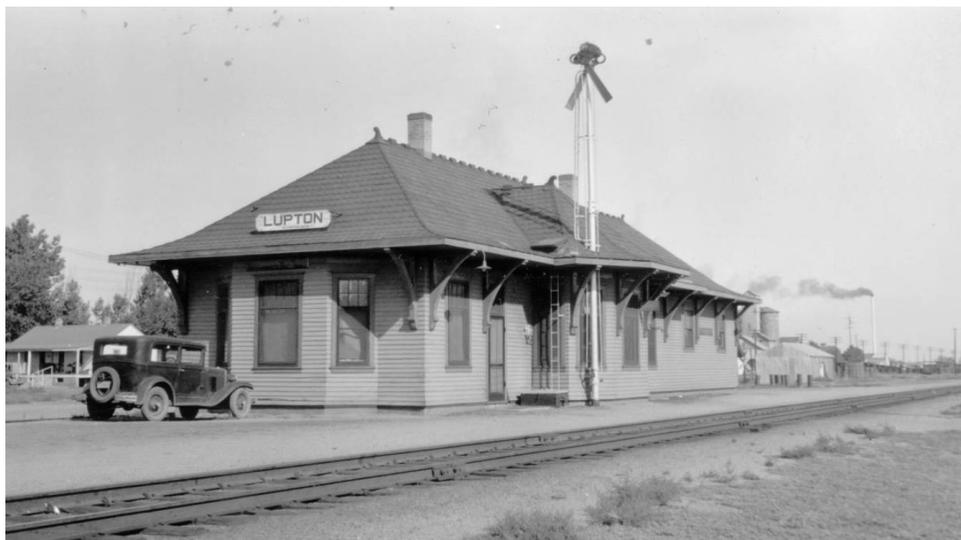
The Fort Lupton Union Pacific Railroad Depot ca. 1948. Note the hip roof, prominent oversized bracketing, and the slightly flared eaves is somewhat evocative of Classic Cottage architecture. This style of architecture is most common in residential buildings, with several examples in the Reynolds Addition and Reynolds Second Addition, but also sometimes appears in rural train depots and small municipal buildings.

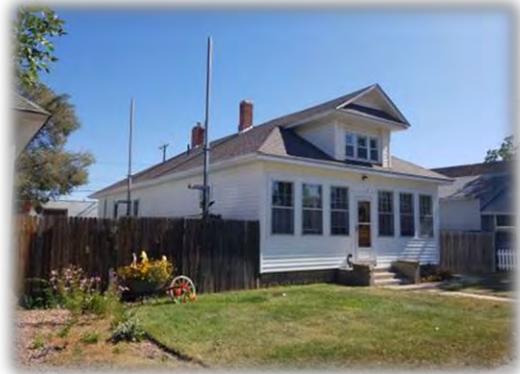
**Figure 1: 114 S. Park Avenue**

This one-and-a-half story, hipped roof, Classic Cottage has a rectangular plan. The front elevation (façade) faces west towards S Park Avenue. The Clock Residence has a concrete-masonry-unit foundation. The building is clad in horizontal, wood weatherboard siding painted white; the trim is also painted white. The roof is clad in grey, asphalt shingles and has two brick chimneys. Except when otherwise stated, all of the windows on the building are vinyl, six-over-six, double-hung, sash windows. Concrete steps lead to the entrance of the house, which is centered in the façade. A two-light storm door covers the wood entrance. There are three windows on either side of the entrance, stretching across the entire façade. A gable-roofed dormer is directly above the entrance. A three-part ribbon window is in the dormer. All three parts are one-over-one, double-hung, sash windows, though the center window is slightly wider than the other two flanking it. The north elevation of the house is mostly obscured by a tall fence, but one window is visible on the elevation's west side and two others on the east side. The east elevation is not visible from the pedestrian right-of-way. On the east side of the south elevation, there is another entrance, flanked by two small windows. Further west is another window. A narrow, squared bay with a gabled roof extends from the center of the elevation. A three-part ribbon window sits in the bay. Another window is just west of the bay.

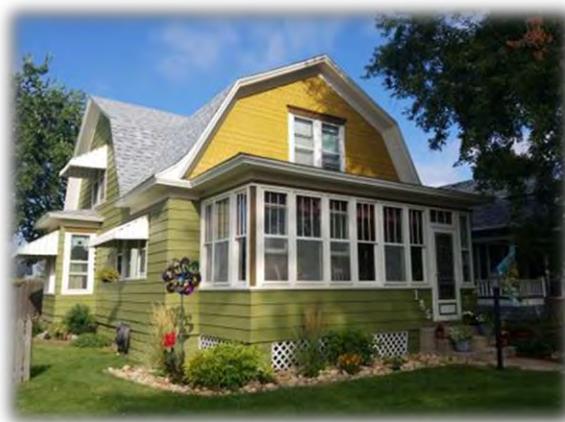
**Figure 2: 145 S. Park Avenue**

The McClave Residence is a vernacular building with features representative of the Dutch Colonial-style. It has a rectangular plan and is built on a stone block foundation, painted green. The residence is a two-story, gambrel roofed house clad with green painted horizontal clapboard siding, except on the second story of the east elevation, which is clad in decorative fish scale shingles that have been painted yellow. All windows appear to be made of vinyl and do not appear to be original. Window frames are all wood. Window and door frames are painted white. A covered porch projects from the primary (east) facing elevation and contains a ribbon of 13 vertically oriented three-over-three double hung sash windows, painted white. A metal screen door with a fixed three pane transom is located towards the northern end of the elevation and is flanked on either side by a window. A window bay containing two, one-over-one double hung sash windows is centered on the second story of the elevation. The south facing elevation has a small bump out containing three, one-over-one double hung sash windows. To the east of the bump out is a large window bay containing a fixed pane picture window flanked on either side by a narrow, double hung sash window. A window bay containing two, one-over-one double hung sash windows is centered on the second story of the elevation. Windows on the south elevation are covered by metal awnings. The north elevation has a single vertically oriented one-over-one double hung sash window. To the west of the centermost window is a square, one-over-one double hung sash window and to the east is a diamond shaped fixed pane accent window. A window bay containing two, one-over-one double hung sash windows is

centered on the second story of the elevation. This survey was conducted from the public right-of-way; the west (rear) facing elevation is obscured from view.

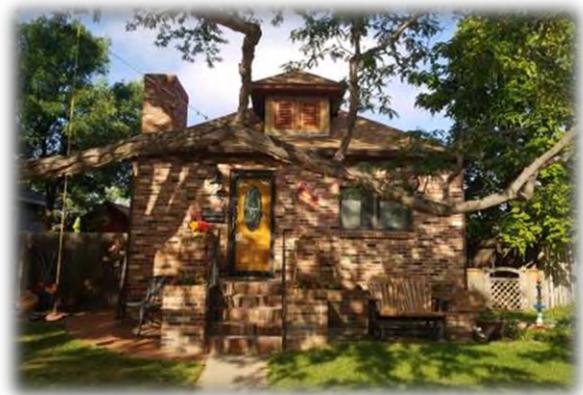
**Figure 3: 127 S. Park Avenue**

The house has a rectangular plan and is built on a poured concrete foundation. The residence is a one and a half story, hipped roof (with ridge) cottage with overhanging eaves, clad in brick and stucco. The original windows have been replaced with metal framed modern windows, painted dark brown. The façade (east facing) is clad entirely in brick and projects slightly from the main structure. The elevation contains an offset wooden door with a decorative window, behind a metal storm door. Five brick steps flanked by two wrought iron railings lead up to the front door. On either side of the steps is a brick planter. To the north of the door is a horizontal sliding window with a projecting brick sill. A brick planter is located beneath the window. A hipped roof dormer containing two window vents is located in the center of the elevation. The remaining elevations have a brick water table, above which the house is clad in stucco. The north elevation contains two vertically oriented casement windows. The south facing elevation similarly contains two vertically oriented casement windows and one square casement window. A brick chimney separates the two larger windows from the square window. The chimney projects slightly from the

elevation and extends to just above the roofline. This survey was conducted from the public right-of-way; therefore, the west facing elevation was obscured from view.

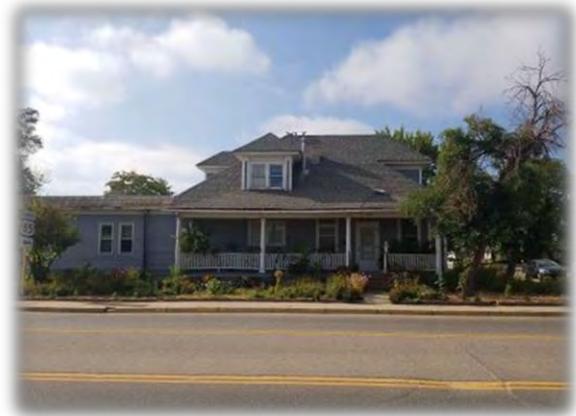
**Figure 4: 604 1<sup>st</sup> Street**

This one-and-a-half-story, hipped-roof house has a rectangular plan. The façade (north facing) fronts 1st Street. The house has a masonry foundation. The hipped roof is clad in grey, asphalt shingles. There is brick and a prefabricated, metal chimney on the north side of the roof. The building is clad in horizontal, wood, clapboard siding painted blue. The trim is painted white. Except when otherwise stated, all of the windows on the house are tall, rectangular, two-light, double-hung windows with wood surrounds. A covered porch with a hipped roof stretches across the façade of the house. Brick steps lead to the porch. The porch supports have cushion capitals and a wood railing. The entrance is on the west side of the façade beneath the porch; it is a six-light wood door. There is a window on either side of the entrance. There is a horizontal, rectangular, two-light sliding window on the east side of the porch. Directly above this window, on the upper half story, is a hipped-roof dormer. There is a pair of windows in the dormer. A single-story, flat-roof addition is built off of the east elevation of the house and had a concrete foundation. A pent roof clad in wood shingles is attached to the cornice line and wraps around north and east elevation of the addition. The north elevation of this addition has two pairs of windows. The east elevation of the addition has an entrance on the north side. It is single-light glass door with a transom. Brick stairs on a small, concrete platform lead to the entrance. A single window is on the south side of the east elevation of the addition. There is a hipped-roof dormer with a single window is

on the upper half story of the east elevation of the main house. The rest of the east elevation is not visible from the pedestrian right-of-way. On the west side of the south elevation there is a pair of windows. In the center of the elevation, there is a single, square, fixed-light window. To the east of that window is a small, horizontal window. There are two windows on the east side of the south elevation. There is also a hipped-roof dormer on the upper half story, identical to the one on the north elevation. The south side of the west elevation has a three-part ribbon window. The windows are short, two-light, double-hung windows with wood surrounds. The north side has an identical, paired window. The upper half story has a hipped-roof dormer with a single window.

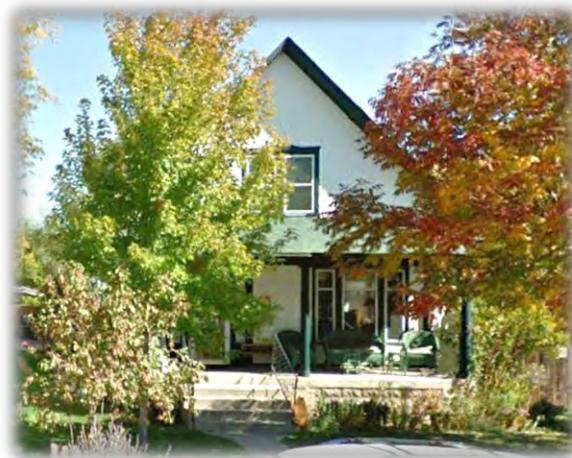
**Figure 5: 154 S. Park Avenue**

This two-story, gable front house is a vernacular representation of the Edwardian style, with simple ornamentation and lacking a tower common to the architectural style. The house has a rectangular plan and fronts S Park Avenue. and was constructed on a rough stone block foundation. The gabled roof is clad in green asphalt shingles. There is a brick chimney on the north slope of the gable roof. The majority of the building is clad in wide, white, asbestos shingles. The front gable and dormers are clad in wooden fish scale shingles painted white. The trim is painted black. Except when otherwise stated, all of the windows on the house are tall, rectangular, two-light, double-hung, vinyl windows with plain wood surrounds. A shed-roof porch with Tuscan columns stretches across the façade of 154 S Park Ave. Concrete steps lead to the porch. The entrance is on the north side of the façade. A tall, three-part window is on the south side. All three windows are two-light, fixed windows with wood surrounds. The upper lights are a third of the size of the lower lights, creating the impression of transoms. The center window is wider than the two on either side of it. Immediately above the porch, in the center of the gable, is a paired window. There is a small window built in the foundation on the east side of the south elevation.

Above that widow is small, square, fixed, window. There is a window in the center and west end of the south elevation. A hipped-roof dormer is built out of the gable in the center of the south elevation. There is a paired window in the gable. The gabled roof has eave returns on the west elevation. There is a vinyl sliding window in the center of the first story of the elevation. There is a window in the middle of the gable. A small wood deck is built off of the west side of the north elevation. The deck leads to a single-light, metal screen door. Just east of the entrance is a short, two-light, double-hung, vinyl window. To the east of the short window, is another window. A one-story, squared bay with a hipped roof extends from the center of the north elevation. There is a three-part ribbon window in the center portion of the bay and a single window on either side. There is a hipped-roof dormer—identical to the one on the south elevation—above the bay.

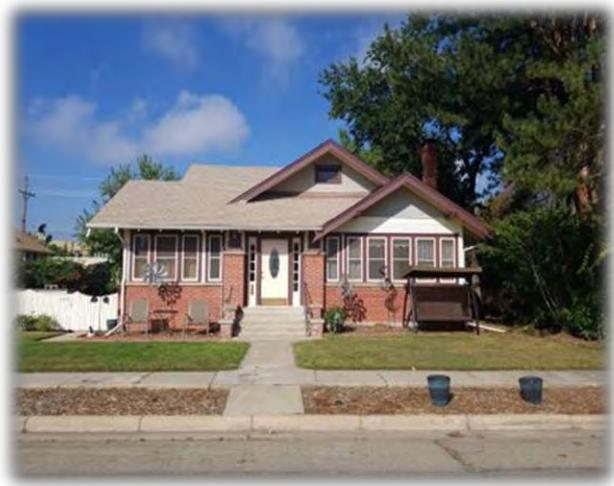
**Figure 6: 217 S. Park Avenue**

This one-and-a-half story cross-gabled house has a rectangular plan. The façade (east facing) faces S Park Avenue. The house has a brick foundation. The roof is clad in grey, asphalt shingles and has exposed rafter tails and roof beams. There is a brick chimney on the north slope. The building is clad in brick and horizontal, wood clapboard painted white. There is stucco painted grey in the gables. The trim is painted maroon. The entrance is in the center of the façade. Concrete steps lead to the entrance. Wide, tall, brick pilasters, supporting square, wood supports, are on either side of the entrance. They mimic Craftsman porch piers. The entrance has an oval light and five-light side lights. The rest of the windows on the façade are single, hung, sash windows. The north end of the façade has a front gable roof, lower than the rest of the

house's roofline. There is a five-part ribbon window. The three center windows are four-over-one light windows. The two on either side are three-over-one light windows. To the south of the ribbon window is a single, three-over-one light window. The south side of the façade has a single, three-over-one light window just south of the entrance. Further south, there is a three-part ribbon window. The center window has four-over-one lights, and the outside two windows have three-over-one lights. A gabled eyebrow dormer extends across the north end of the façade. A horizontal, five-light fixed window sits in the dormer. The east side of the south elevation has two three-part ribbon windows identical to the one on the façade. Visibility of the west end of the south elevation is obstructed by a fence. The edge of a small, wood deck is visible in the center of the elevation, as are three sash windows. A gabled addition is built off of the west elevation of the building. The south elevation of the addition has a screen door and a pair of sash windows. The west and north elevations are not visible from the pedestrian right-of-way.

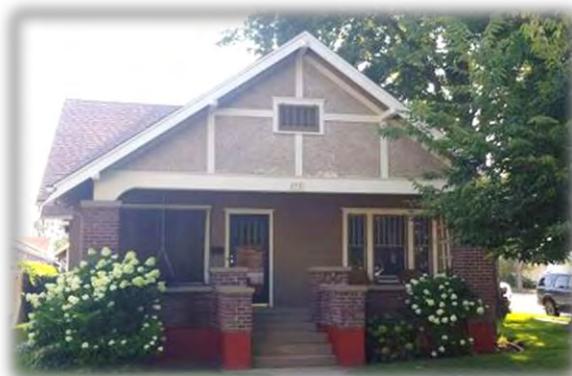
**Figure 7: 248 S. Park Avenue**

The one-and-a-half-story, cross-gabled, Craftsman bungalow has a rectangular plan. The façade (west facing) faces S. Park Avenue. The house has a concrete foundation painted red. The roof has overhanging eaves and exposed rafter tails and roof beams. There is a brick chimney in the middle of the roof. The building's first story is clad in horizontal, wood clapboard siding painted tan. The half story in the gables is stucco with half timbering. All of the trim is painted white. A large, recessed, gable-roofed porch stretches across the façade. There are square, brick piers on either side of the concrete steps and square, brick porch supports on either end of the porch. The

entrance to the house is slightly north of center. The entrance is a large, single-light door, covering a wood door with four lights. There is an identical three-part window on both the south end of the façade and to the immediate north of the entrance. The center window is a six-over-one, single-hung, sash window; on either side of the center window is a thinner, three-over-one, single-hung, sash window. There is also a five-light, fixed window in the center of the gable above the porch. There is a small, rectangular window built in the foundation of the west side of the north elevation. Just east of the porch, on the north elevation, there is a five-over-one, single-hung, sash window. On the east side of the center gable, there is a narrow, one-story, gabled, bay. There is a pair of four-over-one, single-hung, sash windows in the center of that bay. On the east side of the north elevation there is another five-over-one, single-hung, sash window. Like on the façade, there is a five-light, fixed window in the center of the central gable on the north elevation. In the center of the east elevation, there is a small, enclosed entryway. There is a horizontal, two-light, sliding window on the east elevation of the entryway. There is a small cat door beneath the sliding window. On the south elevation of the entryway, there is a wood door with an imprinted panel on the bottom, crisscross pattern in the middle, and large screen on the top half. The door is painted red. There is a pair of four-over-one, single-hung, sash windows on the north end of the east elevation and a pair of shorter, five-over-one, single-hung, sash windows on the south end. Beneath the pair of windows of the south end, there is a single-light basement window built into the foundation. The far east side of the south elevation extends further than the rest of the elevation and has its own one-story, gabled roof. There is a three-part ribbon window in the center of this extension. All three parts are five-over-one, single-hung, sash windows. On the west elevation of this extension, there is a single, five-over-one, single-hung, sash window, identical to the others that make up the ribbon window. On the east side of the first story of the central gable there is a pair of four-over-one, single-hung, sash windows. There is a single, four-over-one, single-hung, sash window to the west of that pair window. There is an un-fenestrated, narrow, bay with a shed roof just east of the single window. One, four-over-one, single-hung, sash window sits on the far east end of the south elevation. Like the façade and north elevation, there is a five-light, fixed window in the center of the central gable in the upper half story.

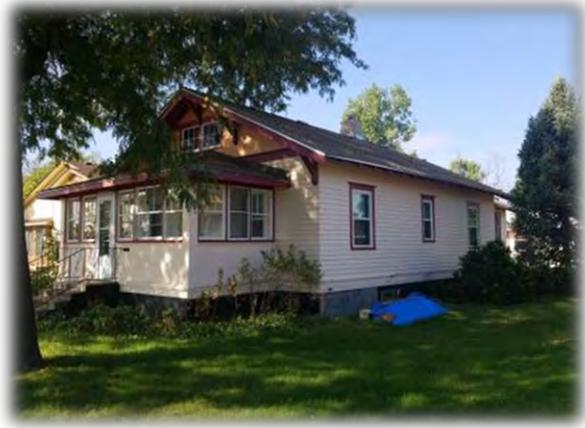
**Figure 8: 315 S. Park Avenue**

The one-and-a-half-story, front-gabled, Craftsman bungalow has a rectangular plan. The façade (east facing) faces S. Park Avenue. The house has a concrete foundation painted dark green. The gabled roof has overhanging eaves and exposed rafter tails and is clad in asphalt shingles. Five, wood, triangle knees braces sit under the gable on the façade; one on each end, two in the middle, and one in the peak of the gable. There is a brick chimney in the middle of the roof. The building's first story is clad in horizontal, wood, clapboard siding painted tan. The half story beneath the gable is clad in square, wood shingles, also painted tan. All of the trim, including the knee braces, are painted maroon. An enclosed porch extends off of the façade.

The porch has a concrete foundation, vertical, wood, clapboard siding, and unelaborated, square, wood columns at the corners. The entrance is just south of center. The entrance is an eight-light, wood door, partially obscured by a two-light, white, metal storm door. Concrete steps with metal railings lead to the entrance. All of the windows on the porch are rectangular, three-over-one, fixed light windows with wood surrounds painted white. There is a pair of windows south of the entrance. To the north of the entrance are a ribbon of three very similar windows, except the middle window is slightly wider than the two on either side of it. The north and south elevations have identical three-part ribbon windows. There is a pair of square, six-light casement windows in the gable of the façade. All the windows on the north and south elevations are rectangular, one-over-one, vinyl, sash windows that do not appear to be original. There are three windows on the north elevation; the window in the center is slightly smaller. There are also three windows on the south elevation. The western-most window is smaller and sits higher on the elevation. A gable-roofed addition is attached to the west elevation, but because this survey was conducted from the public right-of way, most of the elevation is obscured from view.

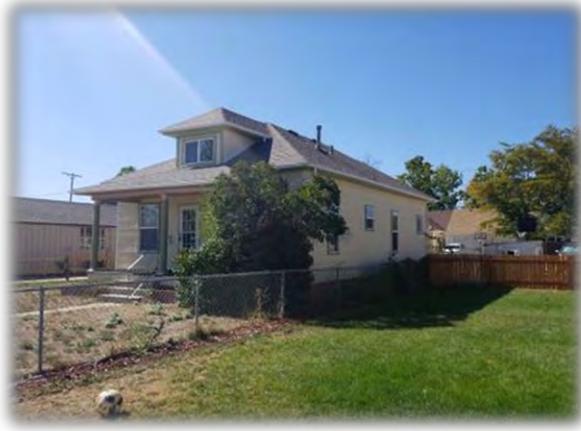
**Figure 9: 125 S. Denver Avenue**

The one-and-a-half-story, hipped roof, Classic Cottage has a rectangular plan. The façade (east facing) faces S. Denver Avenue. The house has a brick foundation. The building is clad in asbestos shingle siding painted yellow; the trim is painted green. The roof is clad in grey, asphalt shingles and has a prefabricated, metal chimney on its north slope. Excepted when otherwise stated, all of the windows on the building are one-over-one, double-hung, sash windows with plain wood surrounds. A hipped-roof porch stretches across most of the façade. Concrete steps lead to the porch, which has three Doric porch supports. The Doric capitals are painted orange. The entrance is slightly south of center. It is a six-over-six light, wood door painted white. There is a window on either side of the entrance. A dormer with a pyramidal roof is built out of the center of the roof above the porch. The dormer has a horizontal, two-light sliding window. The south elevation has a window on its east side. To the north of center is a horizontal, two-light sliding window, and there is a square, single-light, fixed window at the far end of the east side. The west elevation is not visible from the pedestrian right-of-way. The north elevation of 125 S Denver Ave has a small, one-over-one, double-hung, sash window on its west end and just east of the center of the elevation. There are also a window west of center and at the far east side of the elevation.

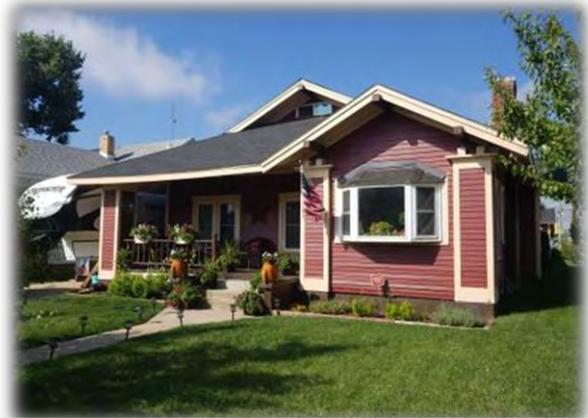
**Figure 10: 103 S. Park Avenue**

This one-and-a-half-story, front gabled, house has a rectangular plan. The façade faces east towards S. Park Avenue. The house has a concrete foundation painted brown. The gabled roof has overhanging eaves and is clad in black, asphalt shingles. There are exposed roof beams under the gable. The building is clad in horizontal, wood, clapboard siding painted red. The trim is painted yellow. A gabled ell with exposed rafter beams extends from the north side of the façade. There is additional wood cladding abutting at the corners of the ell to simulate large, square porch supports. A small bay window extends from the façade of the ell. To the south of the ell, is a porch that extends the same distance as the ell. Concrete steps lead to the porch and a wood railing stretches across the front of the porch. On the south side of the porch is a large, square, wood, porch support. The entrance to the house is on the north elevation of the ell, underneath the porch. Two pairs of rectangular, one-over-one vinyl, sash windows with wood surrounds are on the façade beneath the porch. The porch roof extends nearly to the top of the house's gable. Between the peak of the gable and the top of the porch roof is a small, rectangular, two-light sliding window. Views of the south elevation are obscured by a large RV parked in the driveway next to the house. A gabled entry with exposed roof beams is attached to the west elevation. An entrance sits of the west elevation of the entry. Six-light, double, casement windows with wood surrounds are on the north elevation of the entry; they are likely original windows. There is a small, rectangular, single-hung, vinyl window high on the southern side of the building's west elevation. There is also a small, rectangular, two-light, vinyl, sliding window. A shallow, gabled bay with exposed roof beams extends from the north entrance of the house. There is a pair of rectangular, one-over-one light, double-hung, vinyl, sash windows in the bay. There is an identical pair of windows on the east side of the north elevation. There is also a brick chimney that extends from the ground to above the roof. On either side of the chimney are two rectangular, one-over-one light, double-hung, vinyl, sash windows. On the west end of the north elevation is a small, rectangular, two-light, vinyl, sliding window.

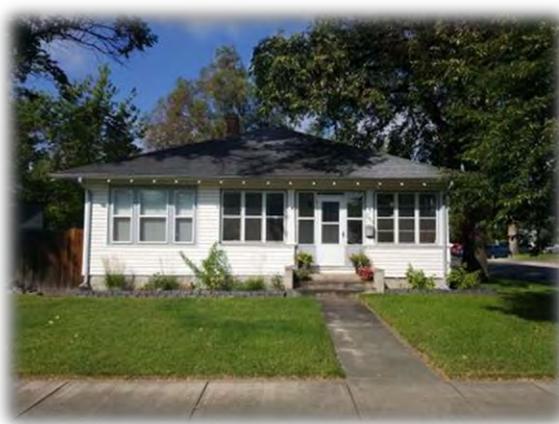
**Figure 11: 203 S. Park Avenue**

This one-story, pyramidal house has a square plan. The façade (east facing) faces S. Park Avenue. The house has an unpainted, concrete foundation. The pyramidal roof has overhanging eaves with exposed rafter tails and is clad in the black, asphalt shingles. The building is clad in horizontal, wood, clapboard siding that is painted white. The trim is painted grey. There is a brick chimney, and a round, metal, prefabricated chimney on the southern slope of the roof. The entrance on the façade is off center to the north. Concrete steps lead to the entrance that appears to open up on to an enclosed porch, which stretches across the northern two-thirds of the facade. It is a two-light, white, metal, storm door. The entrance is flanked by two windows. All of the windows on the building (unless otherwise noted) are tall, rectangular, two-light, double-hung, vinyl, sash windows. On either side of the entrance are three-part ribbon windows. There is another three-part ribbon window on the south side of the façade; the middle window is slightly wider than the two on either side of it. This ribbon window has wood surrounds. A tall fence obstructs views of the south elevation. The west elevation has three windows with wood surrounds. There is also a small, horizontal, vinyl, sliding window on the west side of the north elevation. The north elevation has a single window on its west side and a three-part ribbon window with wood surrounds just east of center. This ribbon window, like the one on the façade, has a slightly wider middle window. There is another three-part ribbon window on the east side of the north elevation that makes up part of the enclosed porch.

house has no major additions, though the original windows and doors have been replaced, and the previously open porch was enclosed at some point. For these reasons, the house does not retain integrity of design, materials and workmanship. While these integrity considerations eliminate this resource from consideration for individual listing to the NRHP/SRHP and as a Fort Lupton Historic Landmark, the building retains sufficient integrity through its form, massing, and key exterior features to warrant further investigation as a contributing resource in the potential Reynolds Addition(s) historic district listed under Criterion C.

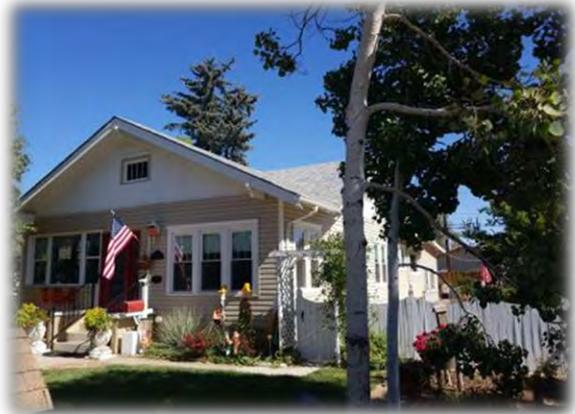
**Figure 12: 218 S. Park Avenue**

The one-and-a-half-story, cross-gabled, Craftsman Bungalow has a rectangular plan. The façade (west facing) faces S. Park Avenue. The house has a concrete foundation painted tan. The roof has overhanging eaves and exposed, decorative roof beams. The building's first story is clad in horizontal, wood clapboard siding painted tan. The half story in the gables is stucco painted white. The trim is painted white. Unless otherwise stated, the windows are three-over-one, double-hung, sash windows with plain wood surrounds. The entrance on the façade is just north of center. This contemporary entrance has a large, single-light, fixed window. There is a two-light sidelight on the south side of the door. Both the door and the wood surround of the sidelight are painted red. Three concrete steps lead to the entrance. There is a three-part ribbon widow on the south side of the façade. There is a contemporary, three-part, vinyl, picture window on the north side of the façade. The large center window is a single, fixed light. There is a one-over-one, double-hung window on either side of the fixed-light window. In the upper-half story of the façade, in the gable, there is a horizontal, four-light, fixed window. The north elevation of 218 S. Park Ave is mostly obscured by vegetation, but a horizontal, four-light, fixed window is visible in the center of the gable. The east elevation is not visible from the pedestrian right-of-way. The south elevation is also partially obscured by vegetation and a fence. There is a pair of windows in the center of the elevation and a second pair at the far west side.

The house has not been moved and the neighborhood is relatively unchanged from when the house was constructed. For these reasons, the resource retains integrity of location, setting, feeling and association. The multi-light windows, exposed roof supports, and other stylistic details are still intact; therefore, the house retains its workmanship. The property has an addition built off of its east elevation; therefore, the house has diminished integrity of design. The entrance and a ribbon window on the façade have both been replaced, and

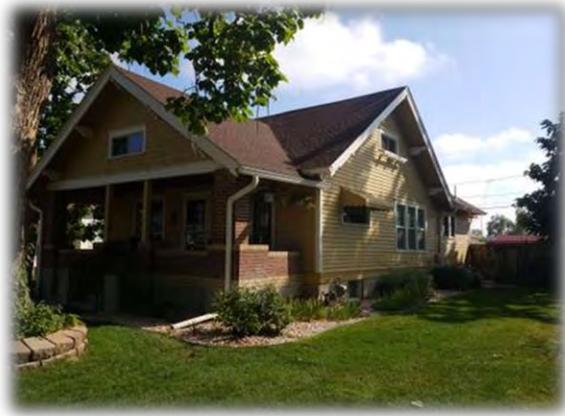
**Figure 13: 134 S. Park Avenue**

This one-and-a-half story, side-gabled, Craftsman Bungalow has a rectangular plan. The façade (west facing) faces S. Park Avenue. The house has an unpainted, concrete foundation. The gabled roof has overhanging eaves with decorative, exposed roof beams and thin, decorative, wood, verge boards in the gables. The roof is clad in asphalt shingles. The building is clad in horizontal, wood, clapboard siding that is painted yellow. The trim is painted white. A large, gabled porch stretches across the majority of the house's façade. Concrete steps lead to the porch. A solid, brick railing wraps around the porch. Most of the railing is red brick, but there is a yellow brick belt line at the bottom, right above the foundation. On

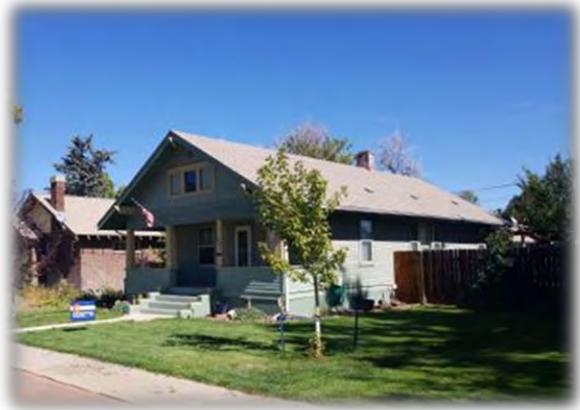
**Figure 14: 236 S. Park Avenue**

This one-and-a-half story, front-gabled, Craftsman Bungalow has a rectangular plan. The façade (west elevation) faces S. Park Avenue. The house has a concrete foundation painted light blue. The roof has overhanging eaves and exposed rafter beams and is clad in grey, asphalt shingles. There is a brick chimney at the peak of the roof on the east side. The building's first story is clad in horizontal, wood clapboard siding painted light blue. The half story in the gables is clad in wood shingles. All of the trim is painted yellow. Unless otherwise stated, the windows are large, one-over-one, double-hung, sash windows. Although a close visual inspection of the windows was not possible during this evaluation, windows appear to be made of wood. A

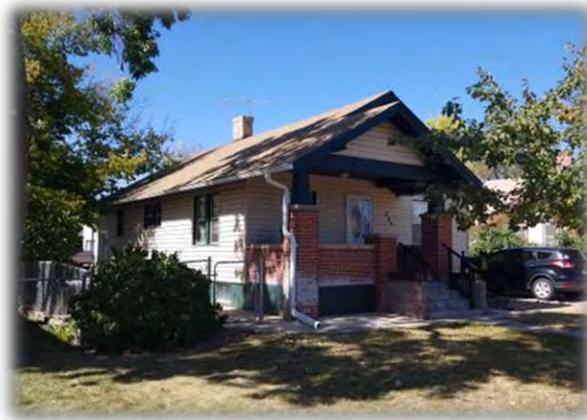
**Figure 15: 229 S. Park Avenue**

This one-and-a-half story, front-gabled, Craftsman Bungalow has a rectangular plan. The façade (east facing) faces S. Park Avenue. The house has a concrete foundation painted green. The house is clad in horizontal, wood clapboard siding painted tan. All of the trim is painted green. The roof has overhanging eaves and exposed roof beams and is clad in brown, asphalt shingles. There is a brick chimney on the west end of the roof's peak. Unless otherwise stated, all of the windows are one-over-one, double-hung, sash windows. An attached, front-gabled porch stretches across the south half of the façade. Concrete steps lead to the porch. A

A solid, brick railing wraps around the porch. Short, square, porch piers sit on top of the brick railing and support the porch roof. The porch roof has exposed rafter tails and roof beams. The entrance to the house is on the north side of the porch. A two-light, metal screen door covers the entrance. There is a window to the south of the entrance, also under the porch. There is a second window north of the entrance that is not under the porch. A square, one-light, fixed window sits beneath the gable peak. A small, horizontal window is built into the foundation on the east end of the south elevation. There is also a paired window on the east end of the south elevation. A second, much shorter, paired window sits in the center of the elevation. A single window is on the far west end of the south elevation. The west elevation of the property is not visible from the pedestrian right-of-way. Visibility of the west end of the north elevation is obscured by a parked vehicle, but a single window is visible in the center of the north elevation and a double window sits on the east side.

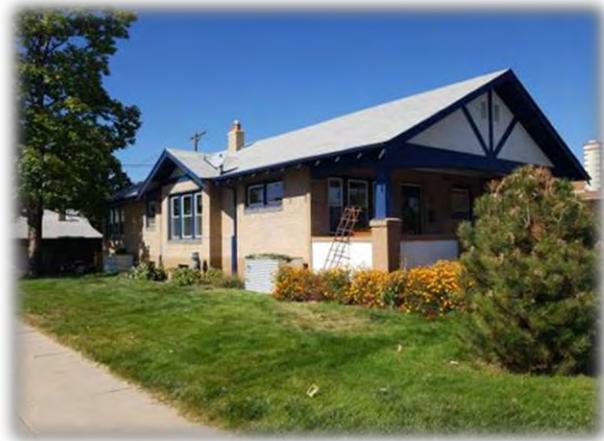
**Figure 16: 243 S. Denver Avenue**

This one story, Craftsman Bungalow is made primarily of brick, is constructed on a poured concrete foundation and has a rectangular plan. The house has a front gabled roof with overhanging eaves. The façade (east facing) contains four windows and the front door granting entrance to the house. Five concrete steps lead up to a covered patio supported by two square tapered columns. The low walls enclosing the patio are clad in stucco and a crossbeam with tapered ends spans the width of the elevation. The main door to the house is centered on the elevation. To the left of the door is window bay containing three, one-over-one sash windows with projecting brick sill- the centermost window is slightly larger than the two flanking it. To the right of the front door is a medium sized one-over-one sash window with projecting brick sill. The north facing elevation contains three casement basement windows evenly distributed across the bottom the elevation. Above each basement window is a larger window bay. The centermost window bay contains a single one-over-one sash window with projecting brick sill. The window bays to the left and right of the single window each contains two, one-over-one sash windows with a projecting brick sill. The south facing elevation can be split into three separate sections. Each section has a basement casement window. The centermost section projects out from the rest of the house slightly and contains a window bay with three, narrow one-over-one sash windows with a projecting brick sill. The centermost, projecting section of the south elevation is covered by a gabled roof. The section to the right-of-center contains a narrow rectangular window bay with two casement windows and a projecting brick sill. The section to the left-of-center contains a one-over-one sash window and a medium size window bay with three, one-over-one sash windows with a projecting brick sill. The rear (west) facing elevation of the house can be separated into two sections. Four concrete steps lead to a wooden screen door, flanked on either side by two vertically oriented, narrow fixed pane windows. The right section contains a window bay containing three, one-over-one sash windows with a projecting brick sill. A detached single-car garage with a gable roof is located on the southwest corner of the parcel. The garage opens to the south, and a shed roof addition was constructed off of the east elevation to allow for additional covered parking. Like the main house, the roof of the garage, including the addition, has overhanging eaves.

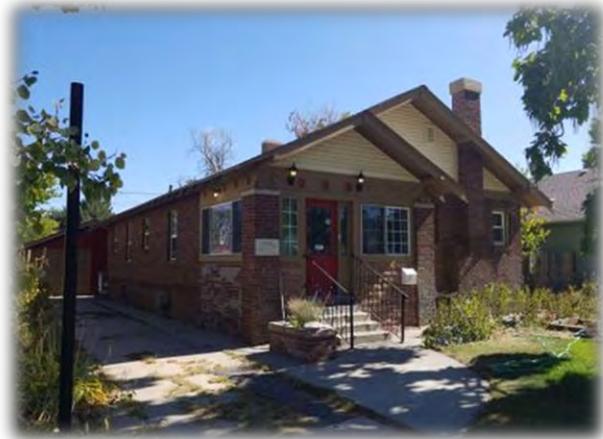
**Figure 17: 226 S. Park Avenue**

The one-story, front-gabled, brick, Craftsman house has a rectangular plan. The façade (west facing) faces S. Park Avenue. The entire house is brick, except underneath the gable peaks which is clad in horizontal, wood clapboard siding painted white. The gabled roof has overhanging eaves and exposed rafter tails. There is a brick beltline at foundation height. The trim is painted mustard brown. A narrow, front-gabled, entryway stretches across the north half of the façade, replicating an attached porch. Like the roof, it also has exposed rafter tails. The cladding of this entryway differs from the rest of the house—red sandstone. There are two, large, squared, brick supports, capped with a white stone, on either side of the entryway. The entrance to the house is painted red and has a large, single light. The entrance had a single-light sidelight to its immediate south. To the south of the sidelight is a twelve-light, paired, vinyl, sliding window. To the north of the elevation is an eight-light, fixed window. The south half of the façade has a brick chimney. There is a vinyl, sash window with brick sills on either side of the chimney. The north elevation has two basement windows. There is a vinyl picture window on the west side of the north elevation. Someone replaced or altered the brick beneath this window. There are four sash windows with brick sills along the rest of the elevation, two small and two large. A second brick chimney sits at the

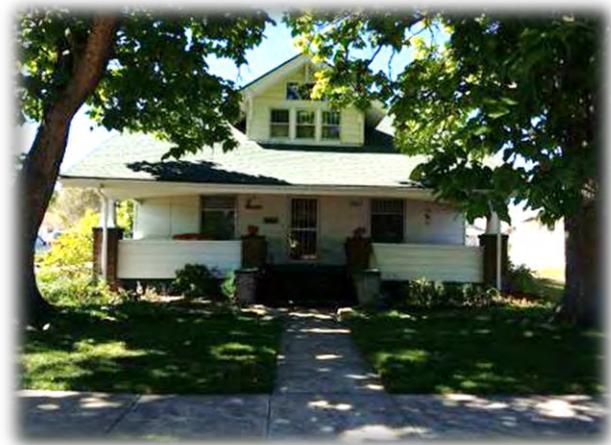
**Figure 18: 247 S. Park Ave**

The one-and-half-story, side-gabled, Craftsman bungalow has a rectangular plan. The façade (east facing) faces S. Park Avenue. The house has a concrete foundation painted green. The gabled roof has overhanging eaves and simple, wood brackets under the gable on the north and south elevations. The roof is clad in green, asphalt shingles. There is a brick chimney on the west slope of the roof and a second brick chimney on the north elevation. The house is clad in horizontal, wood, clapboard siding painted white. Except when otherwise stated, all the windows are five-over-one, sash windows. A recessed porch stretches across the entire facade; the house's gabled roof continues over the porch.

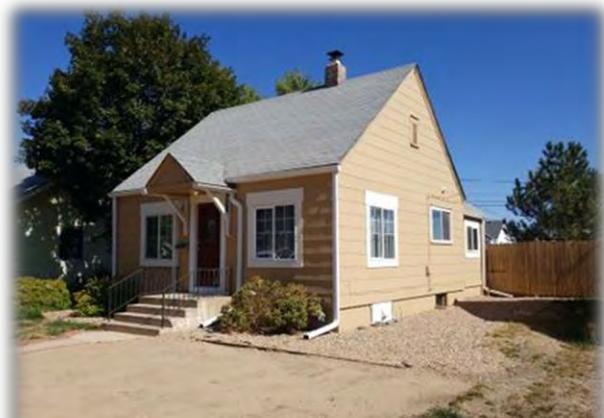
**Figure 19: 320 S. Park Ave**

This one-story, cross gabled roof, Minimal Traditional house has a rectangular plan. The house is constructed on a concrete foundation and the façade is oriented to the west. The house is clad in horizontal, wood weatherboard siding painted yellow with white trim. The roof is clad in grey, asphalt shingles and has a small narrow brick chimney. Unless otherwise noted, all windows on the house are vinyl, four-over-one, single hung sash windows. At some point, an addition was constructed on the rear (east) elevation. Concrete steps lead to the entrance of the house, which is centered in the façade. Wrought iron railings are located on either side of the steps. A single pane, metal frame storm door covers the wood entrance. A slightly projecting, bracketed gable roof covers the front entrance.

The front door is painted a dark red and is flanked on either side by a window opening, each containing four-over-one sash windows. The south facing elevation can be separated into two bays, the west bay and the east bay. The west bay contains two casement windows built into the foundation. Above these basement windows are two window openings. The westernmost window opening contains two, four-over-one sash windows. The easternmost window opening contains a horizontally oriented, single pane sliding window. Above the two window openings is a vent, oriented in the center of the roof peak. The east bay of the elevation contains a single window opening with a horizontally oriented, single pane sliding window. The north facing elevation contains two casement windows built into the foundation. Above the easternmost basement window is a small window opening containing a four-over-one, sash window. A window-mounted air condition unit has been installed in the window opening.

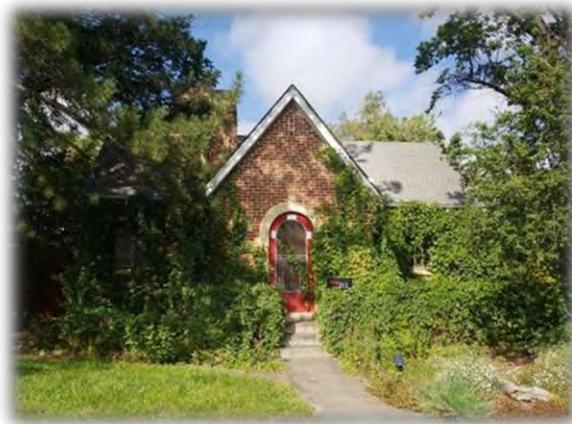
**Figure 20: 211 S. Park Avenue**

This one-story, cross-gabled-and-hipped, vernacular English-Norman cottage has a rectangular plan. The façade (east facing) faces S. Park Avenue. The house is made primarily of red brick, including the foundation. Two yellow-brick belt courses wrap around the house at the top of the foundation. The front of the house has a cross-gabled, steeply pitched roof. An addition in the back has a hipped roof. The roof is clad in black, asphalt shingles. Vegetation on and around the building limits visibility significantly from the right-of-way. A dominant gable extends out from the center of the façade. Concrete steps lead to the entrance. The entrance is a wood door with a round arch. There is a wood, screen door painted red in front of the main entry. Decorative metal bars cover the bottom half of the screen. Decorative yellow brick (with a brick keystone) surrounds the entrance. Two, small, round-arched windows flank the entrance. There are three decorative red bricks in the peak of the gable. On either side of the extending gable are six-light casement windows, painted black with wood surrounds. Those casement windows are flanked by three-light, fixed windows, also painted black. To the south of the extending gable is a large, brick chimney with yellow-brick, decorative details. There is a sixteen-light window in the center of the south elevation. The sill of the window is yellow brick. Views of the rest of the south elevation, the west elevation, and the north elevation are all not visible from the right-of-way. Aerial photos show that an addition is built off of southwest corner of the house.

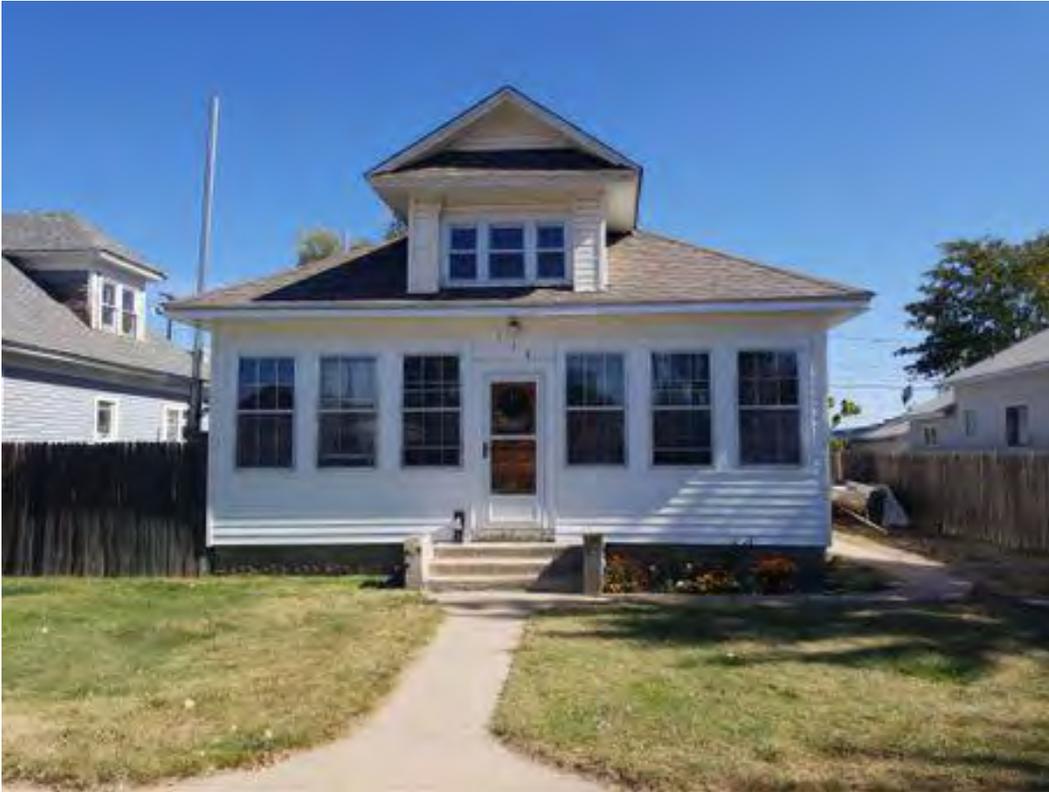
**Photo Number:** 5WL\_8916\_1  
**Description:** Primary (west) elevation. Note gable-roofed dormer.  
**View:** East

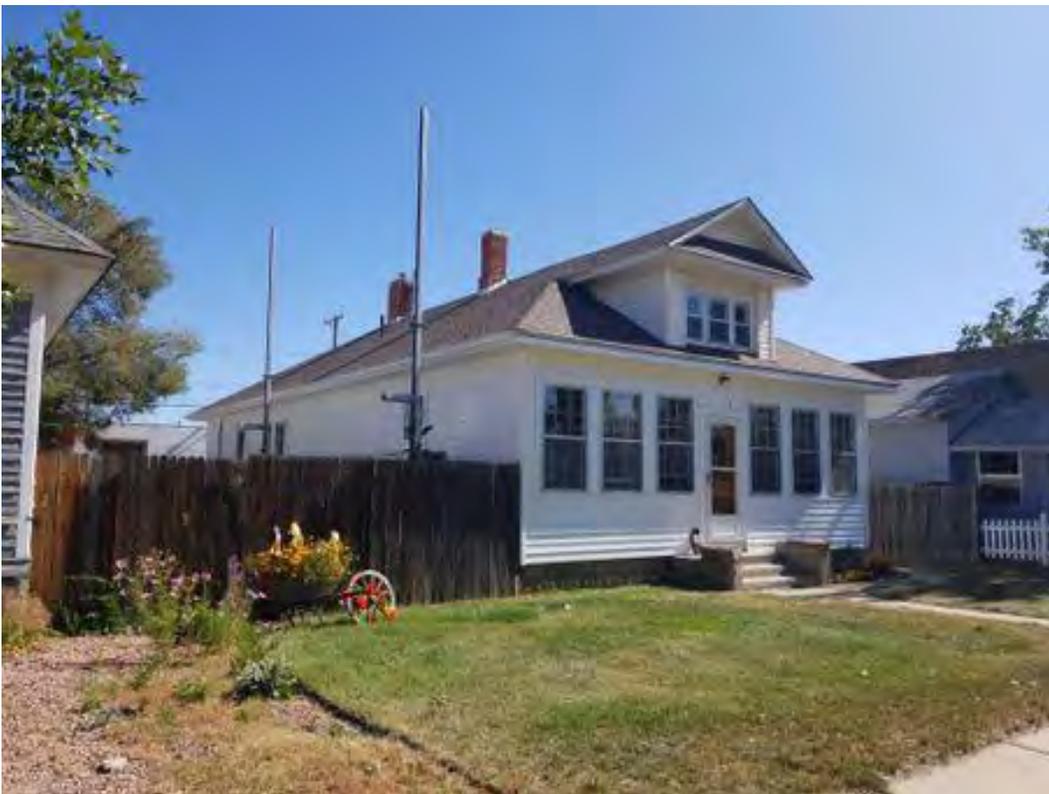
**Photo Number:** 5WL\_8916\_2  
**Description:** Primary (west) elevation and north elevation. Note two brick chimneys.  
**View:** Southeast

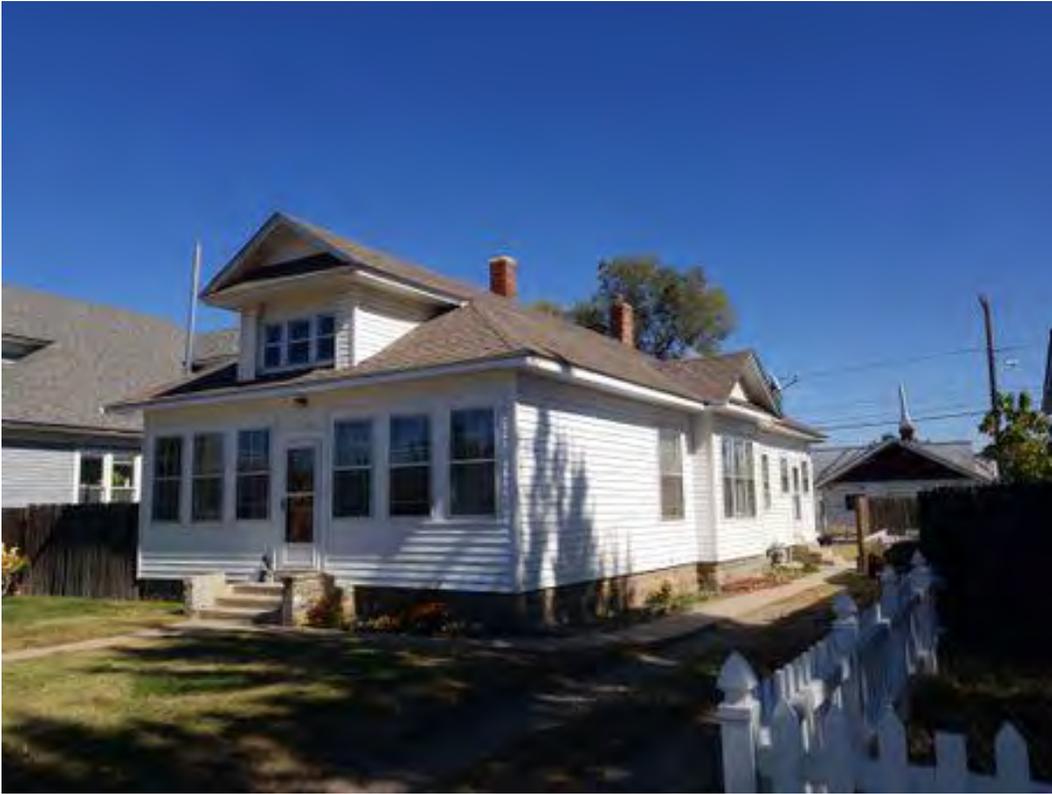
**Photo Number:** 5WL\_8916\_3

**Description:** Primary (west) elevation and south elevation. Note squared bay with gabled roof.

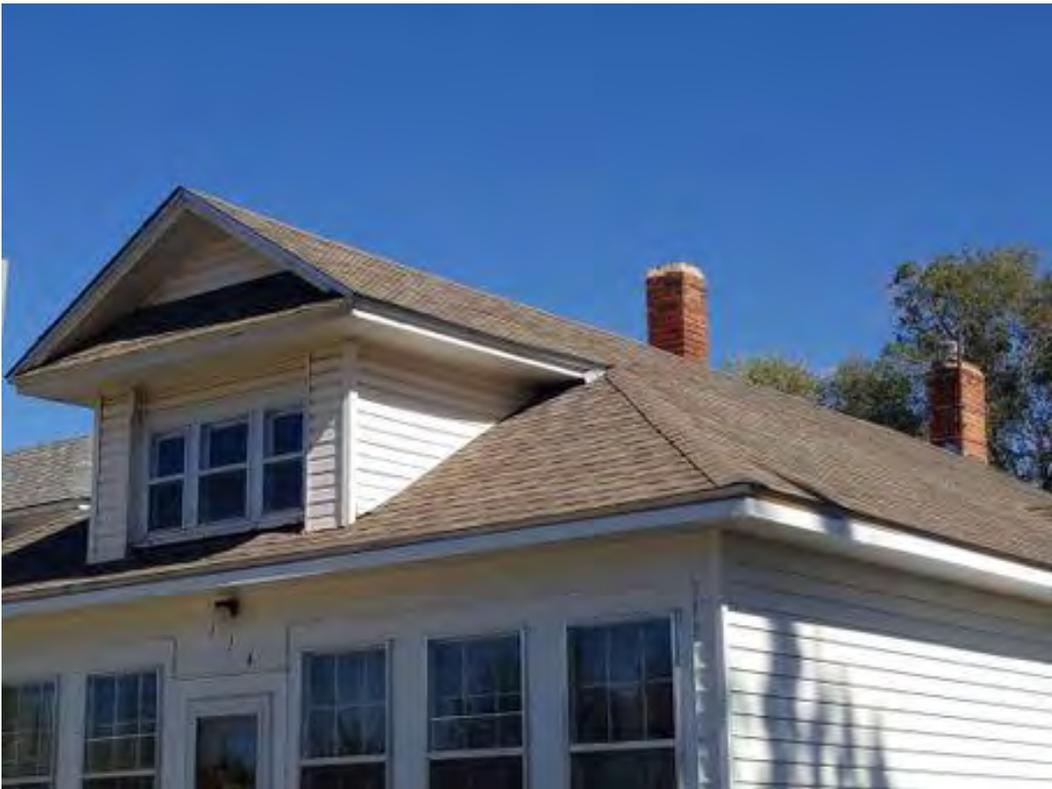
**Photo Number:** 5WL\_8916\_4

**Description:** Dormer with gabled-roof and ribbon window.

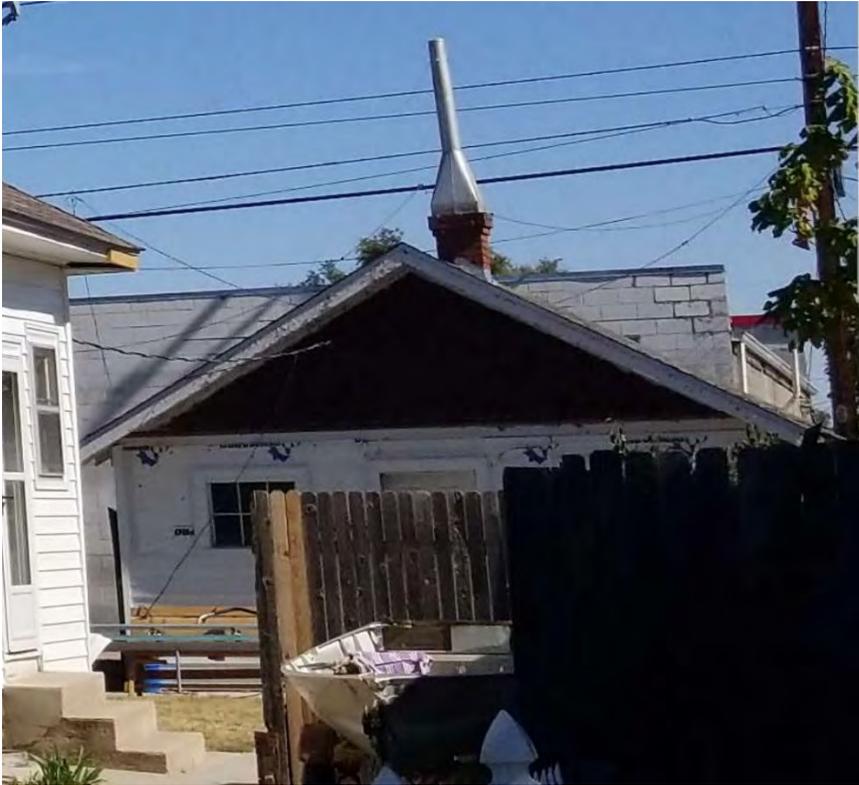
**Photo Number:** 5WL\_8916\_5

**Description:** Detached garage with hipped roof and distinct chimney. Note the siding being replaced.

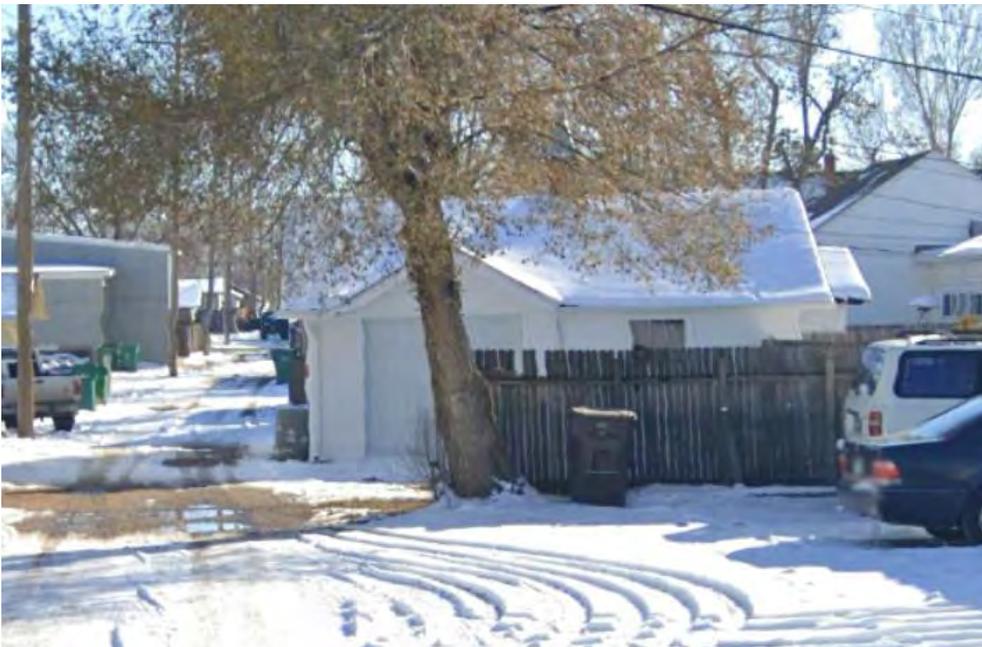
**Photo Number:** 5WL\_8916\_6

**Description:** Hipped roof detached garage. Supplemental photograph from Google Earth. Building was under construction and obscured from view during this evaluation.

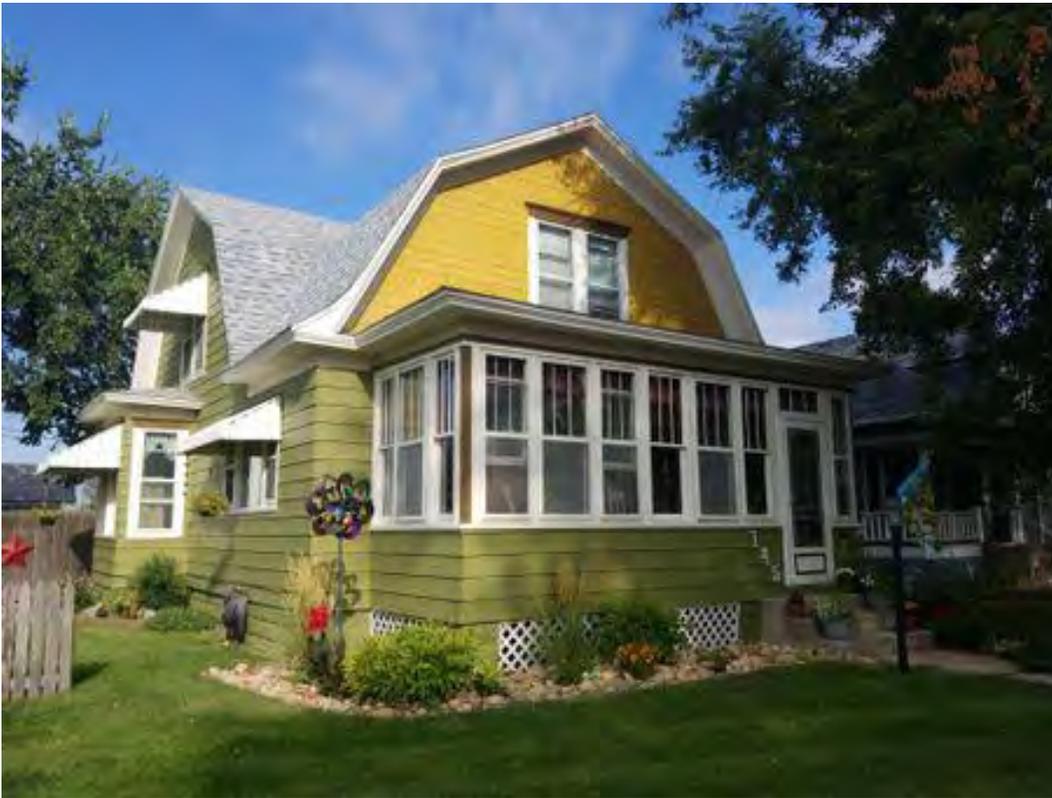
**Photo Number:** 5WL.8917\_1

**Description:** Primary (east) and south elevation of house. Note the yellow painted decorative fish scale siding in the upper bay.
