## **Reynolds Addition and Reynolds Second Addition Intensive Survey**

**Historic Residential Intensive-Level Survey – Phase II  
Certified Local Government Grant No. CO-19-10005  
Fort Lupton, Colorado**

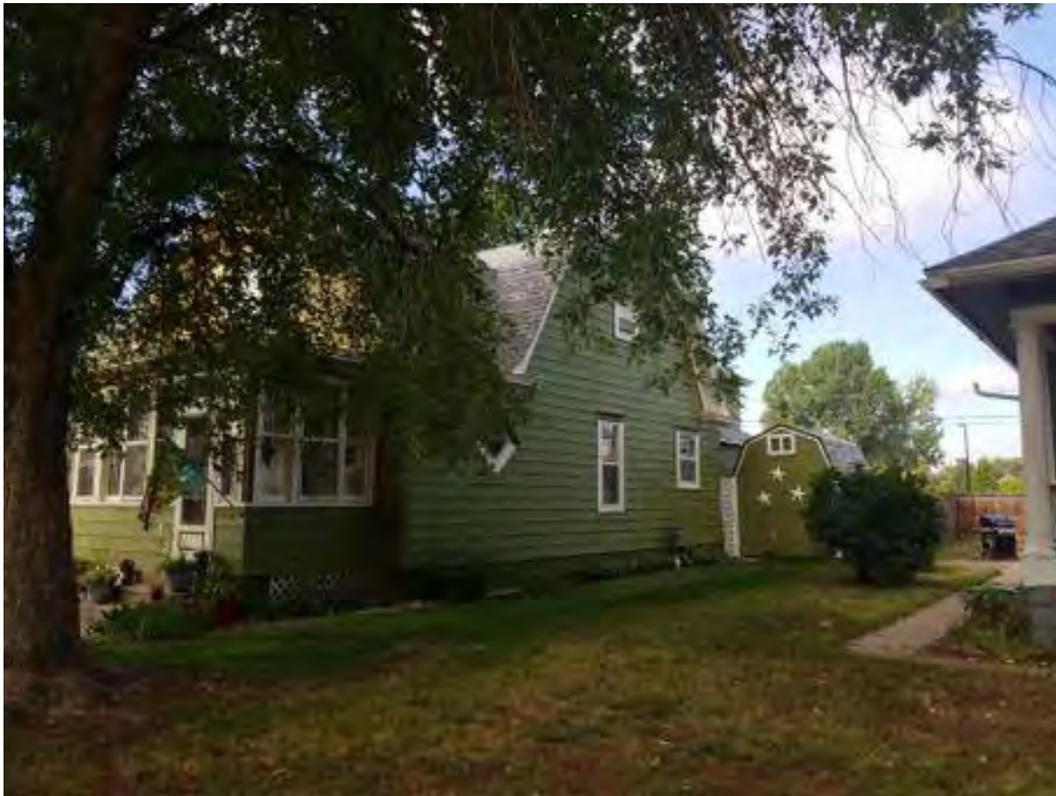
**Photo Number:** 5WL.8917\_3

**Description:** North facing elevation.  
Note the diamond shaped accent window.

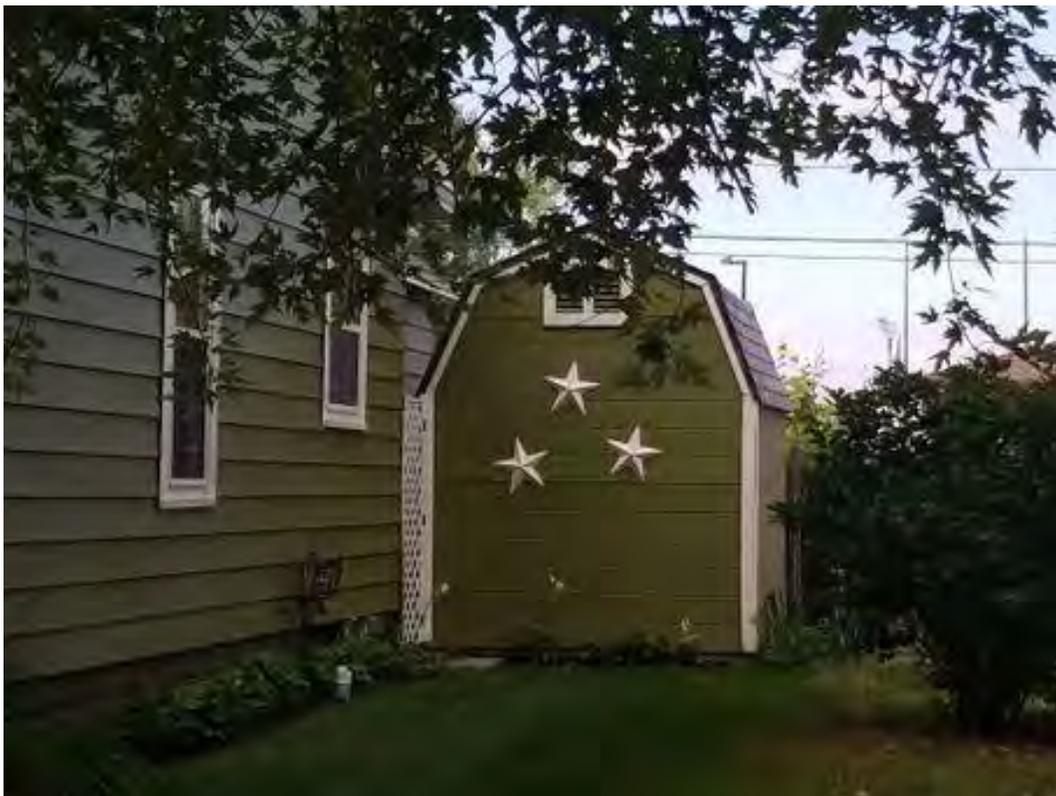
**Photo Number:** 5WL.8917\_4

**Description:** Shed with decorative stars.  
Located on north side of parcel.

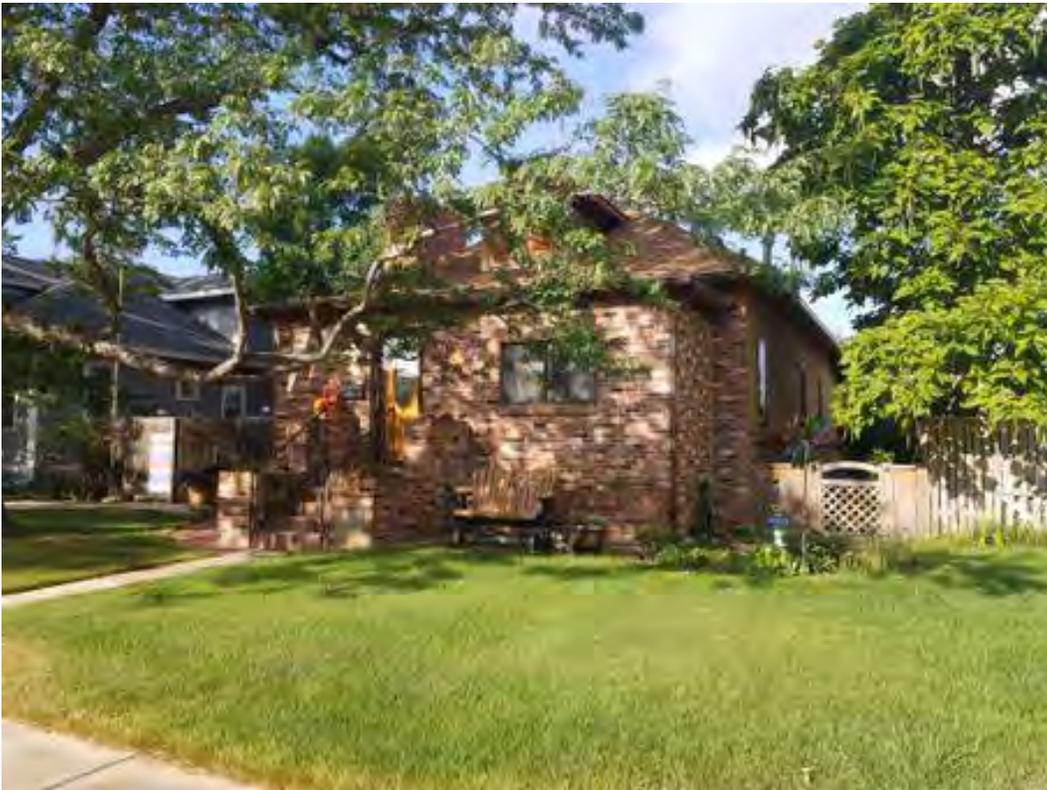
**Photo Number:** 5WL\_8918\_1

**Description:** Primary (east) and north facing elevations. Note the brick planters on either side of stairs and under window. Note dormer with window vents.

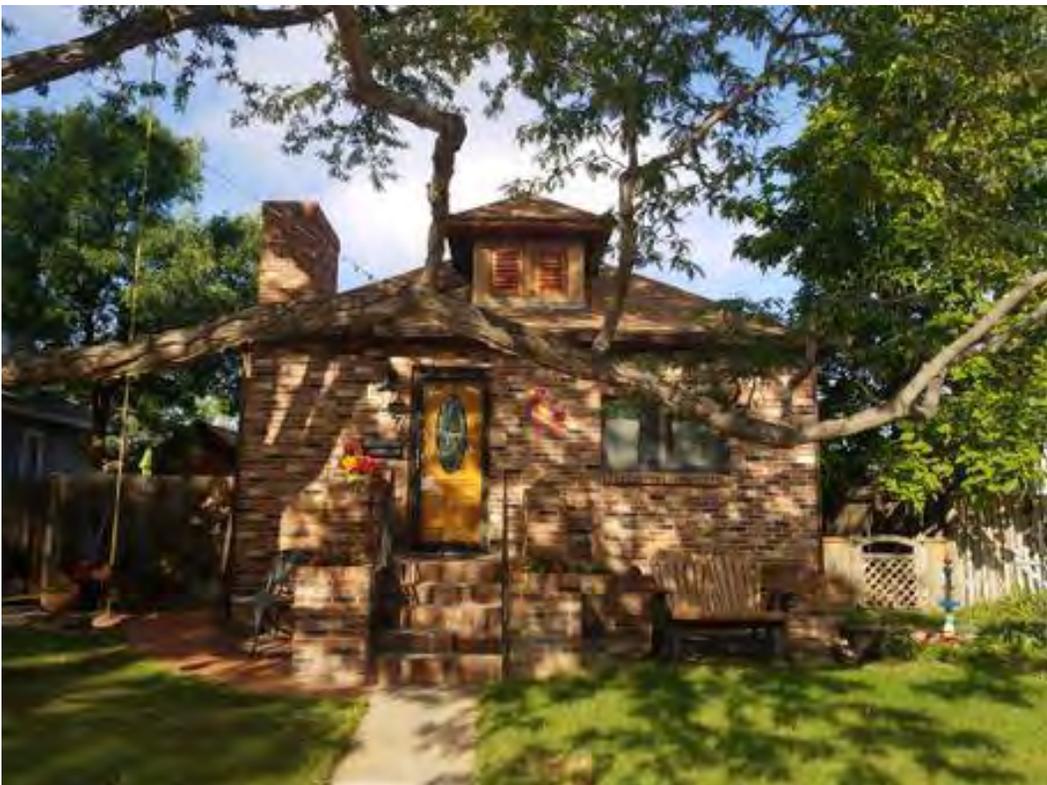
**Photo Number:** 5WL\_8918\_2

**Description:** Primary (east) facing elevation. Note the decorative window on the front door and dormer with window vents. Note brick chimney projecting from south elevation.

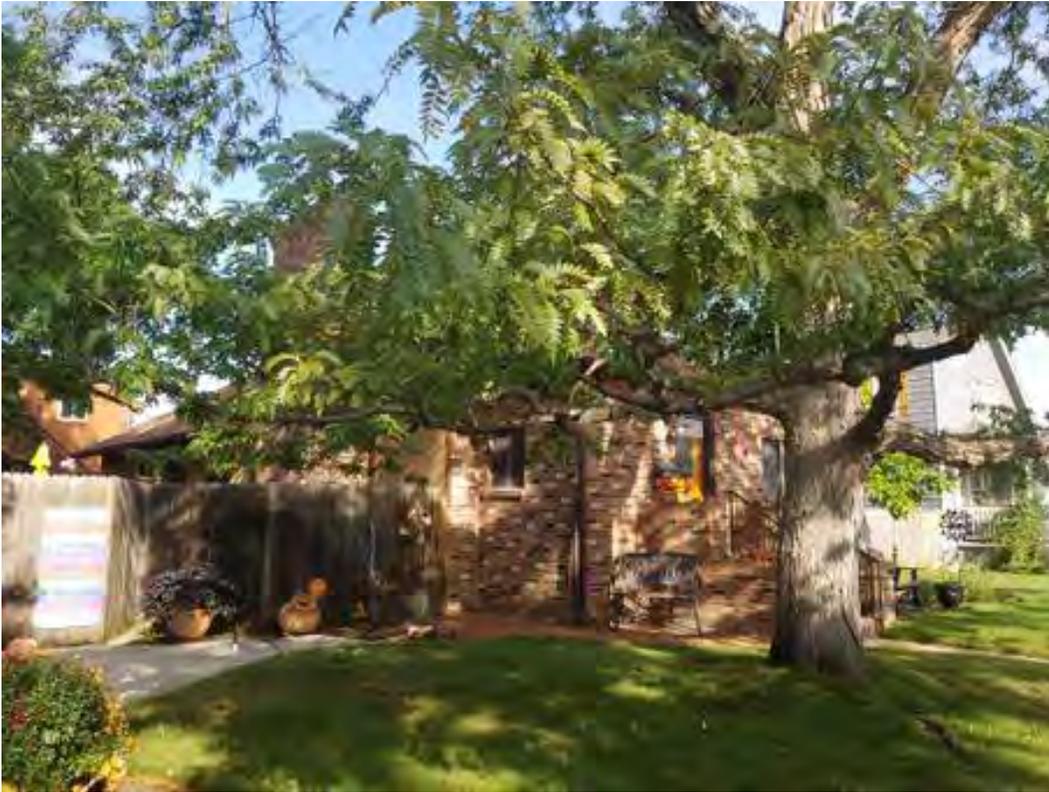
**Photo Number:** 5WL\_8918\_3

**Description:** South facing elevation.  
Note the brick chimney and small window with projecting brick sill

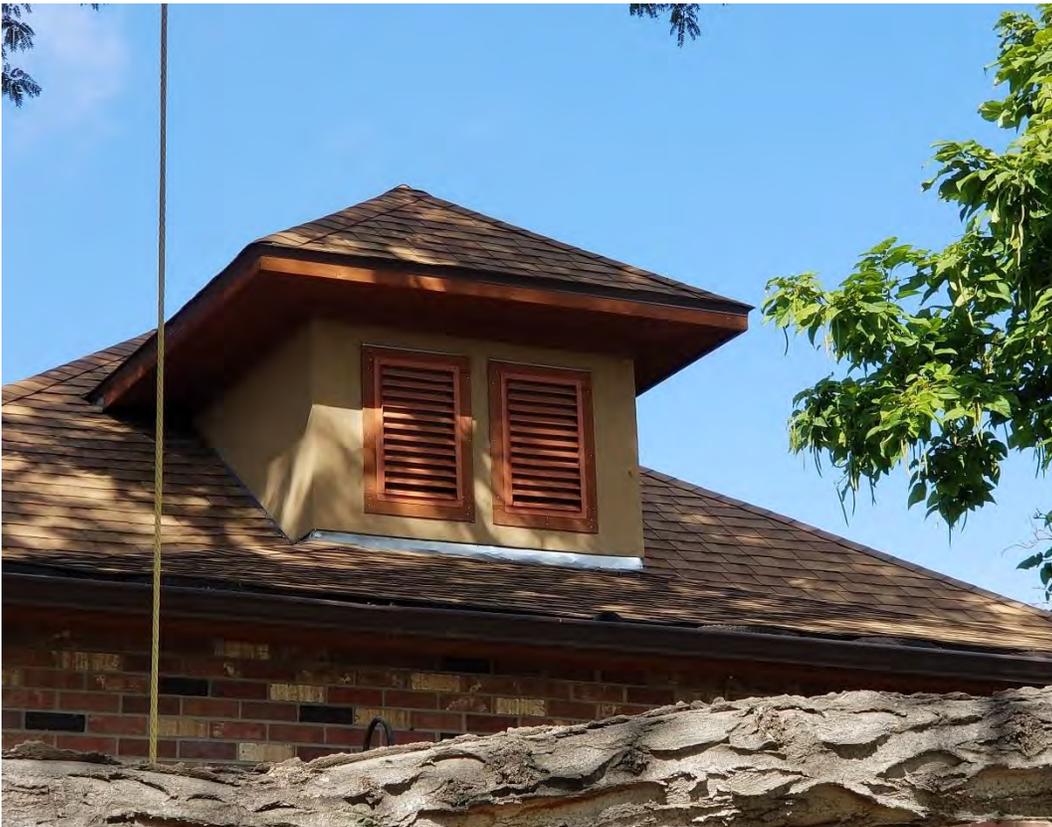
**Photo Number:** 5WL\_8918\_4

**Description:** Dormer with pyramidal  
roof and fixed shutters.

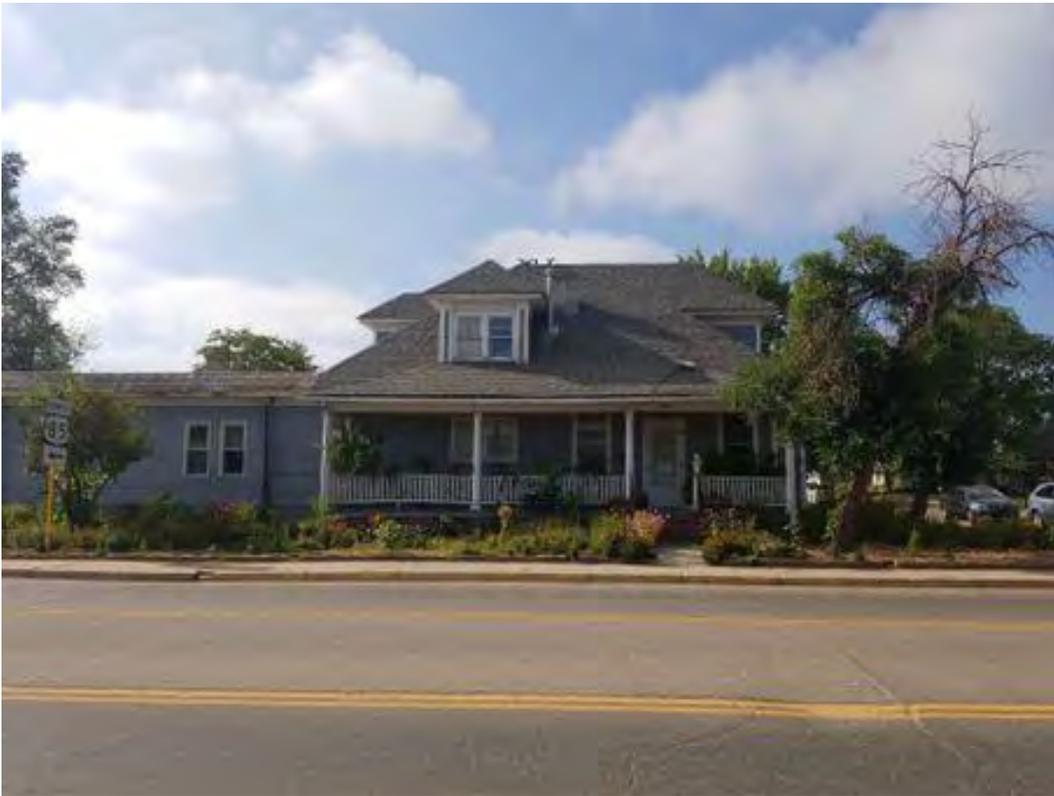
**Photo Number:** 5WL.8919\_1

**Description:** Primary (North) facing elevation. Note flat roofed addition projecting from east (left) side of house. Note the hipped dormer and porch columns with cushion capitals.

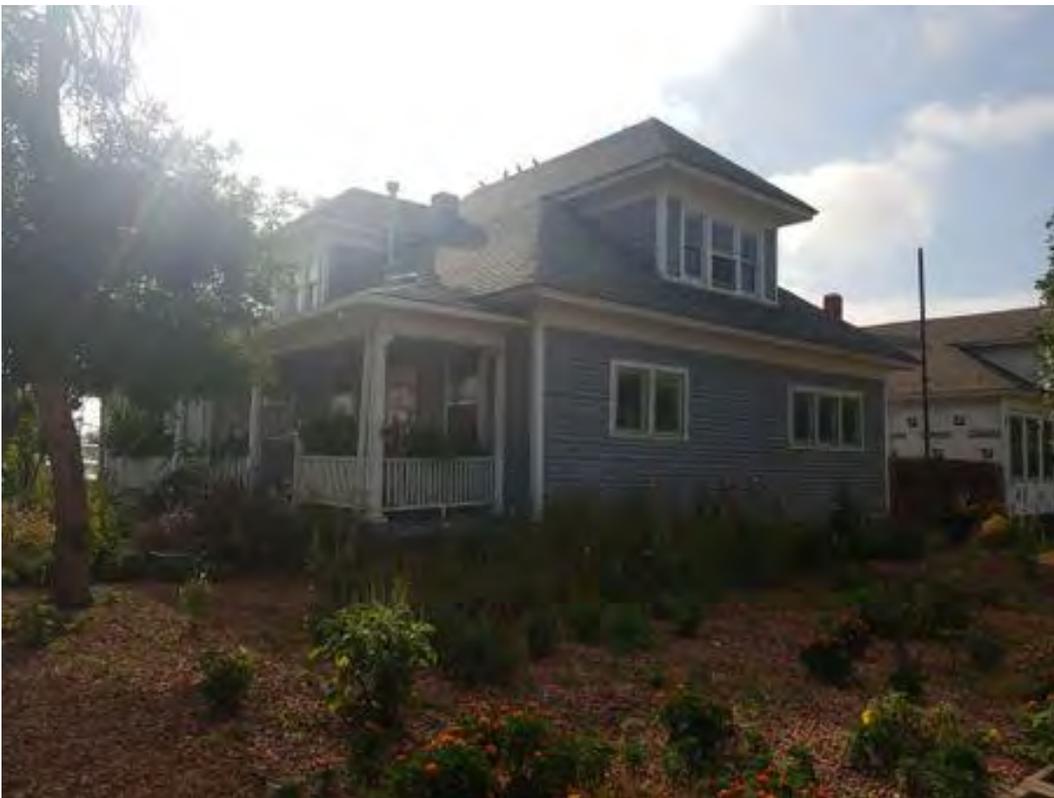
**Photo Number:** 5WL.8919\_2

**Description:** North and west facing elevations. Note roof dormers and porch columns with cushion capitals.

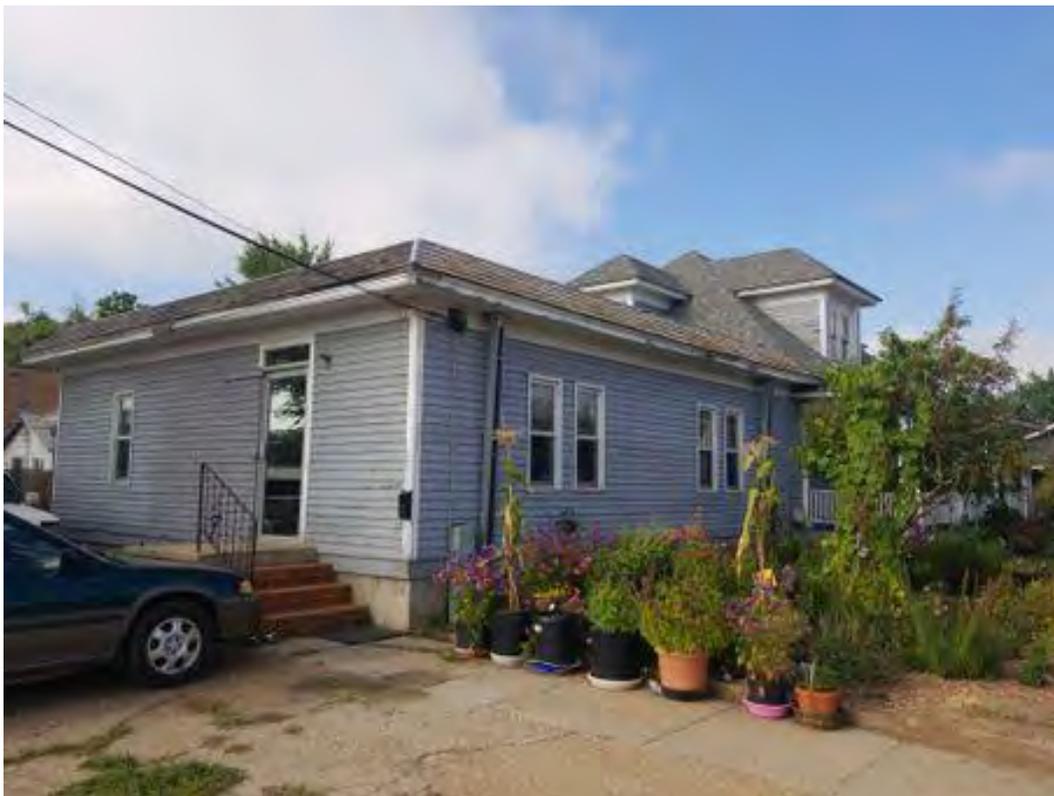
**Photo Number:** 5WL.8919\_4

**Description:** North and east facing elevations. Note the flat roof addition, constructed at an unknown date.

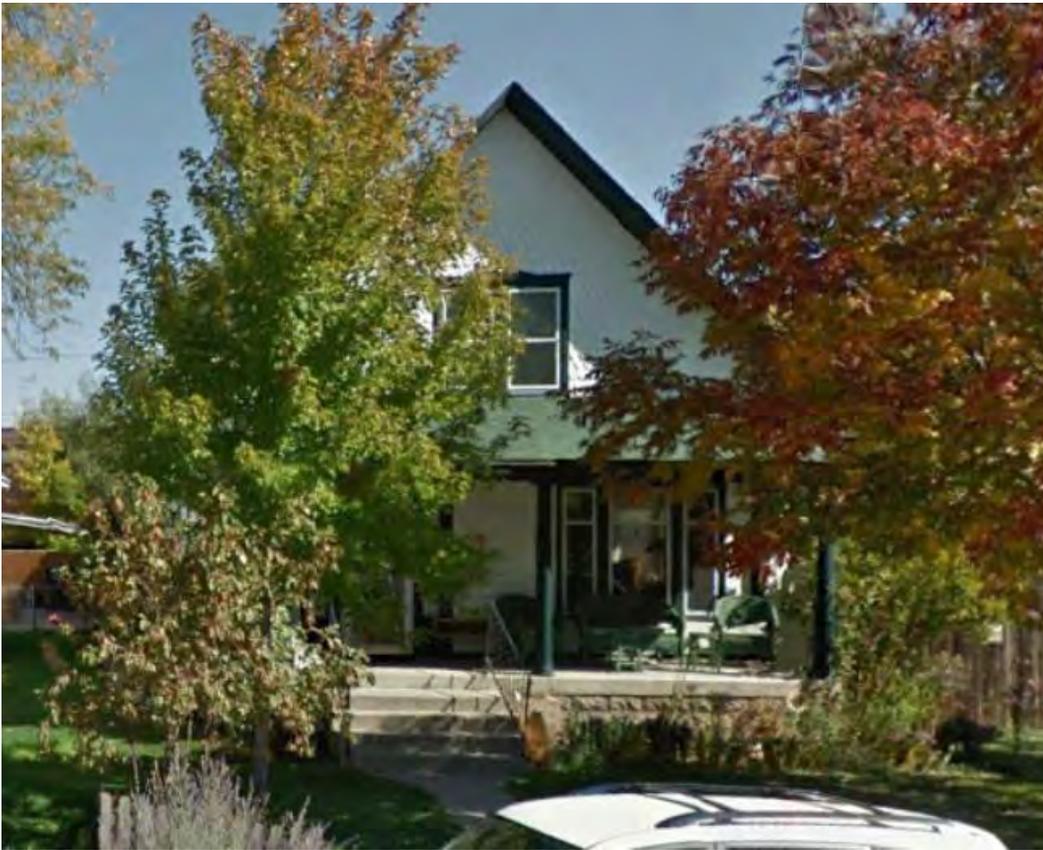
**Photo Number:** 5WL.8920\_1

**Description:** Primary (west) facing elevation. Note the steep, gabled roof and fish scale siding.

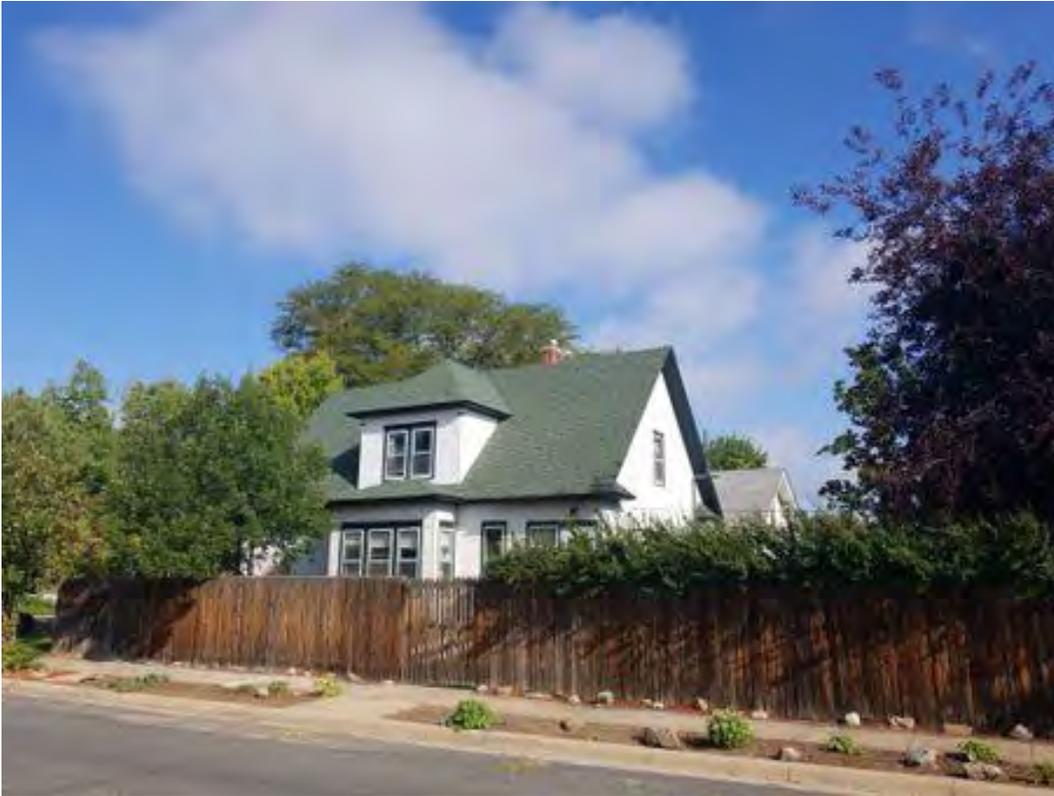
**Photo Number:** 5WL.8920\_3

**Description:** South facing elevation.  
Note the hipped roof dormer over  
a projecting bay on the first story.  
Brick chimney in background.

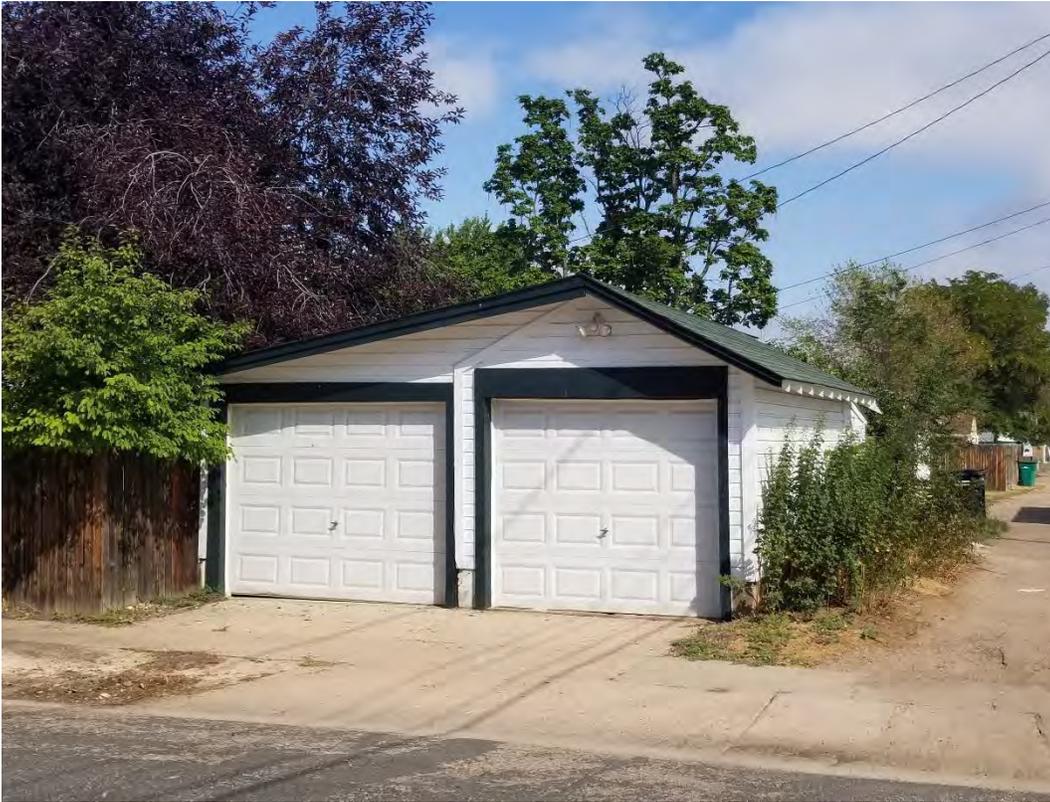
**Photo Number:** 5WL.8920\_5

**Description:** Detached garage, located at southeast corner of parcel. Note the overhanging, bracketed eaves and offset roof, the result of a later addition.

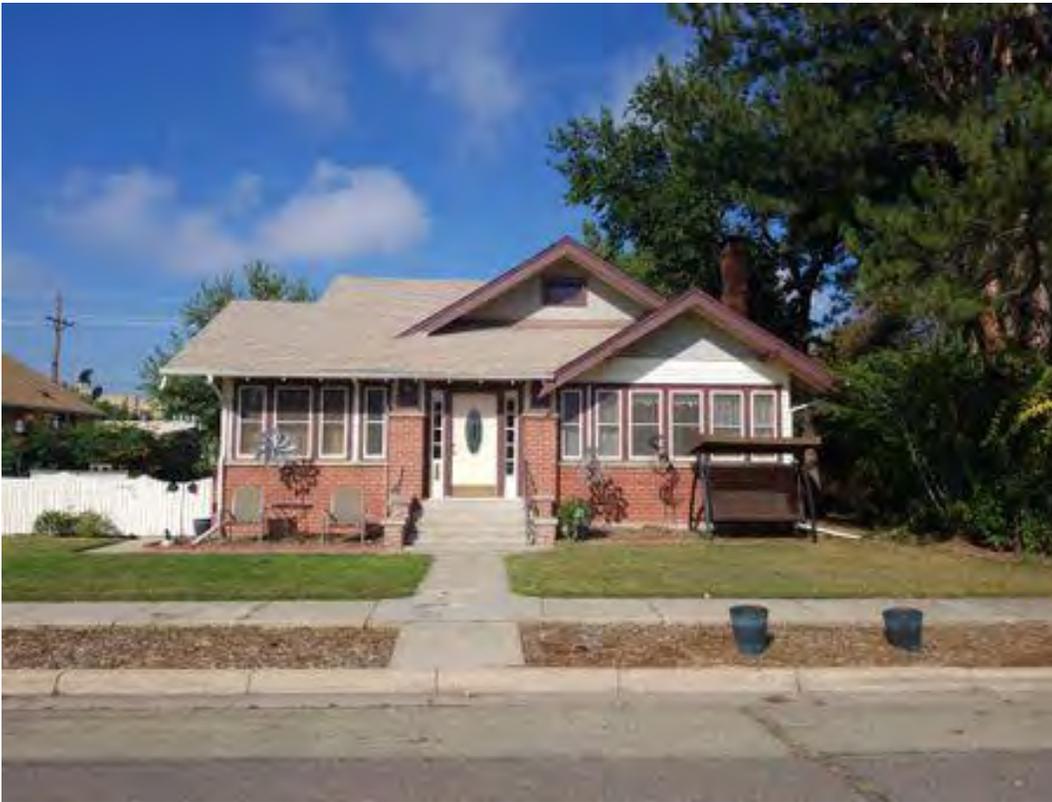
**Photo Number:** 5WL.8921\_1

**Description:** Primary (east) facing elevation. Note the additional gable, brick work and ribbon of sash windows.

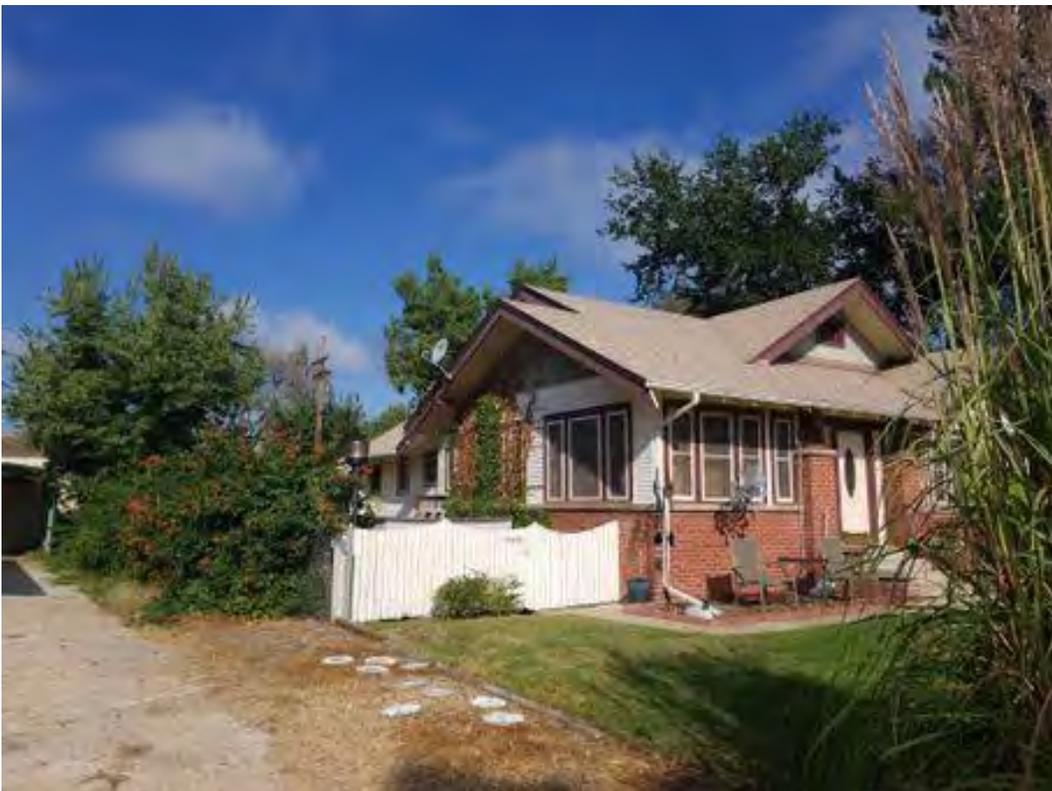
**Photo Number:** 5WL.8921\_2

**Description:** South and East facing elevations. Note the additional gable, brick work and ribbon of sash windows.

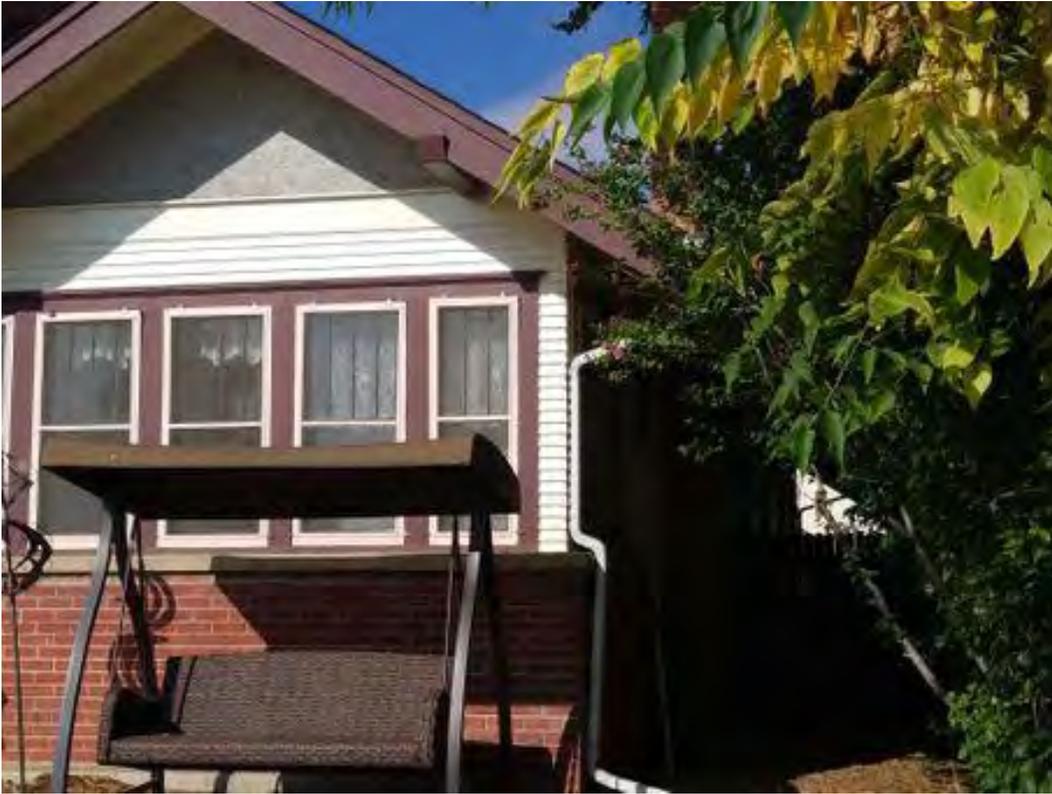
**Photo Number:** 5WL.8921\_3

**Description:** North facing elevation (obscured by shadow) and primary elevation. Note the ribbon of sash windows, brick work and exposed rafter ends.

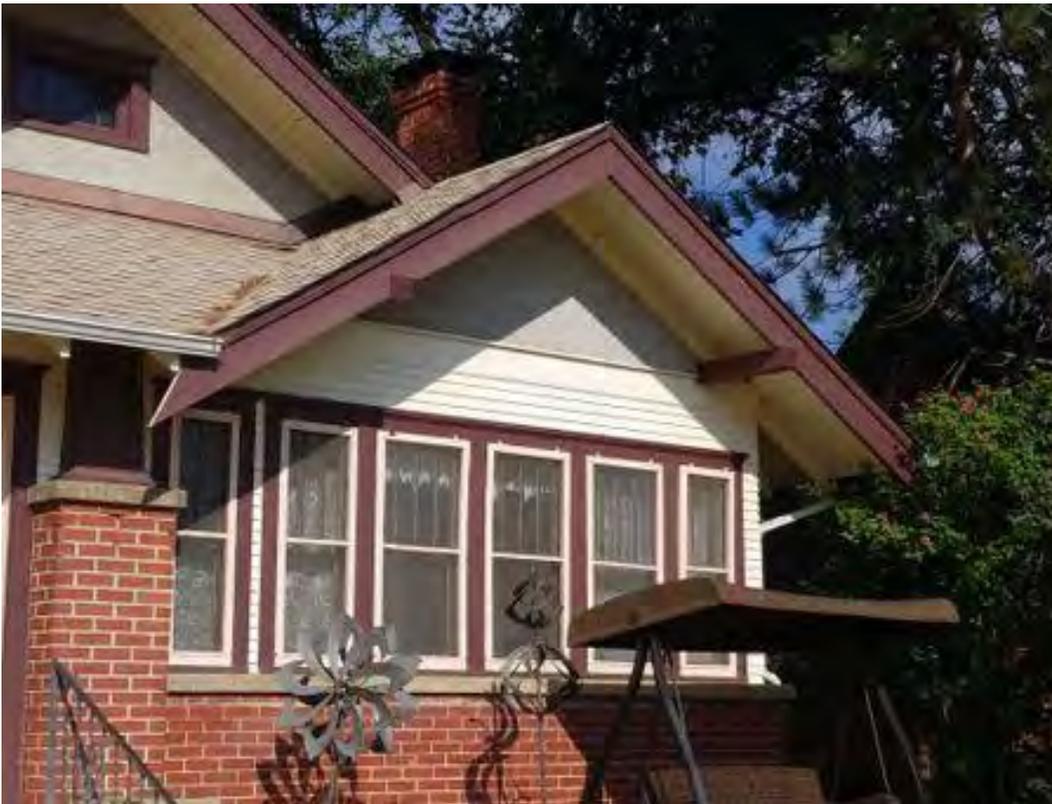
**Photo Number:** 5WL.8921\_4

**Description:** Primary elevation. Note the ribbon of sash windows, brick work and exposed rafter ends.

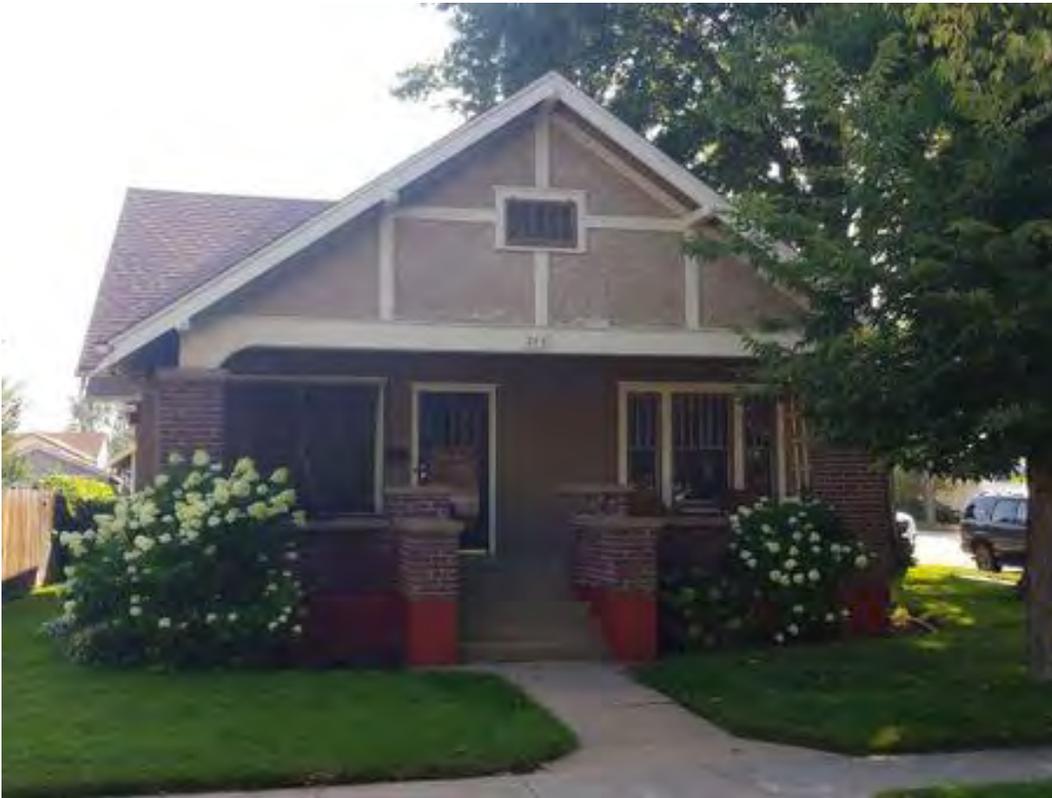
**Photo Number:** 5WL.8922\_1  
**Description:** West (primary) facing elevation. Note the half timbers, exposed rafter ends and brick piers.

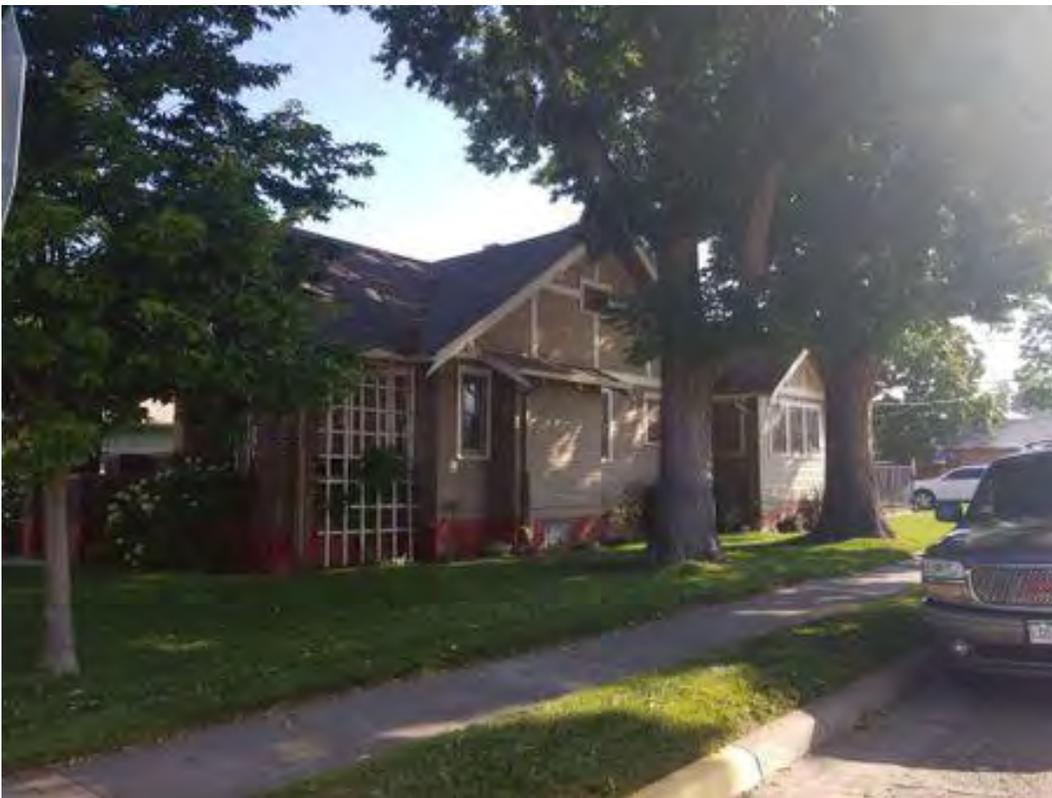
**Photo Number:** 5WL.8922\_2  
**Description:** South facing elevation. Note the half timbers and exposed rafter ends.

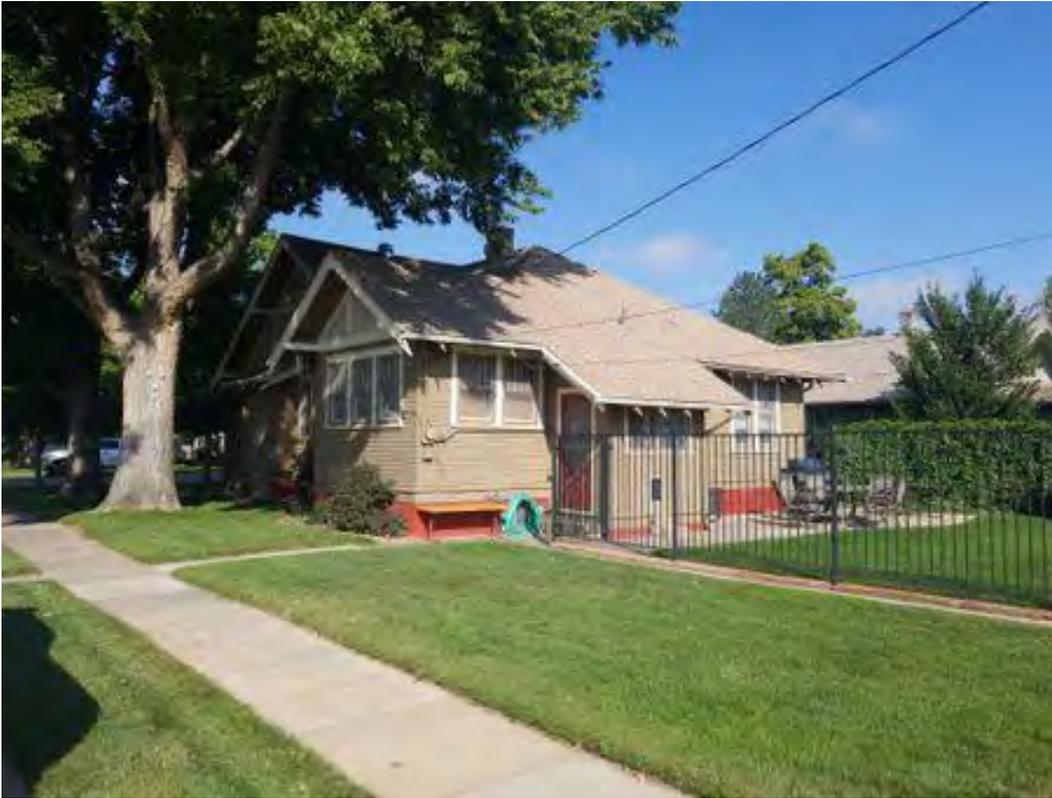
**Photo Number:** 5WL.8922\_3

**Description:** West facing elevation.  
Note the sloping roof and exposed rafter ends.

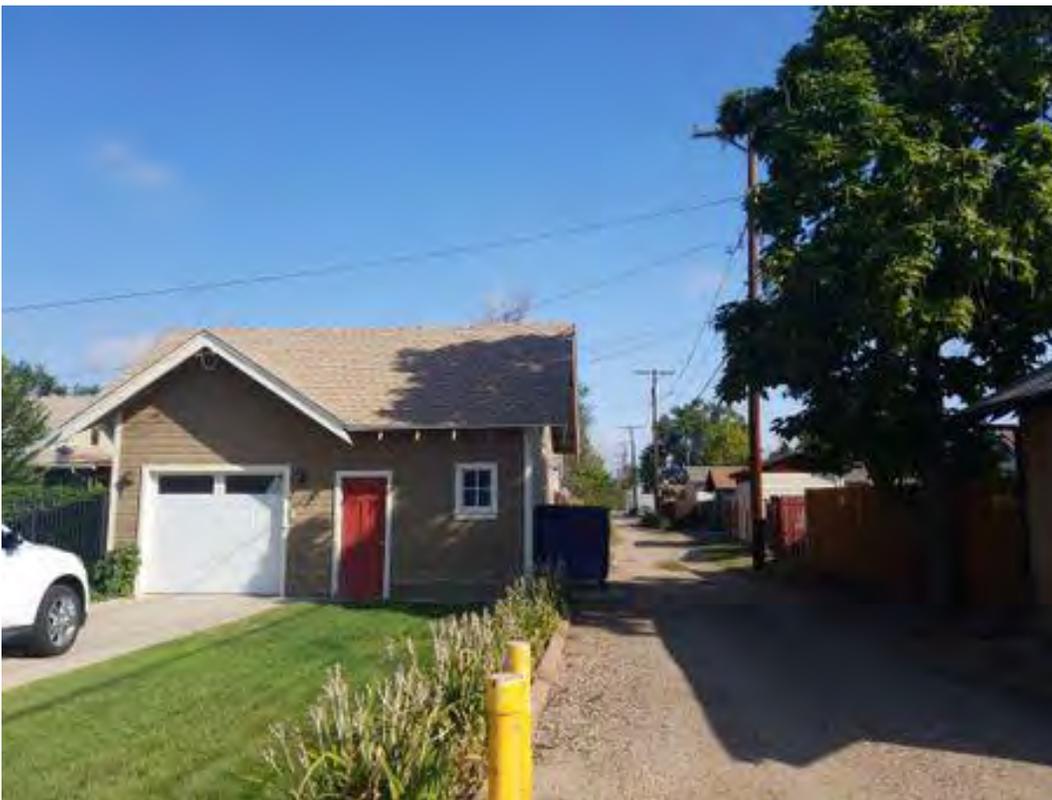
**Photo Number:** 5WL.8922\_4

**Description:** Detached cross gable  
roof garage located east of main  
house. Note the exposed rafter  
ends.

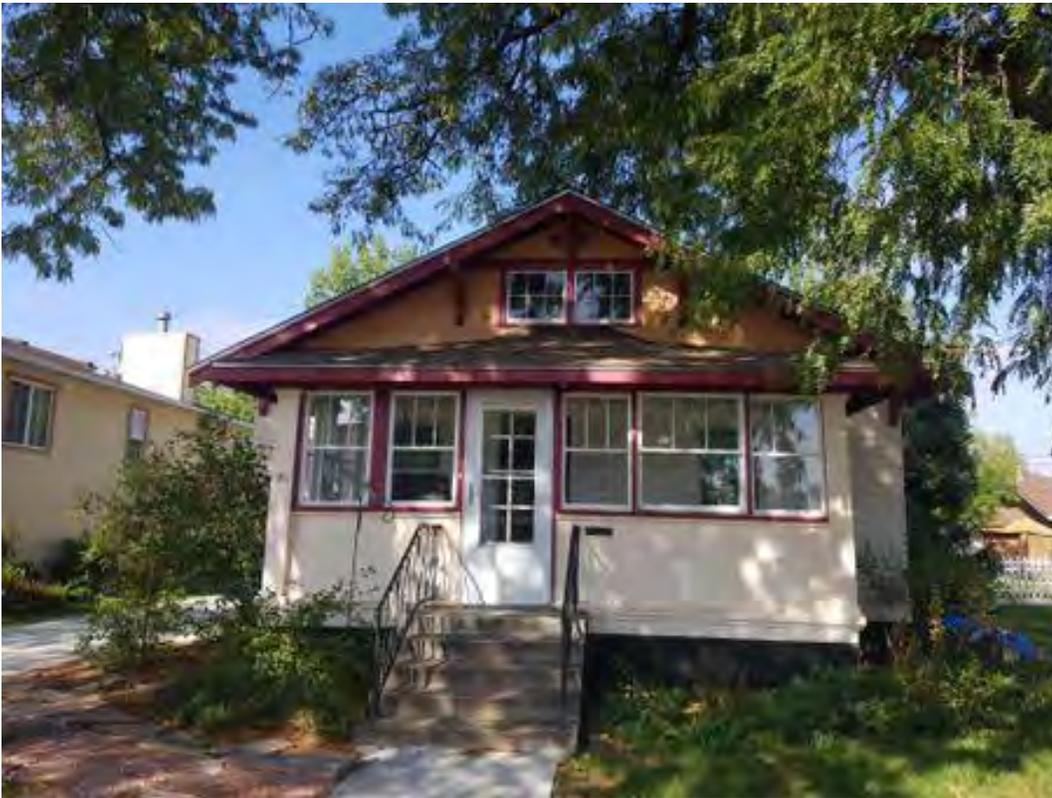
**Photo Number:** 5WL.8923\_1

**Description:** Primary (east) elevation. Note the knee brackets and shingles in the gable.

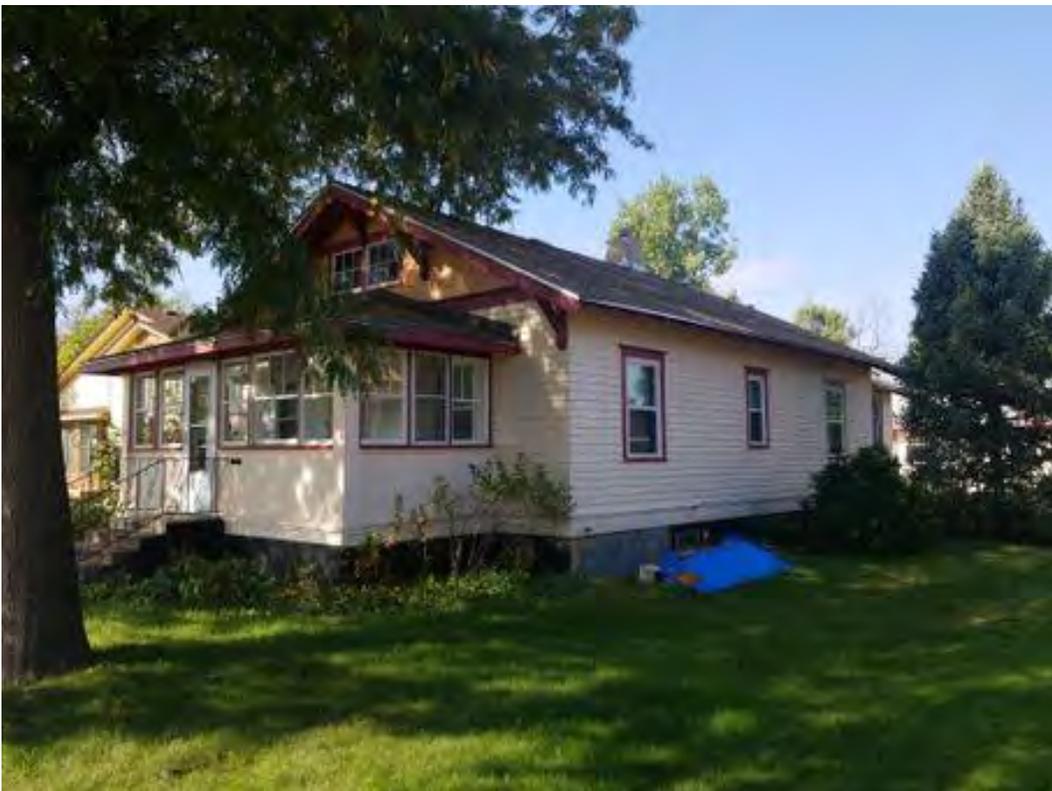
**Photo Number:** 5WL.8923\_2

**Description:** Primary (east) and north elevation. Note the knee brackets and exposed rafter tails.

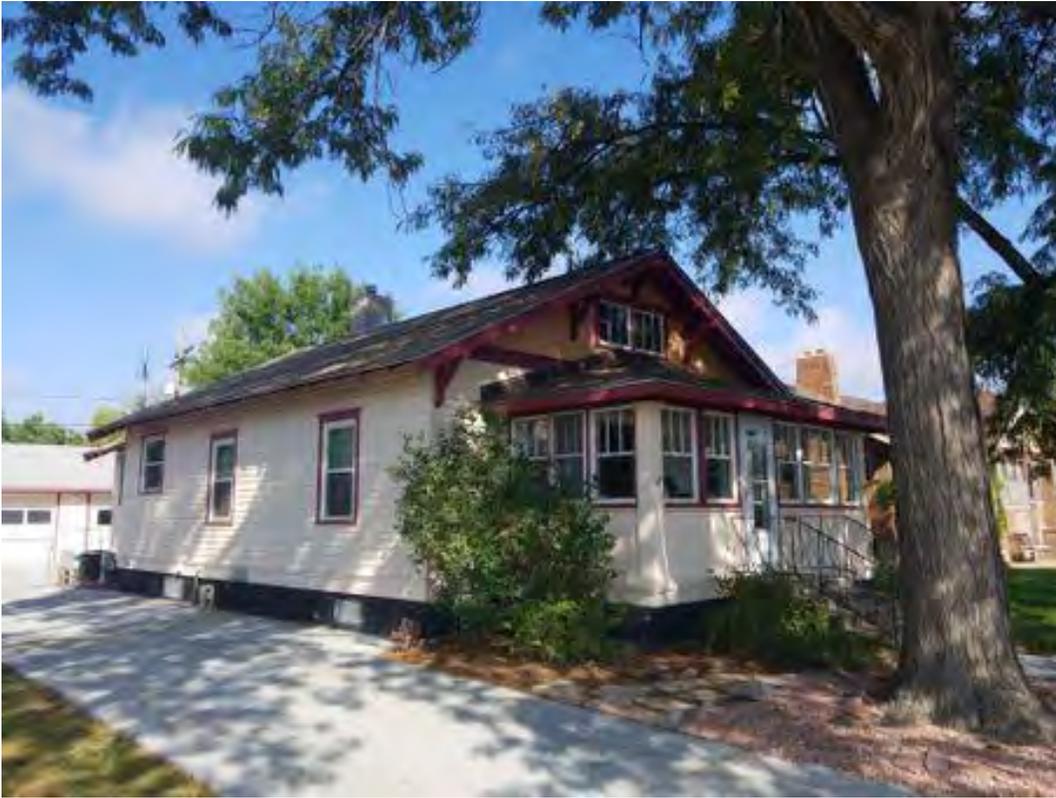
**Photo Number:** 5WL.8923\_3

**Description:** Primary (east) and south elevation. Note exposed rafter tails and replacement windows.

The windows on the house have been replaced with modern, vinyl framed windows.

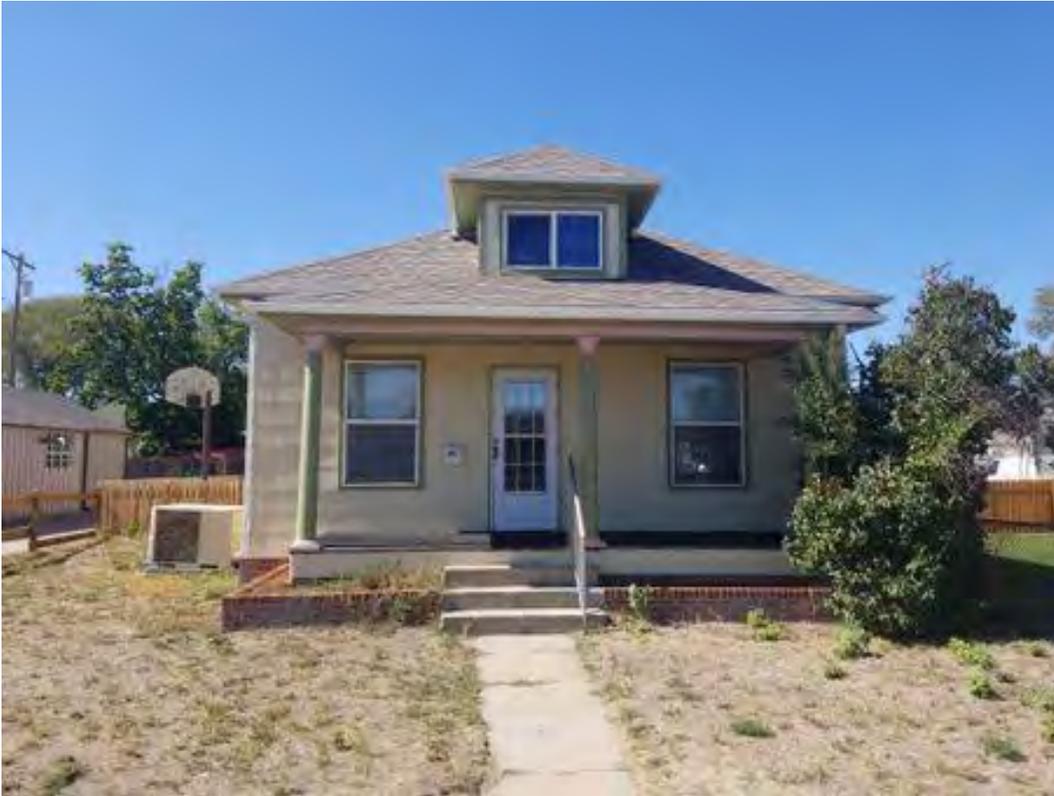
**Photo Number:** 5WL\_8924\_1

**Description:** Primary (east) elevation. Note Doric porch supports, dormer, and brick garden beds.

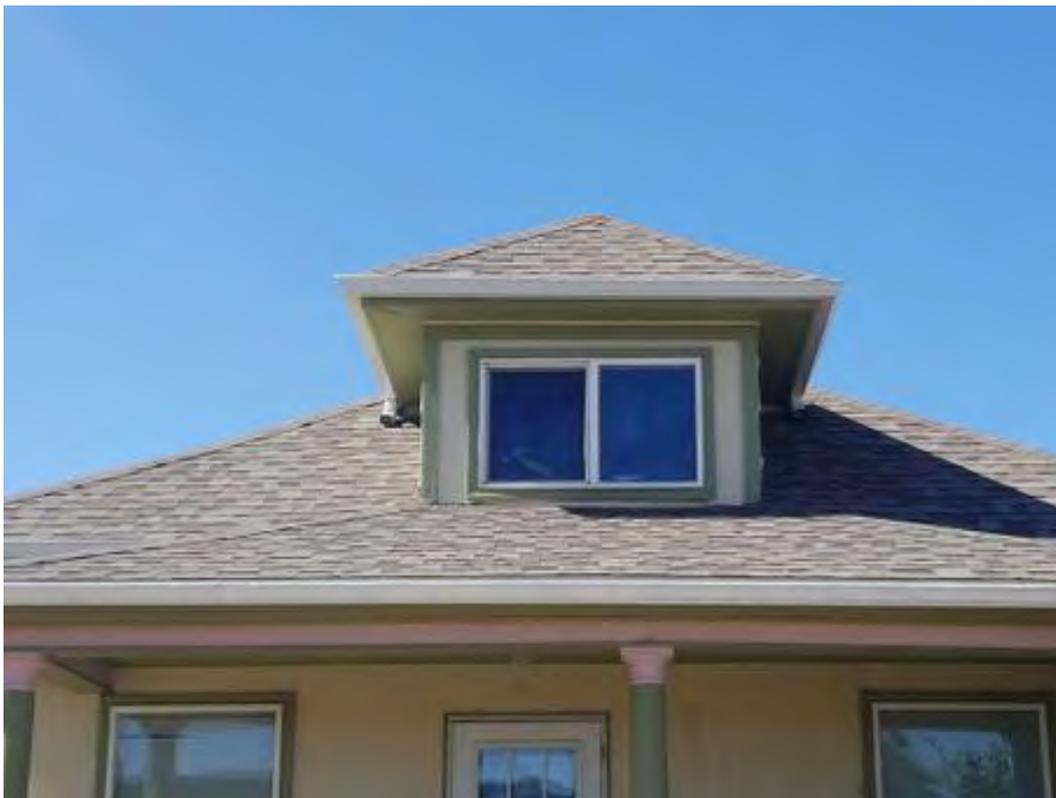
**Photo Number:** 5WL\_8924\_4

**Description:** Dormer with pyramidal roof and sliding window.

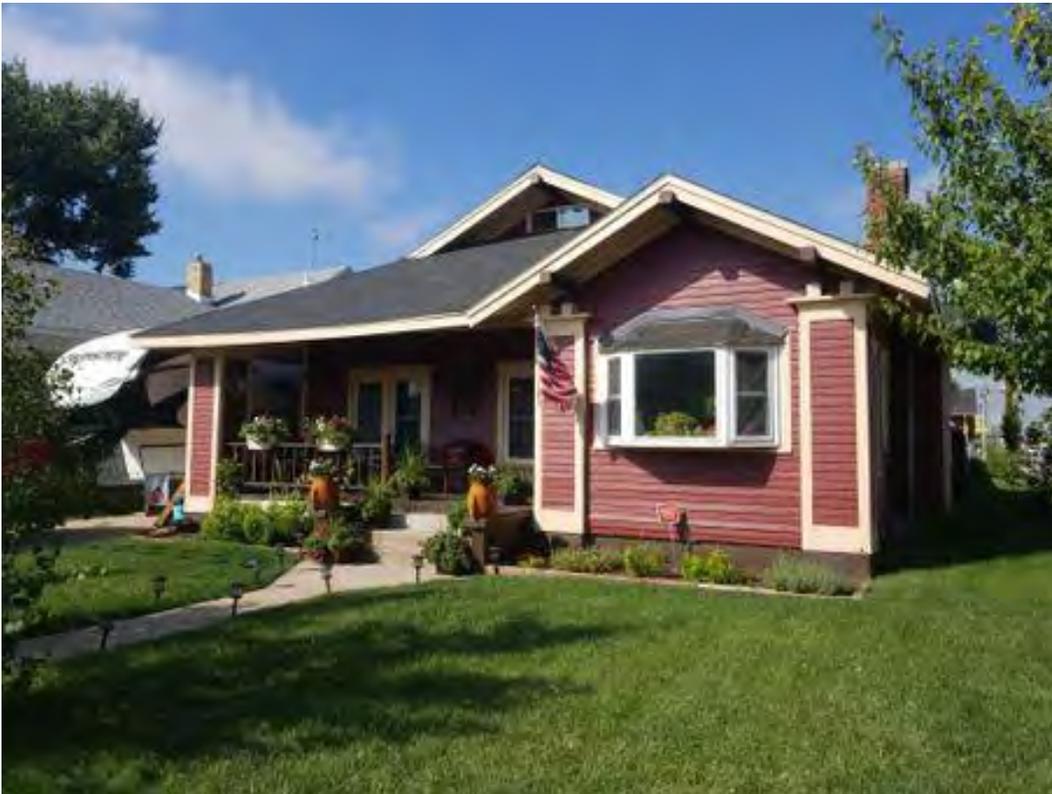
**Photo Number:** 5WL\_8925\_1

**Description:** Primary (east) elevation. Note the exposed roof supports and wide porch.
