## **Reynolds Addition and Reynolds Second Addition Intensive Survey**

**Historic Residential Intensive-Level Survey – Phase II  
Certified Local Government Grant No. CO-19-10005  
Fort Lupton, Colorado**

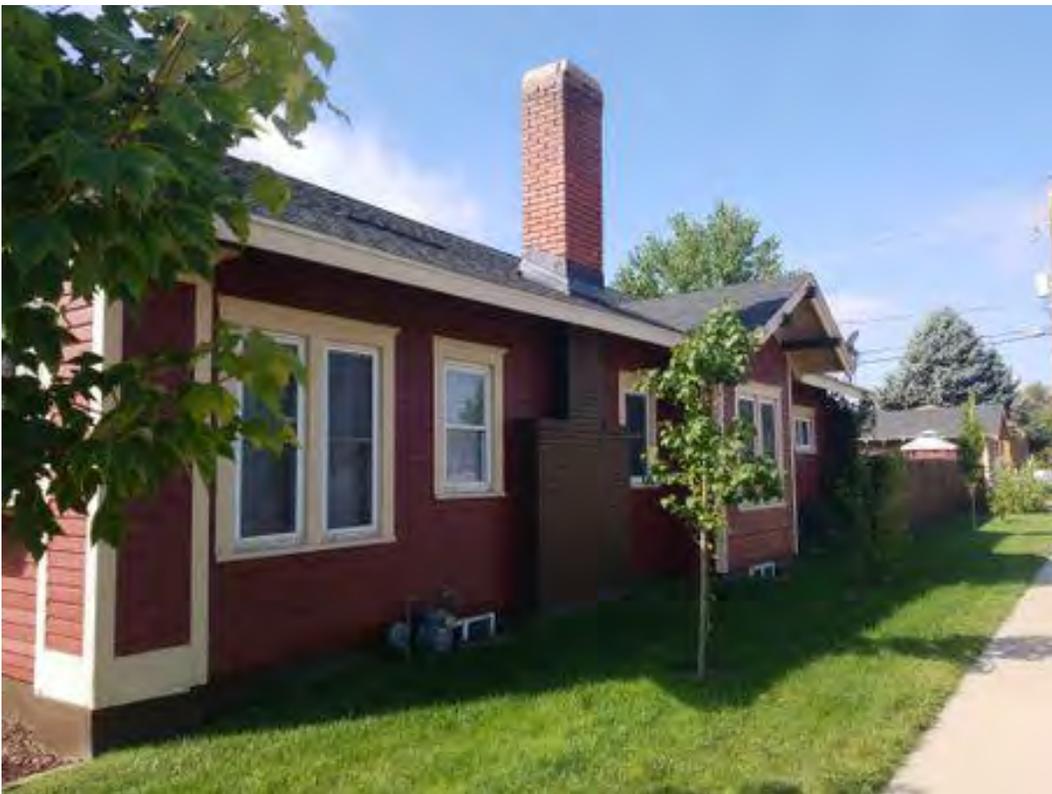
**Photo Number:** 5WL\_8925\_2

**Description:** North elevation. Note the shallow, squared bay, exposed roof supports, and brick chimney.

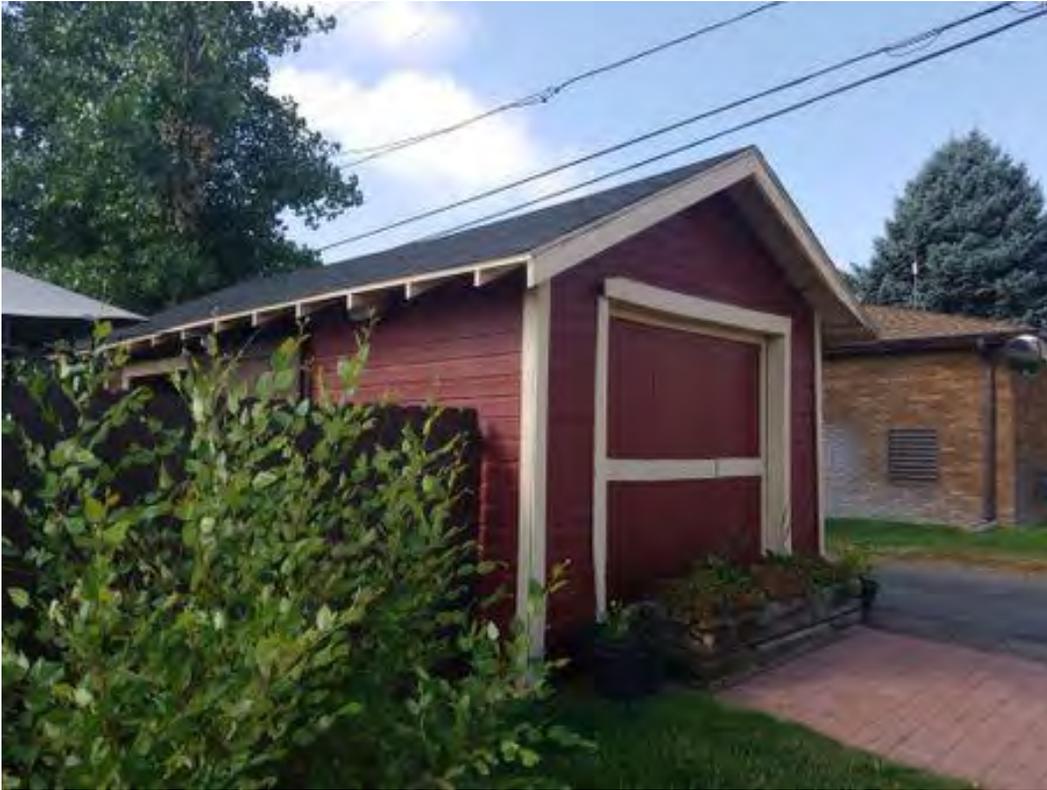
**Photo Number:** 5WL\_8925\_3

**Description:** Garage. Note the exposed rafter tails and original door.

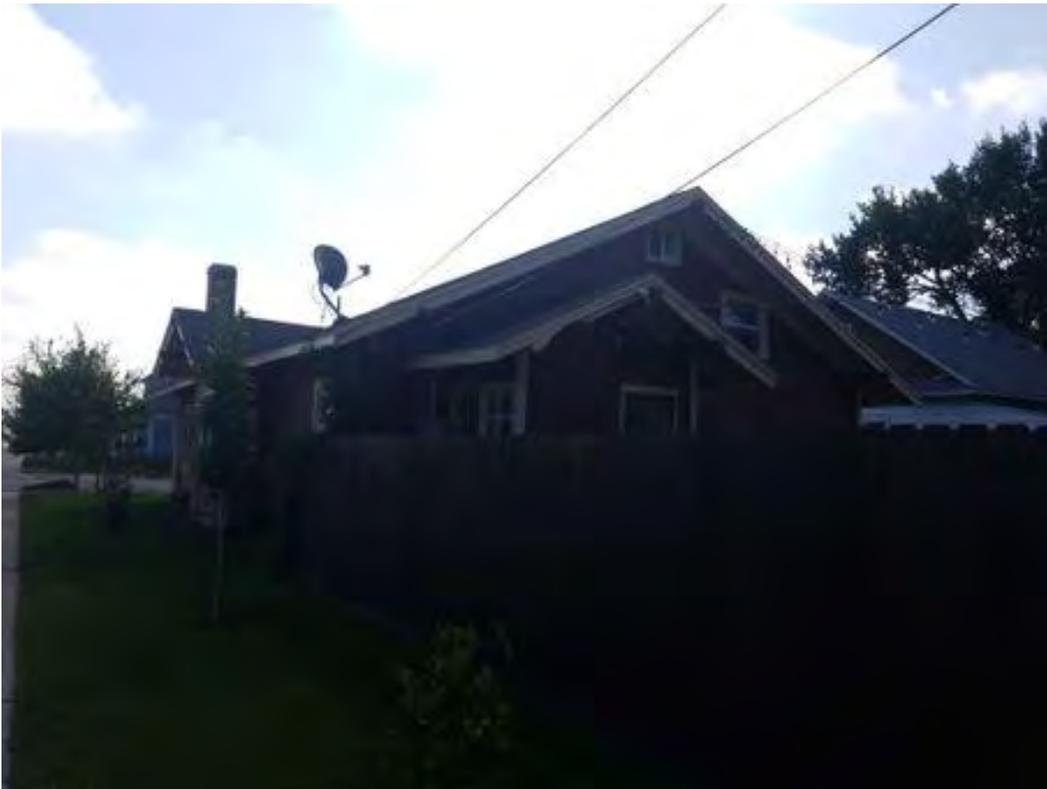
**Photo Number:** 5WL\_8925\_4

**Description:** West and north elevations. Note exposed roof supports and back entryway.

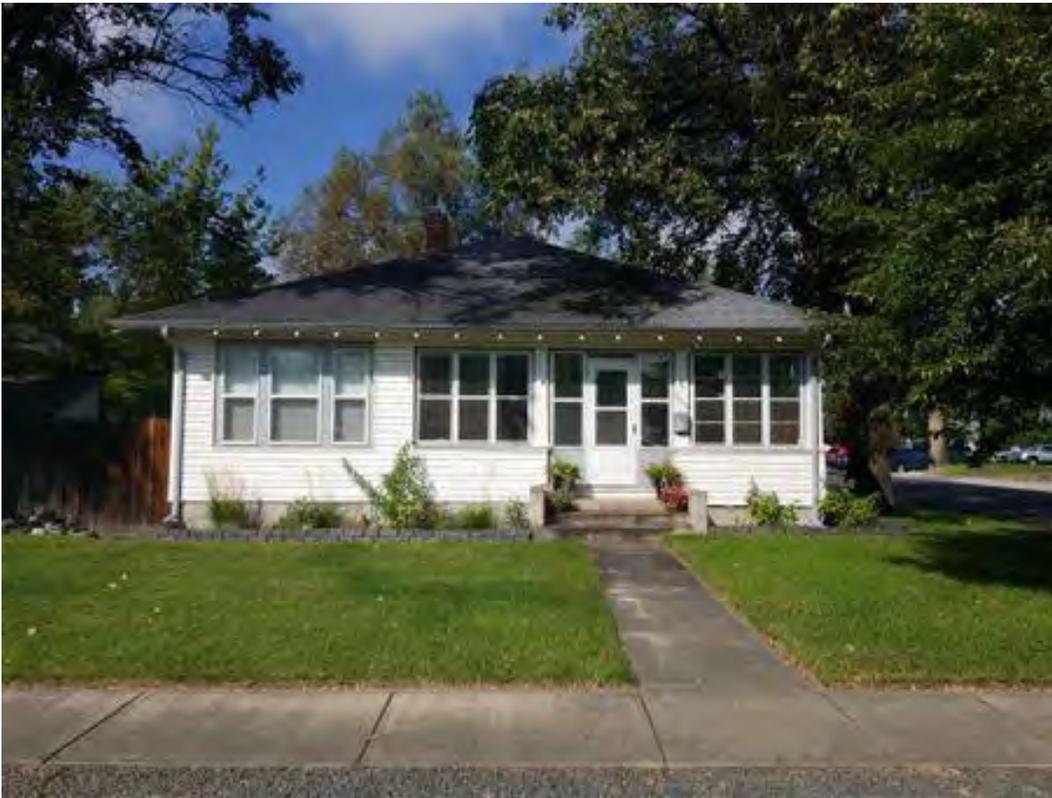
**Photo Number:** 5WL.8926\_1

**Description:** Primary (east) elevation. Note the window ribbons, and bracketed eaves.

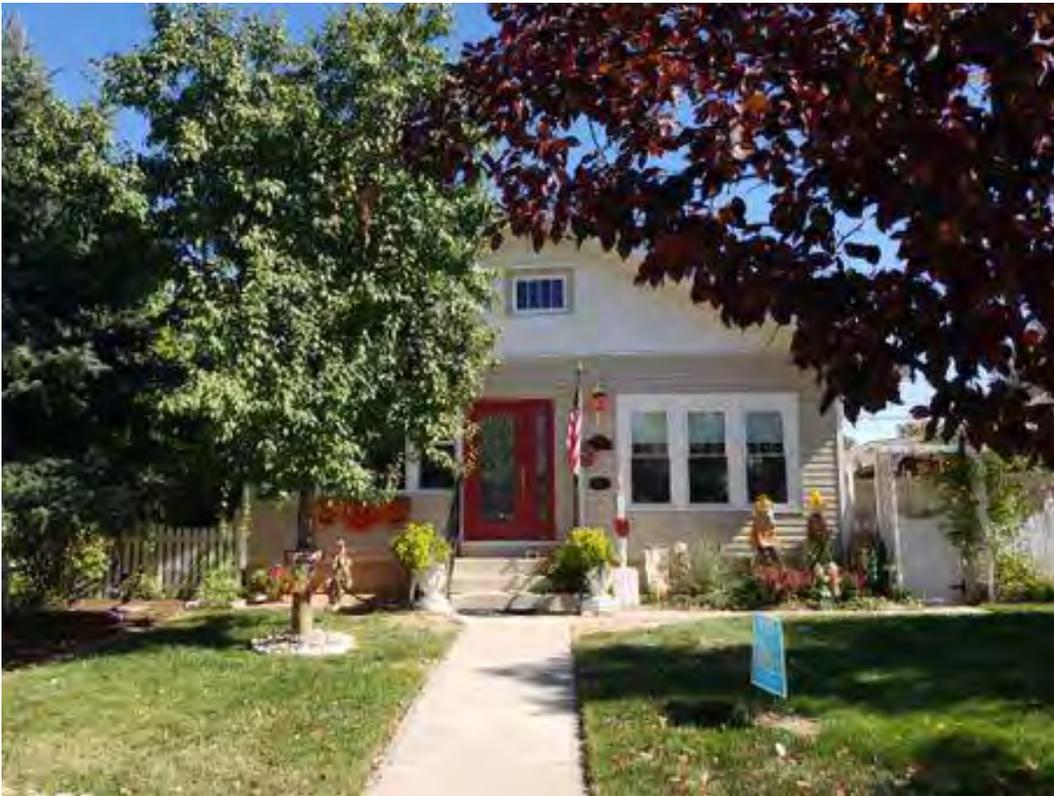
**Photo Number:** 5WL\_8927\_1

**Description:** Primary (west) elevation. Note the upper, multi-light windows.

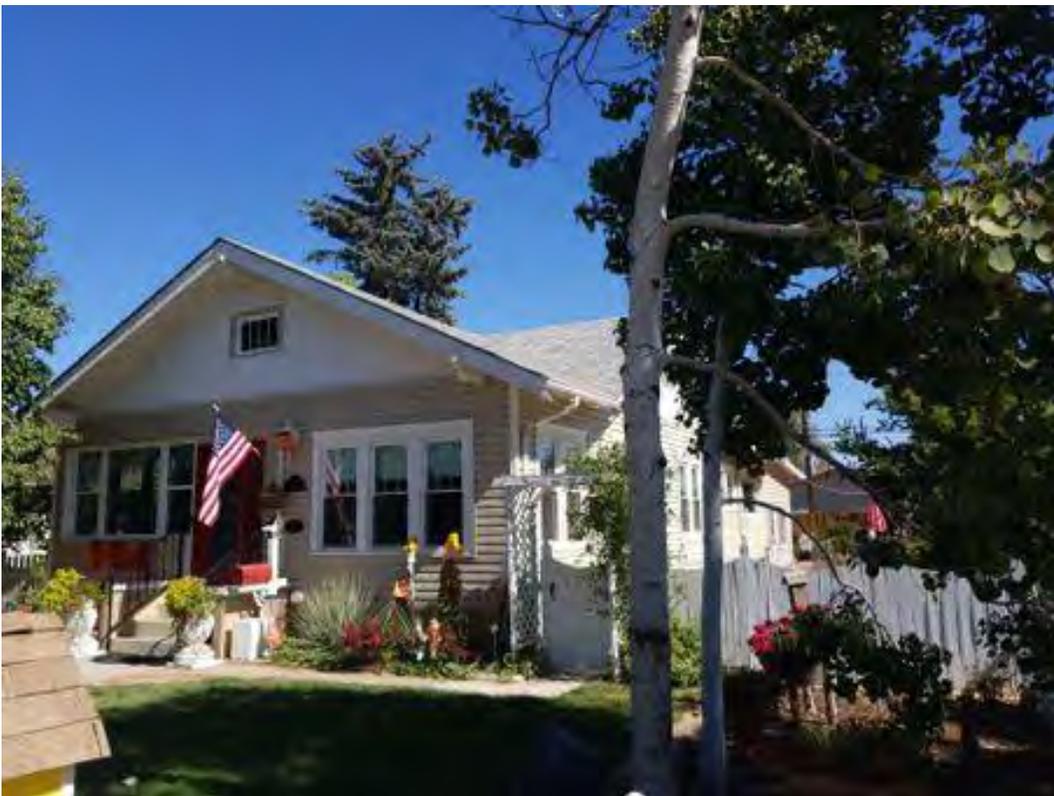
**Photo Number:** 5WL\_8927\_2

**Description:** Primary (west) elevation and south elevation. Note exposed porch supports.

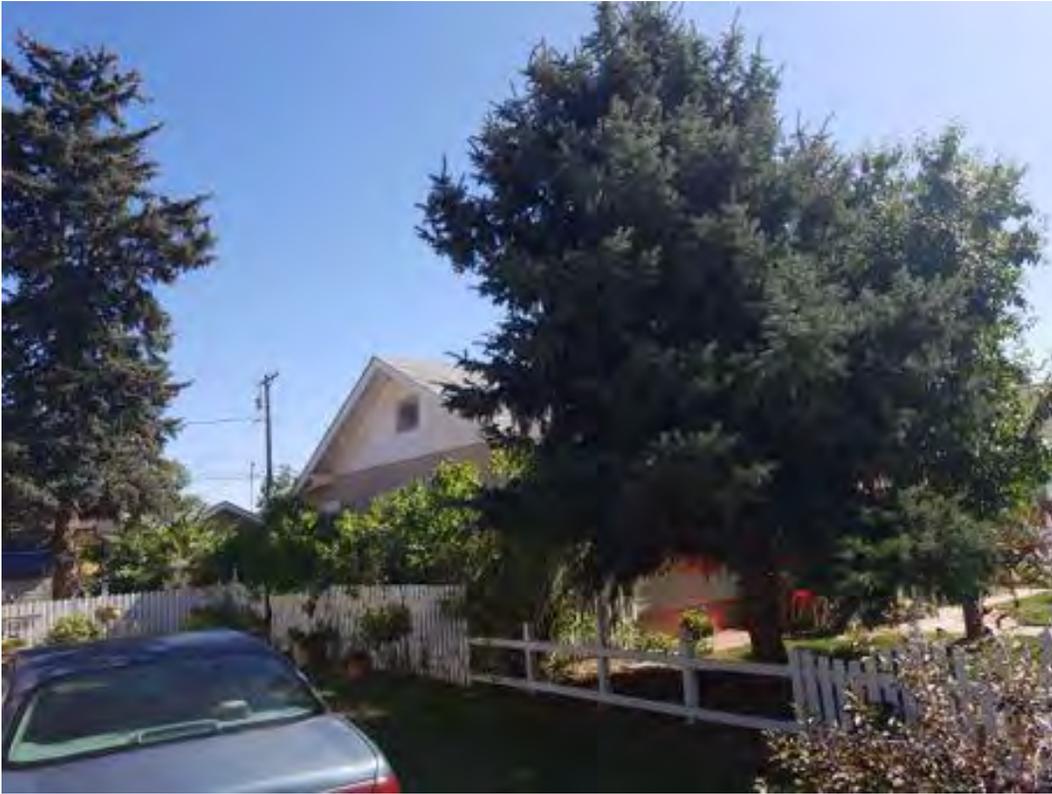
**Photo Number:** 5WL\_8927\_3  
**Description:** North elevation. Note multi-light window in gable.  
**View:** Southeast

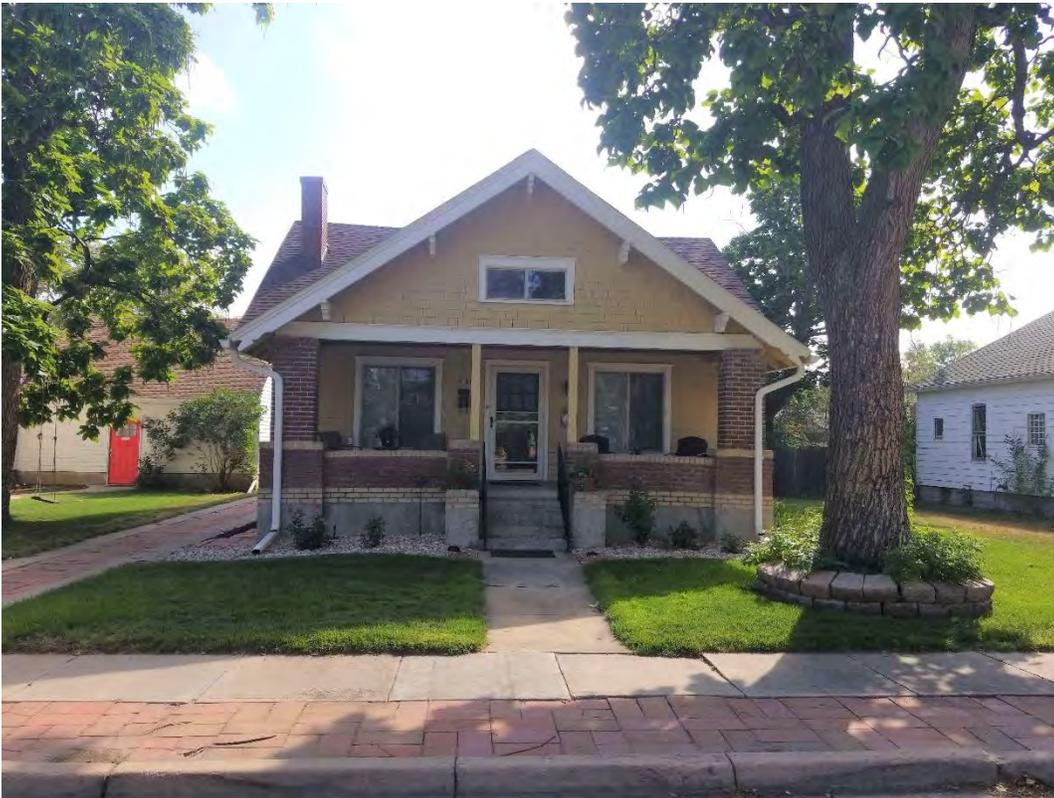
**Photo Number:** 5WL.8928\_1

**Description:** Primary (west) elevation. Note roof supports, decorative verge board, and brick porch supports.

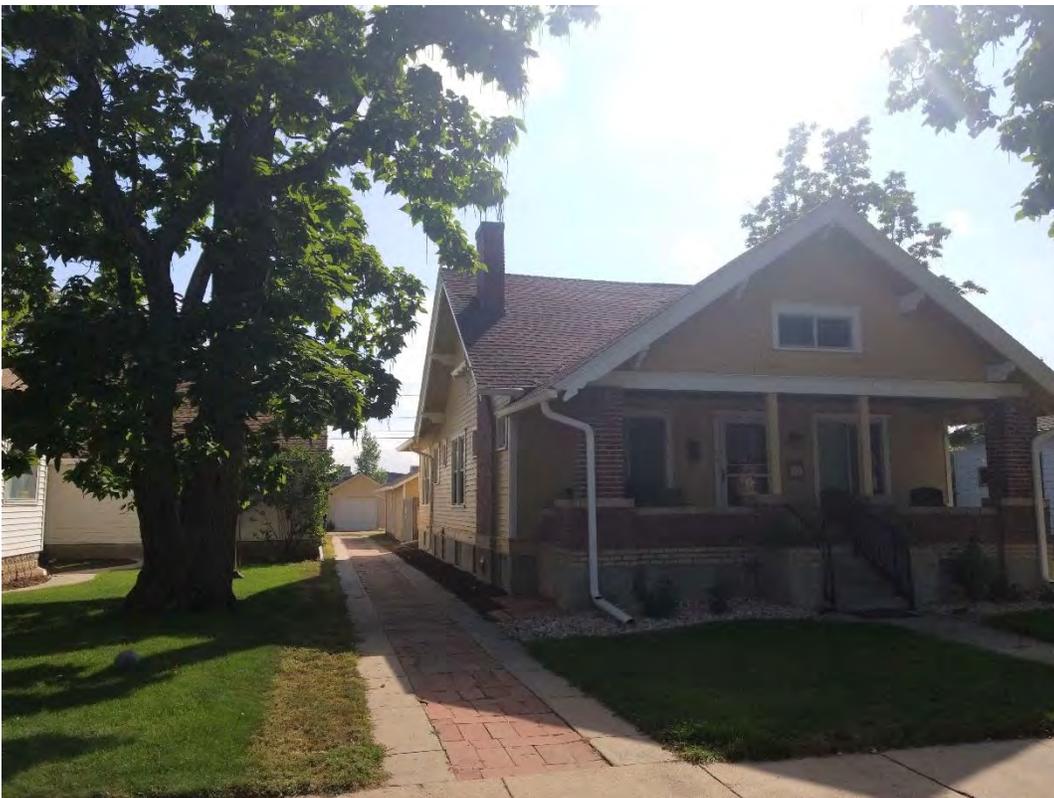
**Photo Number:** 5WL.8928\_2

**Description:** Primary (west) and north elevations. Note brick chimney.

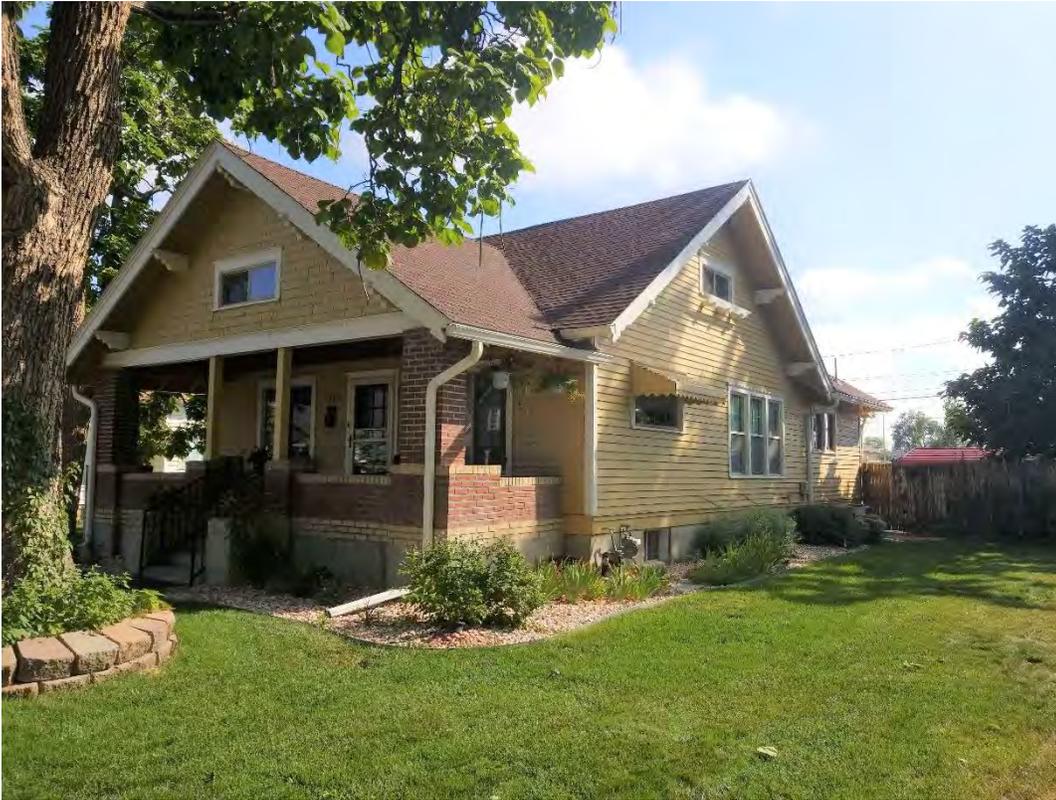
**Photo Number:** 5WL.8928\_3

**Description:** Primary (west) and south elevations. Note roof supports and metal awning.

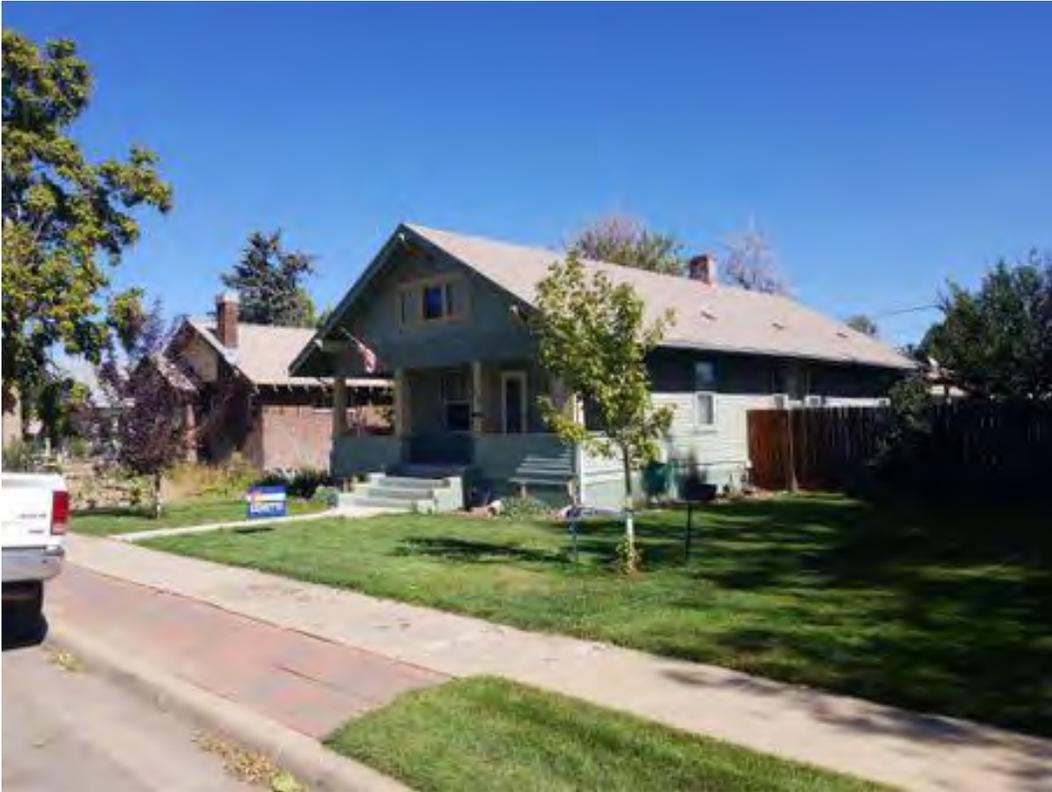
**Photo Number:** 5WL\_8929\_1

**Description:** Primary (west) and south elevation. Note porch and roof supports and brick chimney.

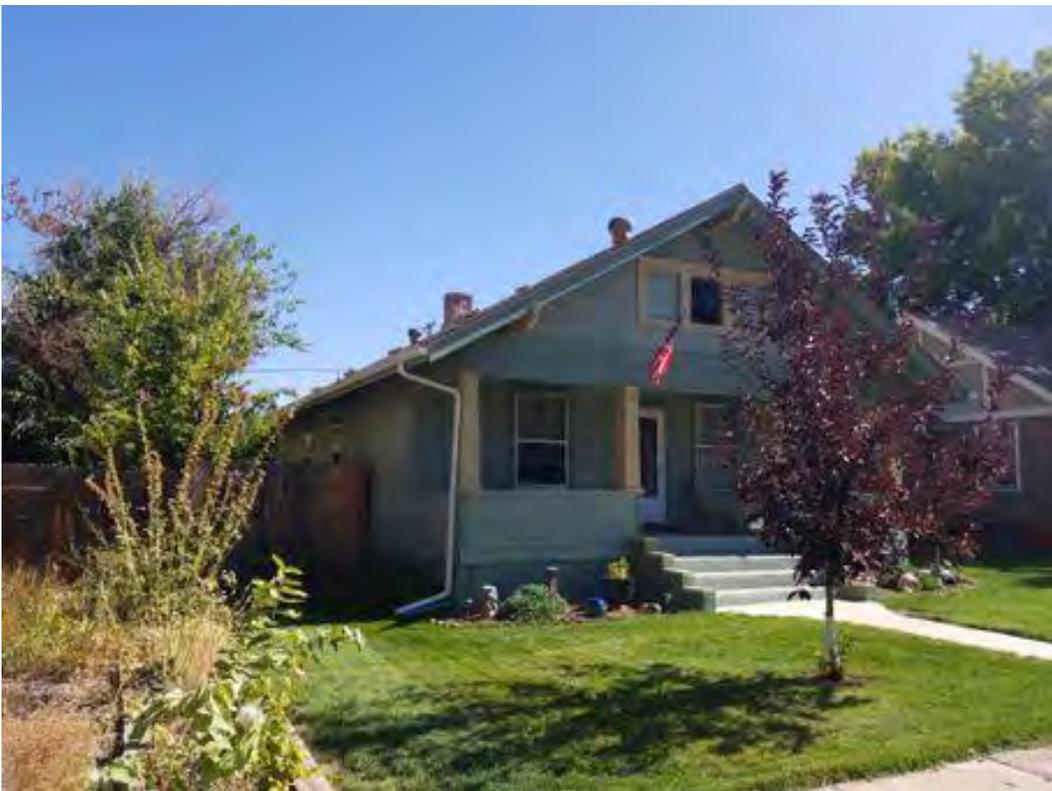
**Photo Number:** 5WL\_8929\_2

**Description:** Primary (west) and north elevation. Note porch and roof supports and brick chimney.

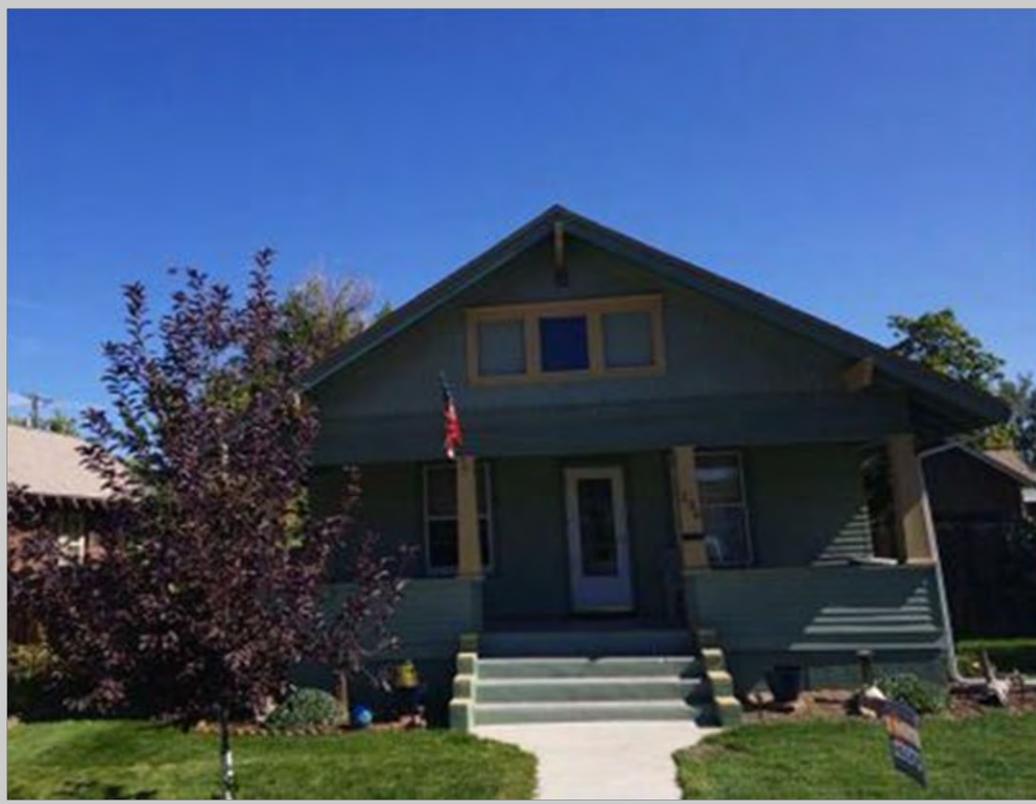
**Photo Number:** 5WL\_8929\_3

**Description:** Primary (west) elevation. Note porch and roof supports.

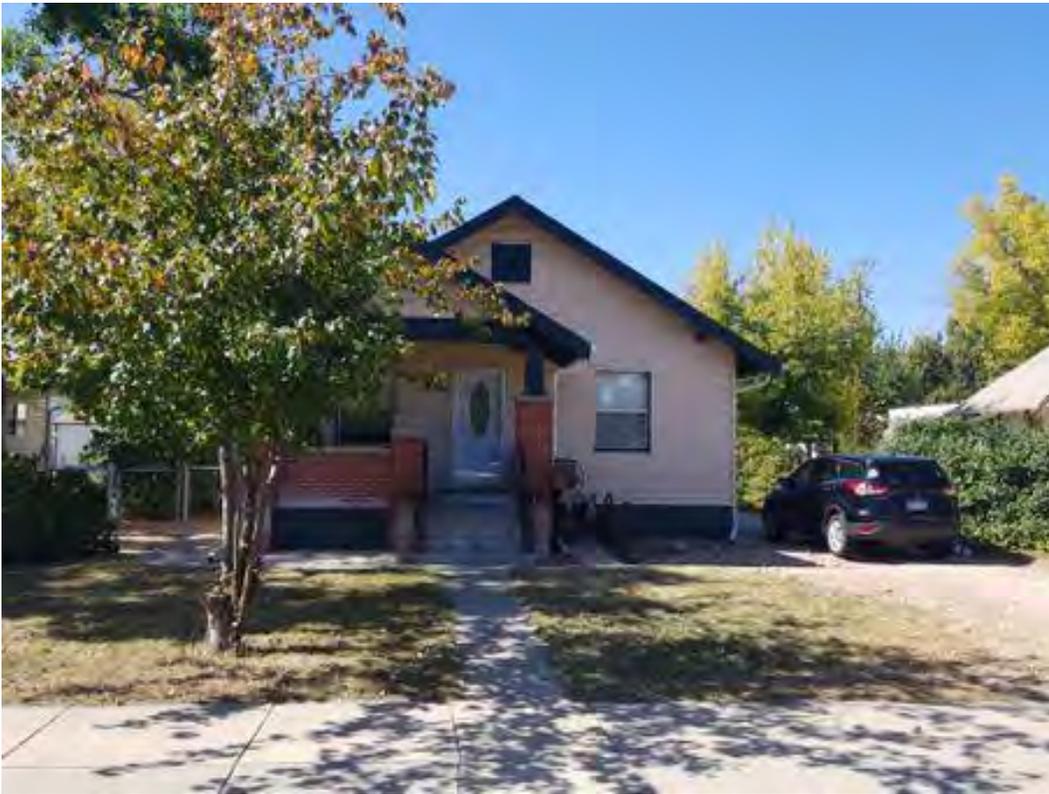
**Photo Number:** 5WL\_8930\_1

**Description:** Primary (east) elevation. Note the square, brick porch piers and exposed roof beams.

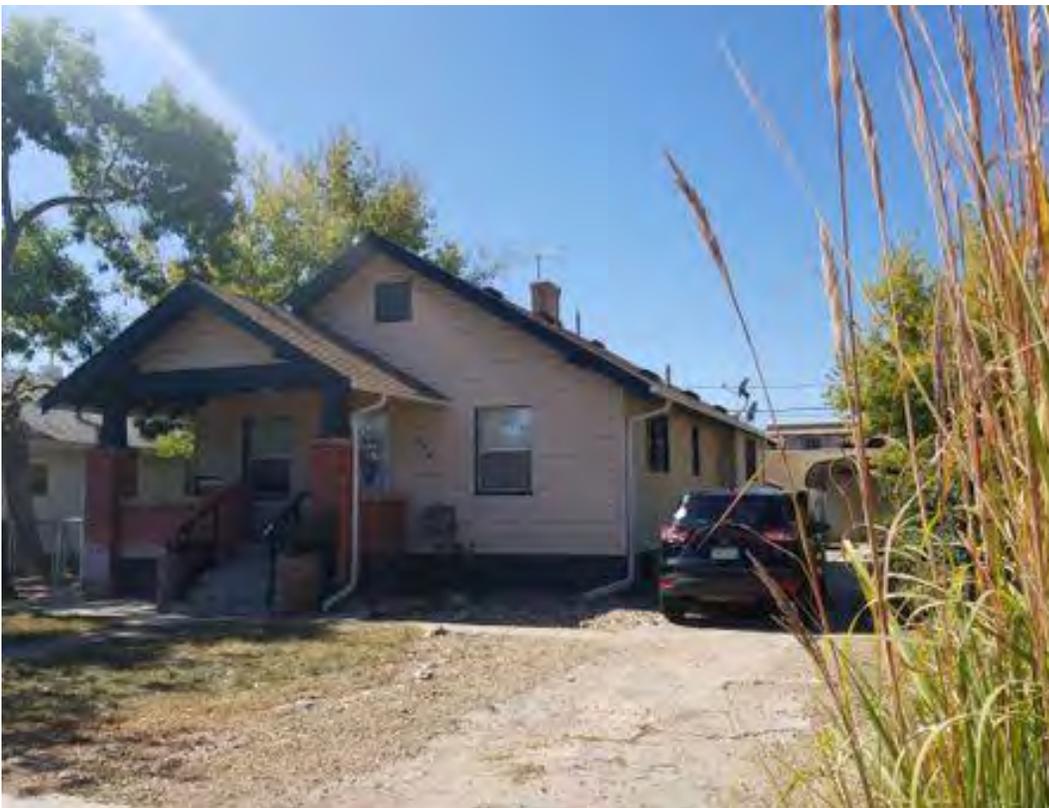
**Photo Number:** 5WL\_8930\_2

**Description:** Primary (east) and north elevations. Note exposed rafter tails on porch.

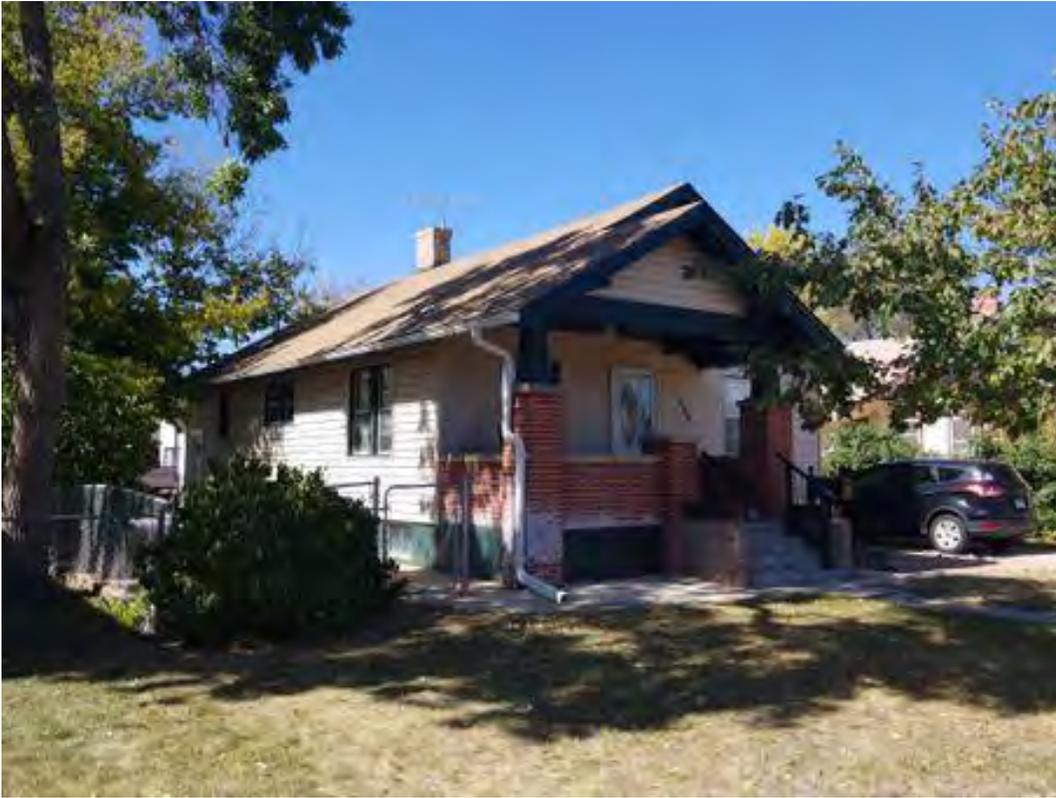
**Photo Number:** 5WL\_8930\_3  
**Description:** Primary (east) and south elevations. Note paired windows.  
**View:** Northwest

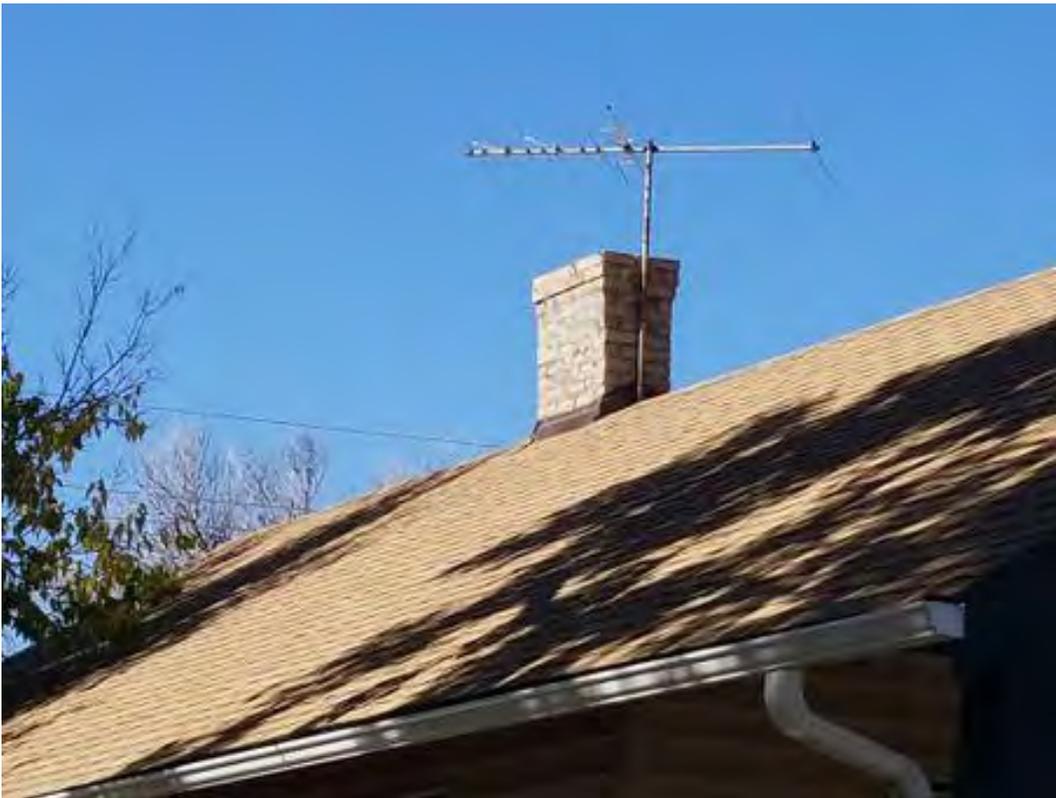
**Photo Number:** 5WL\_8930\_4  
**Description:** Brick chimney.  
**View:** Northwest

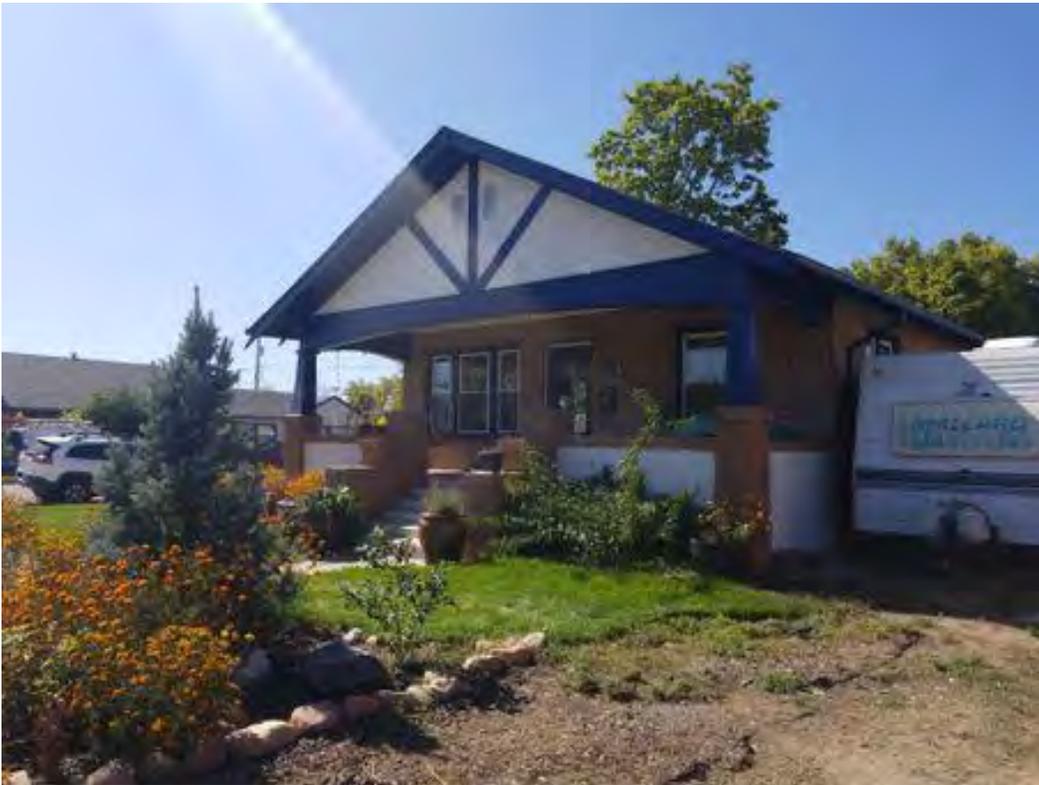
**Photo Number:** 5WL.8931\_1

**Description:** East facing (primary) elevation and north facing elevation (obscured by camper trailer). Note the battered columns and cross beam. Note the stucco treatment to patio walls and stair walls.

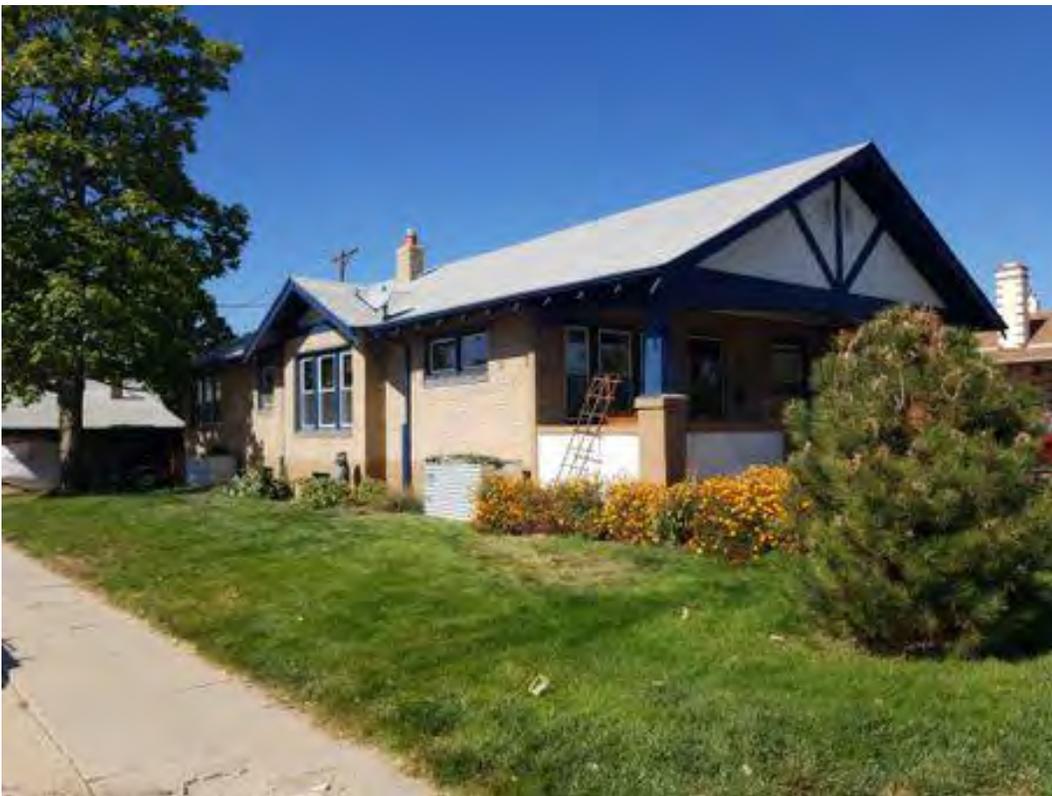
**Photo Number:** 5WL.8931\_2

**Description:** East facing (primary) elevation and south facing elevation. Note the tapered columns and cross beam of primary elevation. Note the slightly projecting section of the south facing elevation.

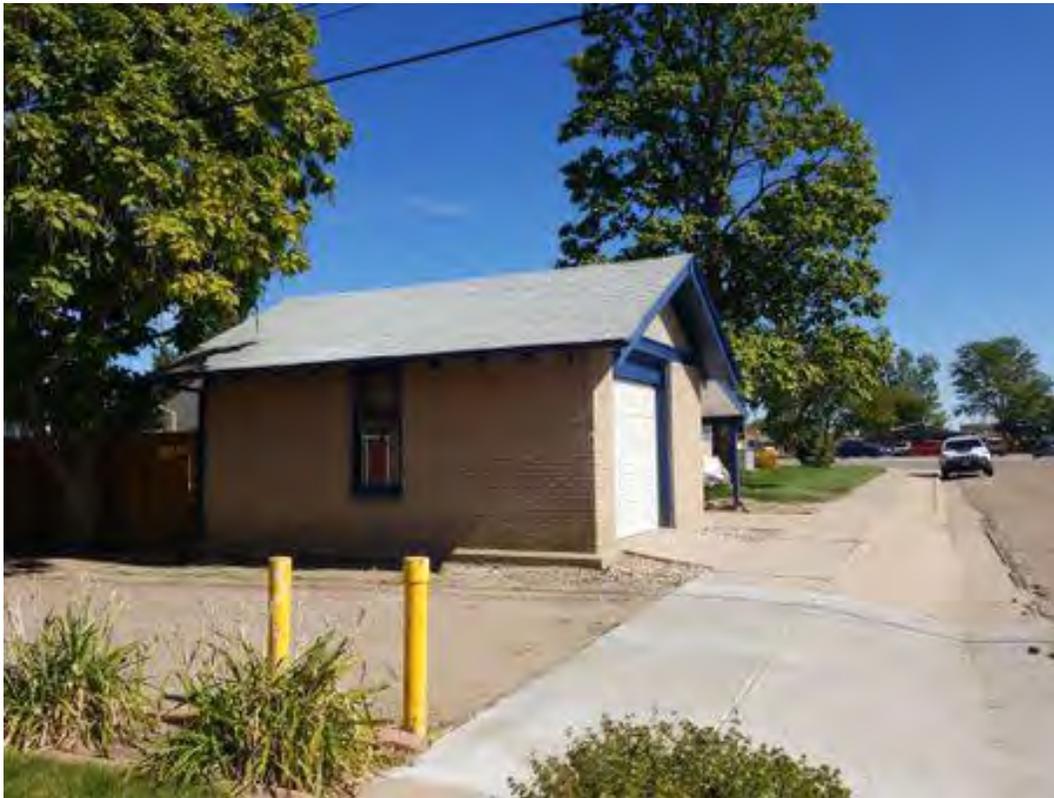
**Photo Number:** 5WL.8931\_3

**Description:** Detached garage with shed roof addition. Note the overhanging eaves, matching the main house.

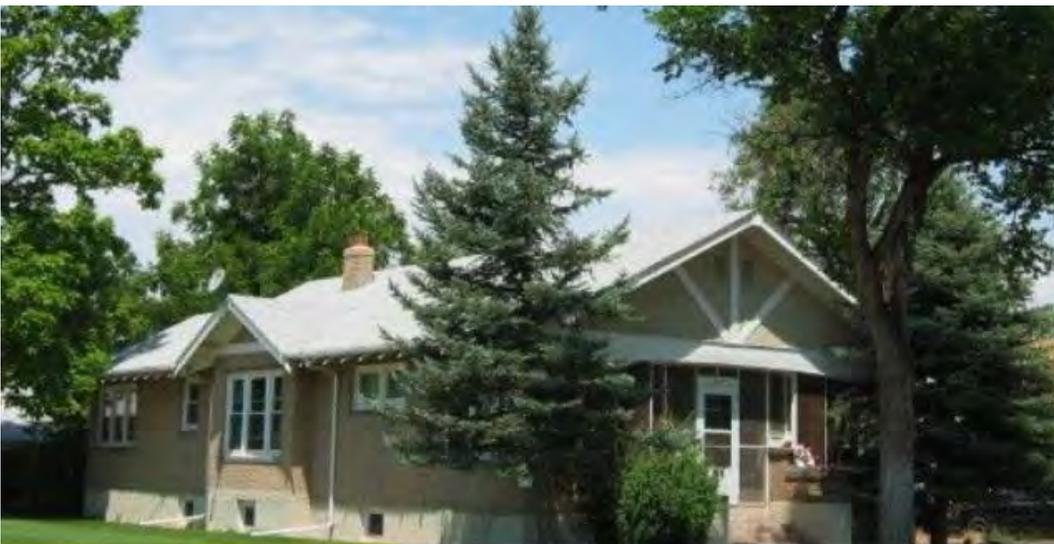
**Photo Number:** 5WL.8931\_3

**Description:** Undated assessor photograph depicting enclosed front porch.

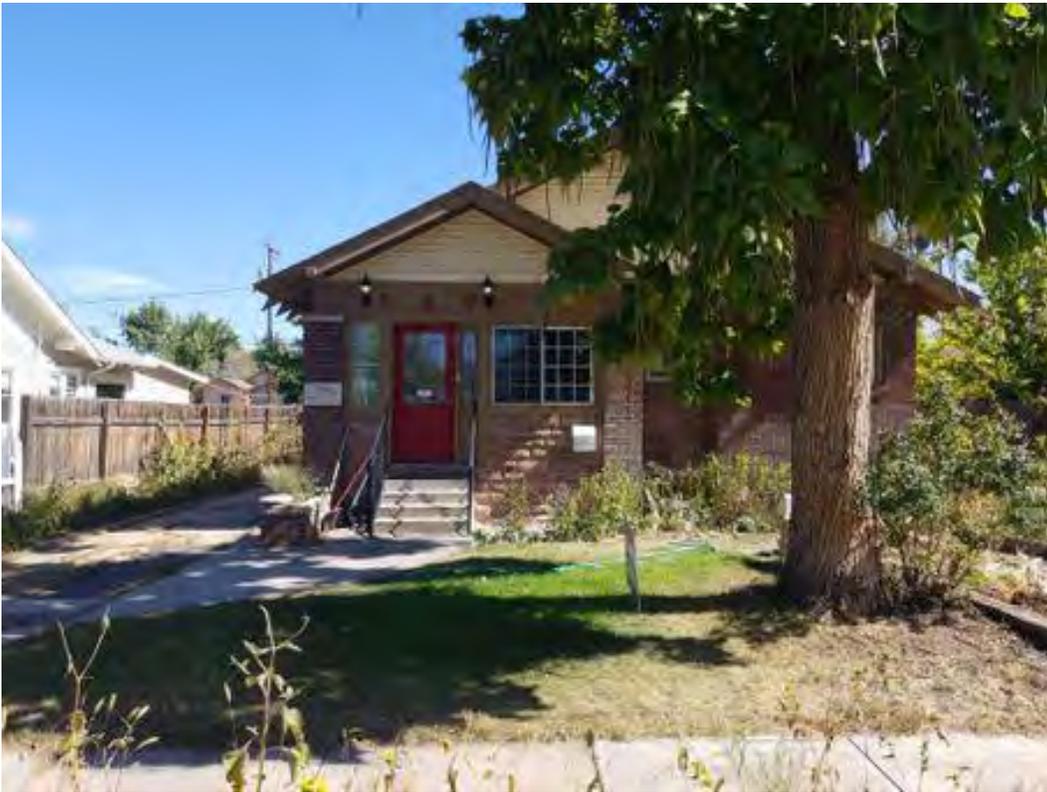
**Photo Number:** 5WL\_8932\_1

**Description:** Primary (west) elevation. Note entryway and exposed rafter tails.

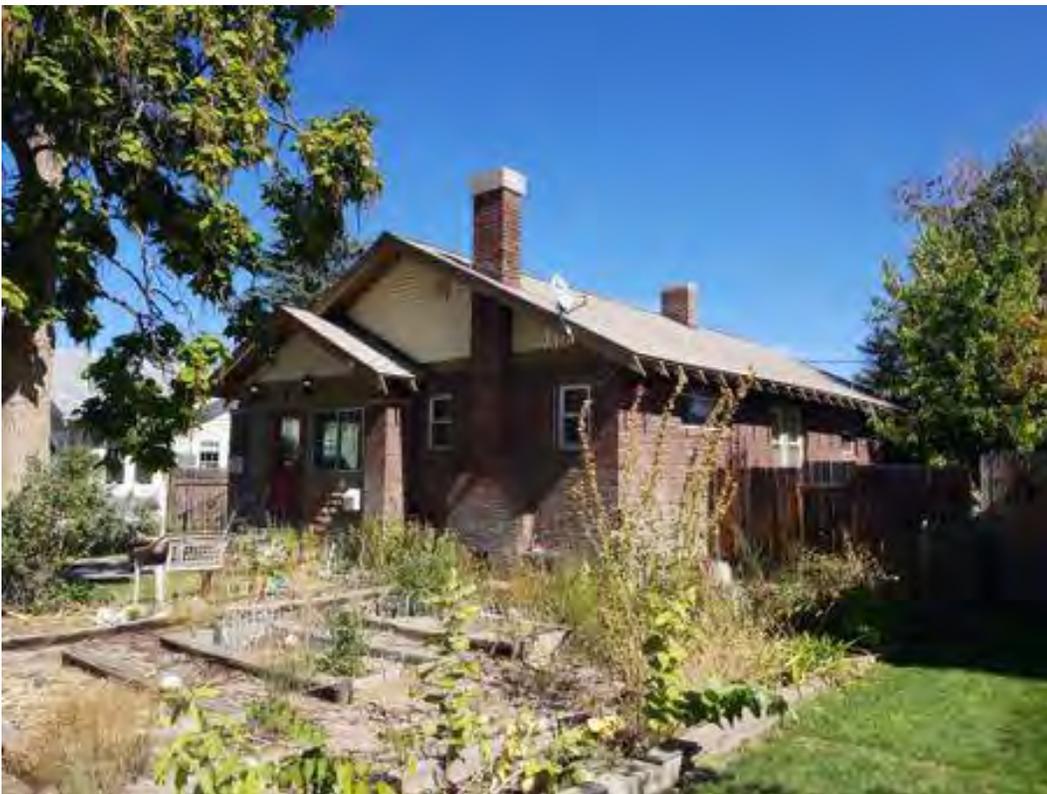
**Photo Number:** 5WL\_8932\_2

**Description:** Primary (west) and south elevations. Note chimney.

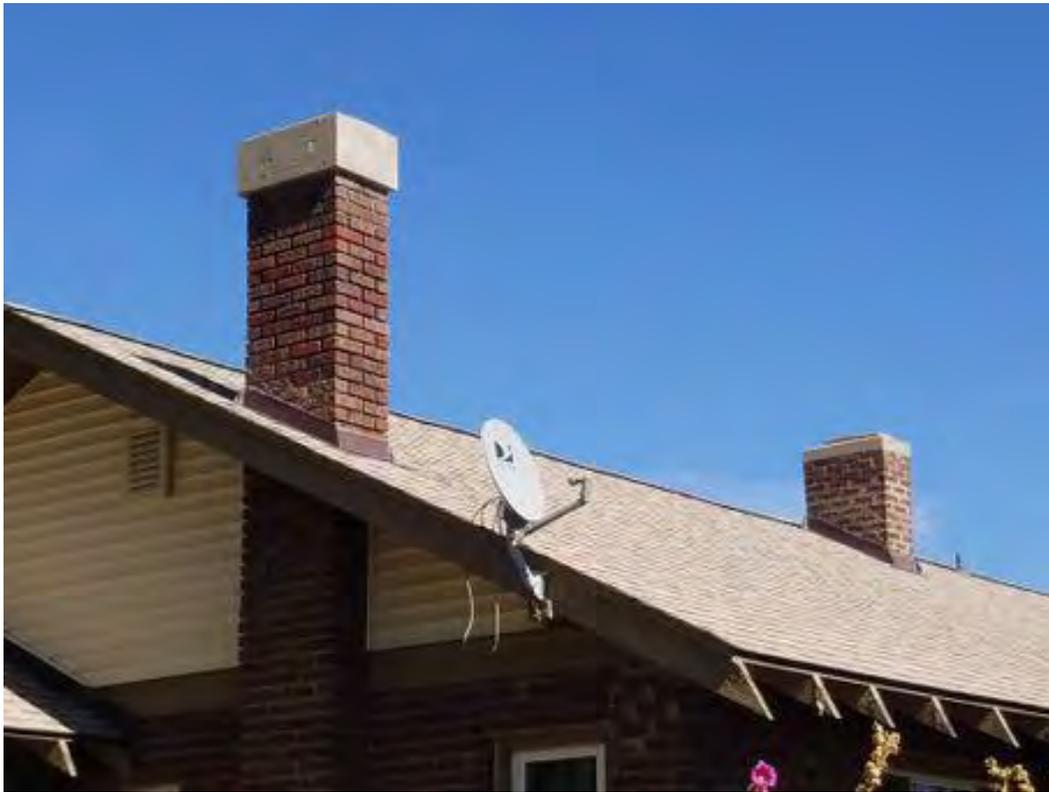
**Photo Number:** 5WL\_8932\_3

**Description:** Brick chimneys and exposed rafter tails.

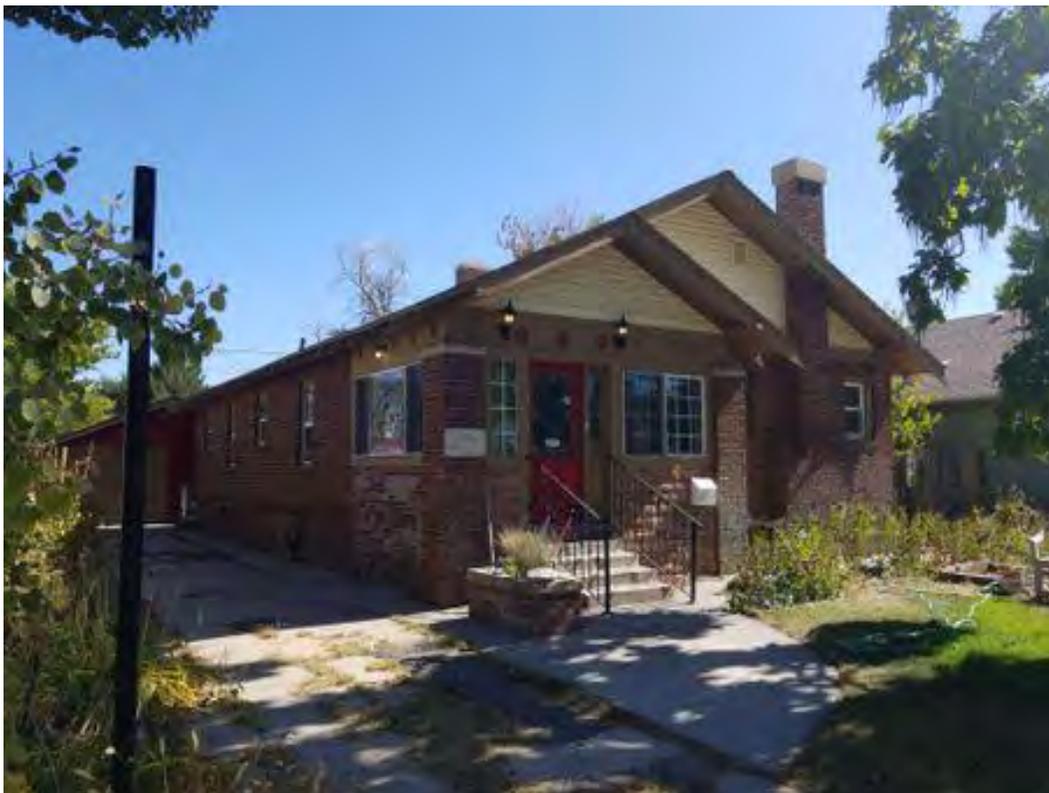
**Photo Number:** 5WL\_8932\_4

**Description:** Primary (west) and north elevations.

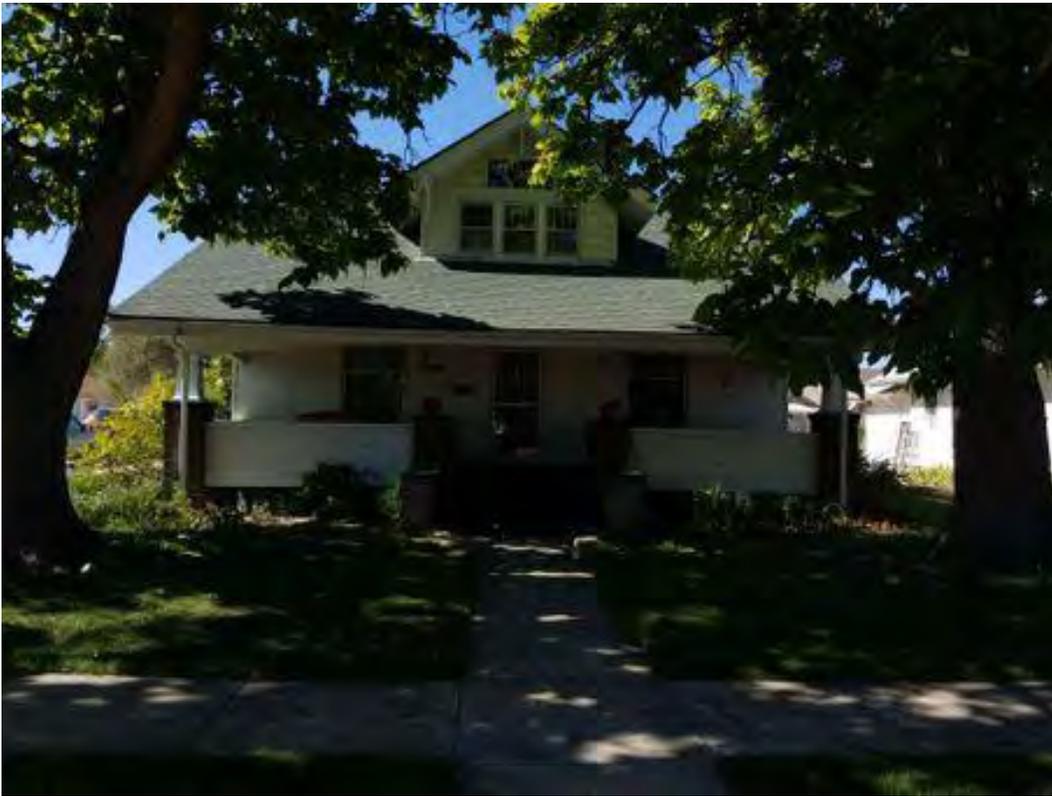
**Photo Number:** 5WL\_8933\_1

**Description:** Primary (east) elevation. Note porch and dormer.

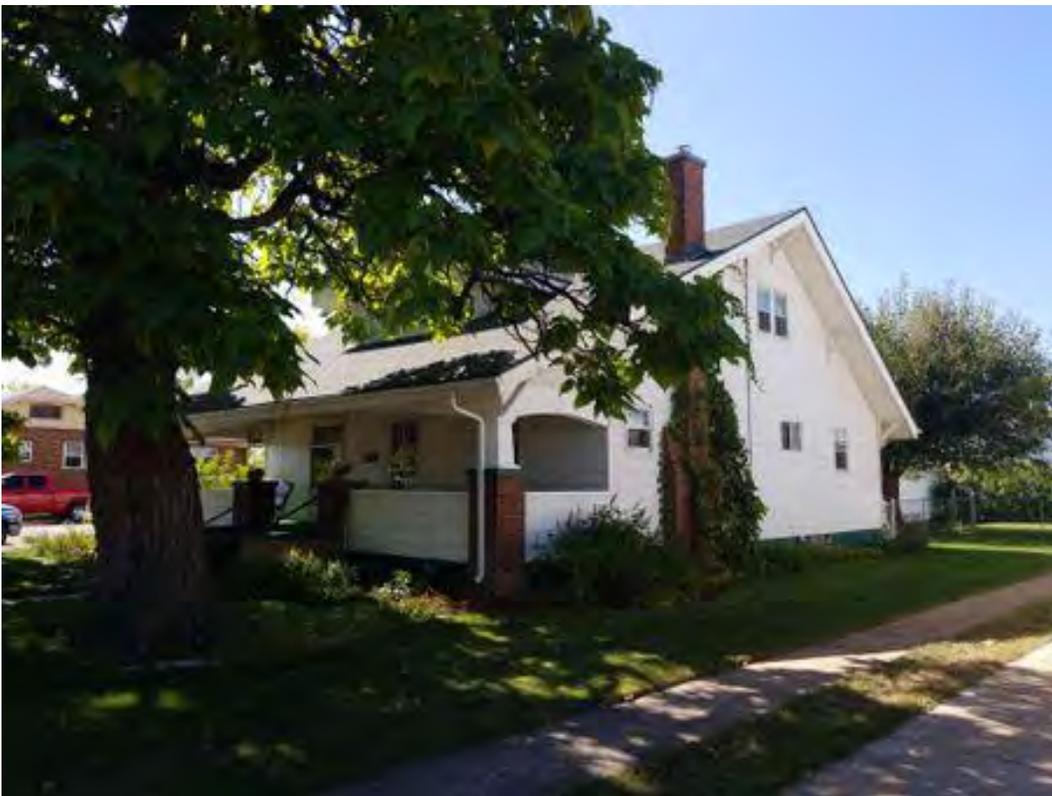
**Photo Number:** 5WL\_8933\_2

**Description:** Primary (east) and north elevations. Note porch supports, chimney, and brackets.
