## **Reynolds Addition and Reynolds Second Addition Intensive Survey**

**Historic Residential Intensive-Level Survey – Phase II  
Certified Local Government Grant No. CO-19-10005  
Fort Lupton, Colorado**

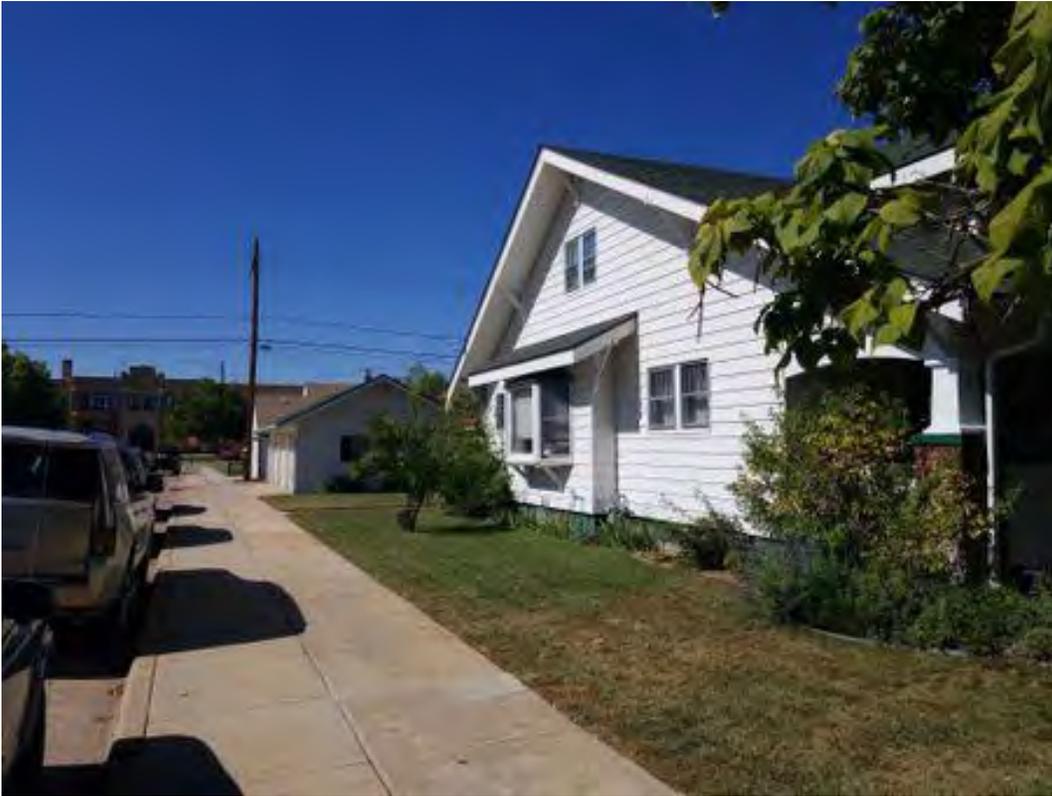
**Photo Number:** 5WL\_8933\_3  
**Description:** South elevation. Note bay.  
**View:** Northwest

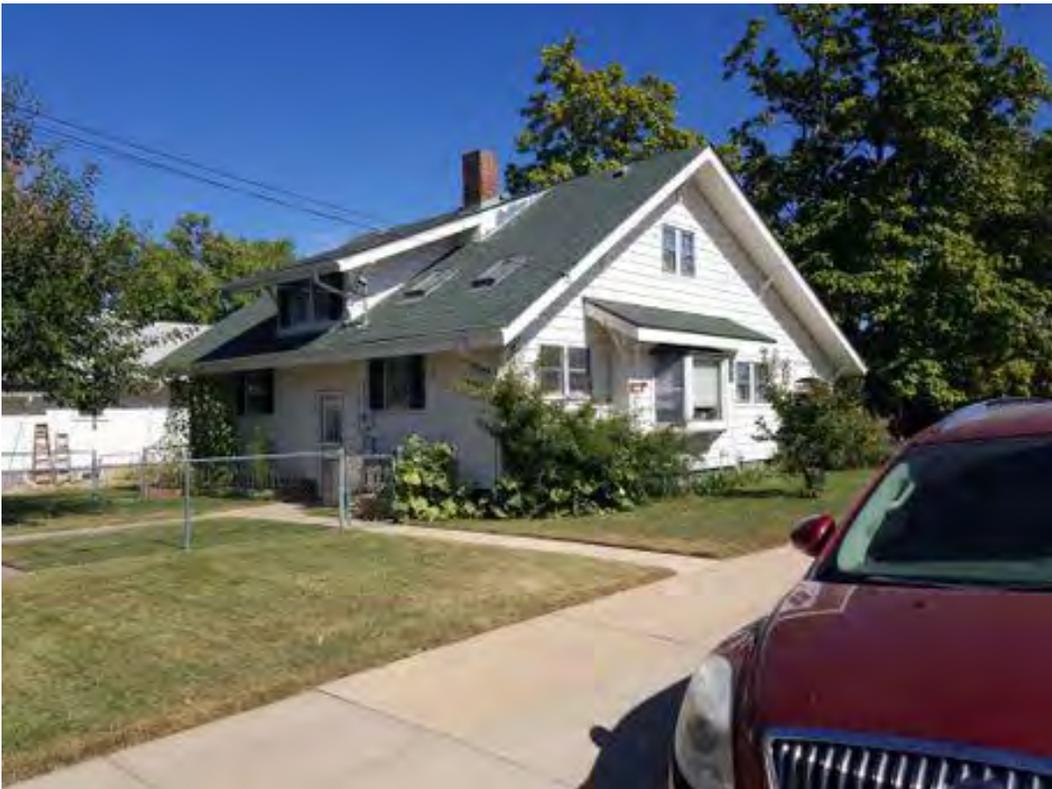
**Photo Number:** 5WL\_8933\_4  
**Description:** South and west elevations. Note shed-roof dormer.  
**View:** Northeast

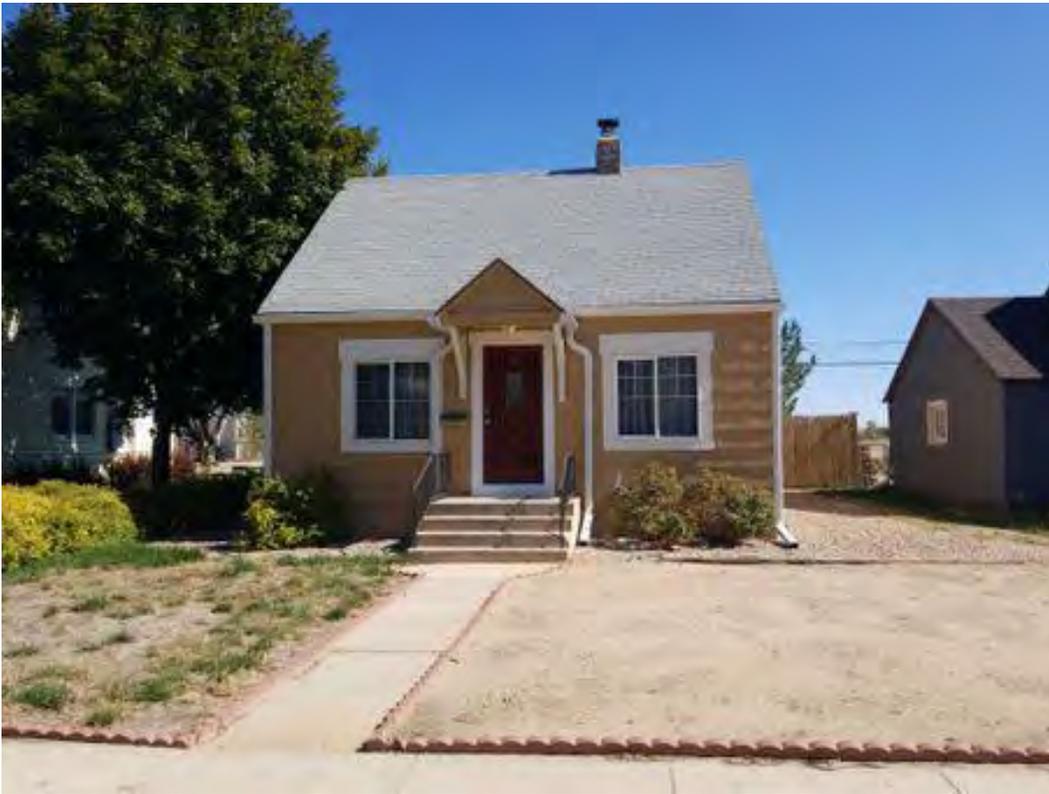
**Photo Number:** 5WL.8934\_1

**Description:** Primary (west) facing elevation. Note the projection covering the porch and the narrow brick chimney.

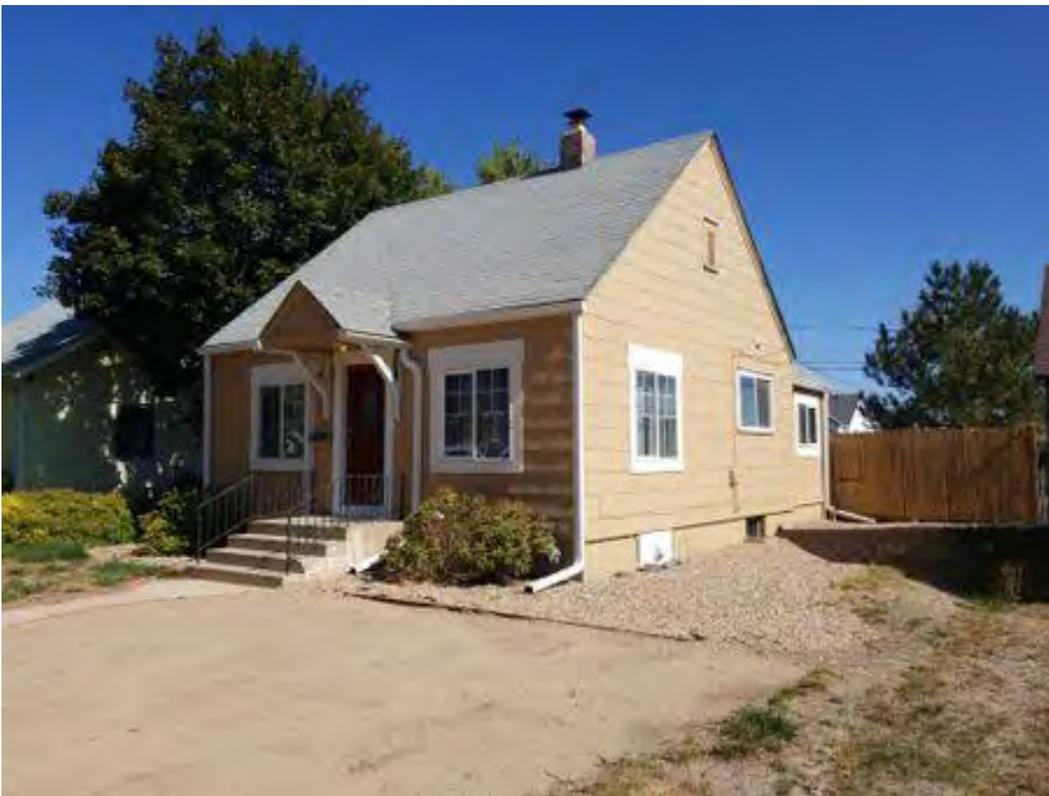
**Photo Number:** 5WL.8934\_2

**Description:** Primary (west) and south facing elevations. Note the small addition off rear of house.

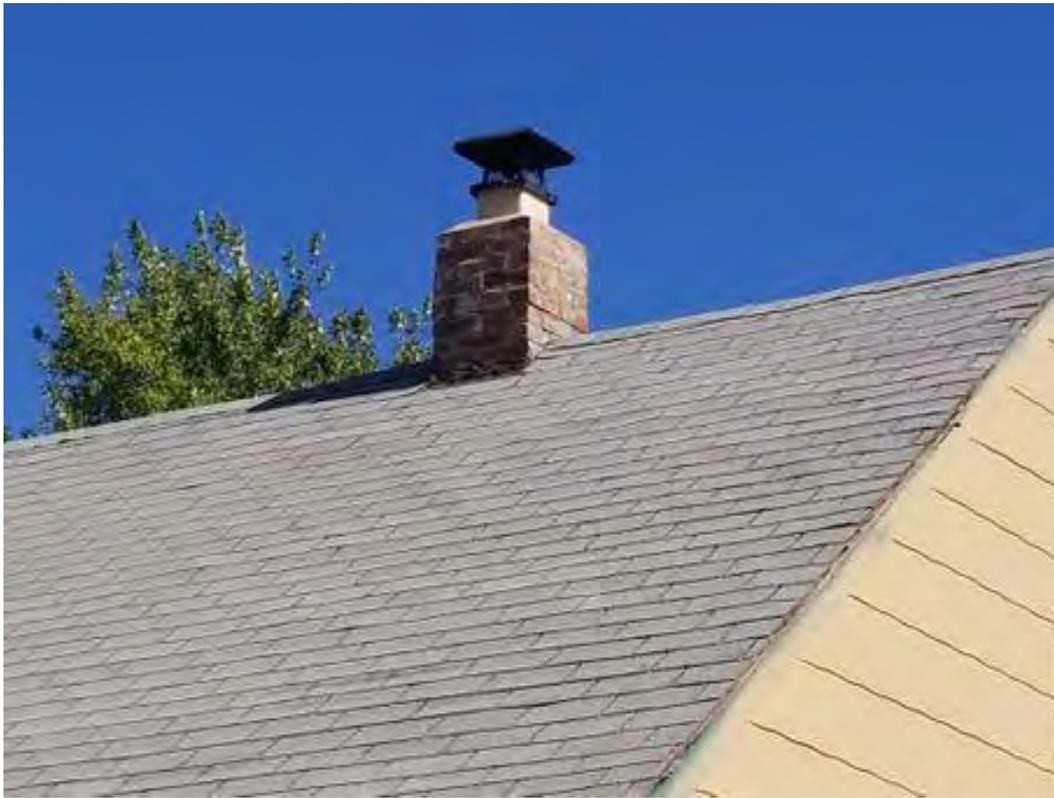
**Photo Number:** 5WL.8934\_3

**Description:** Narrow brick chimney on roof ridgeline.

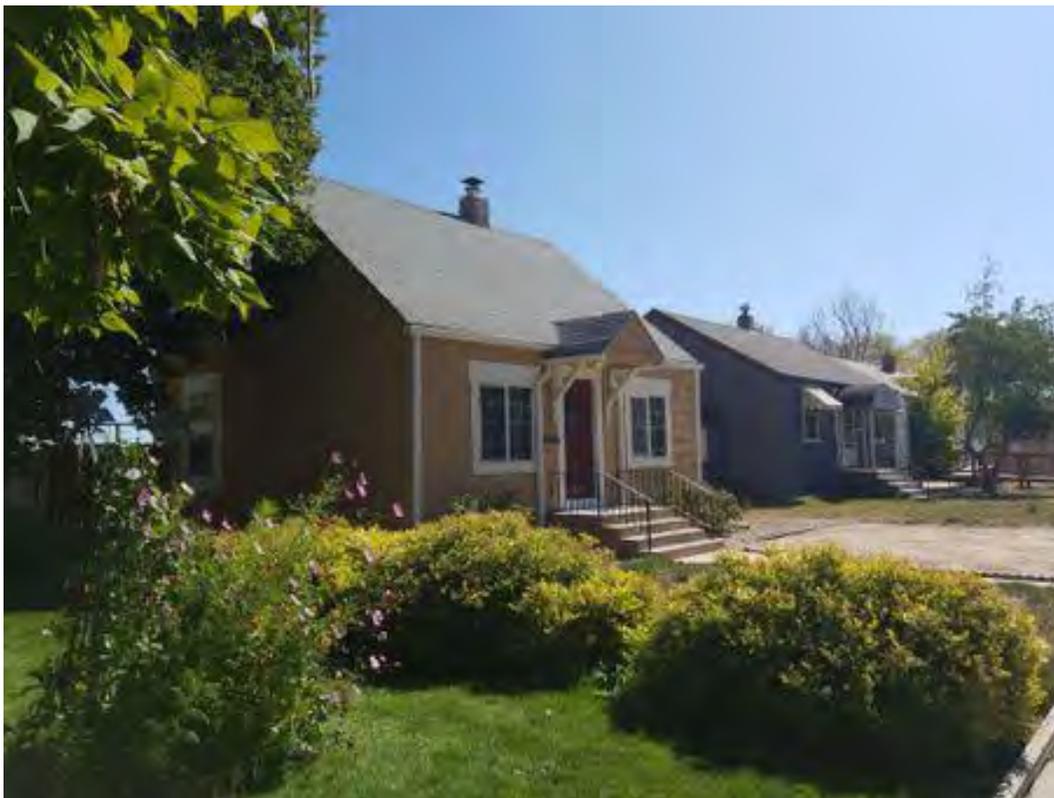
**Photo Number:** 5WL.8934\_4

**Description:** Primary (west) and north facing elevations.

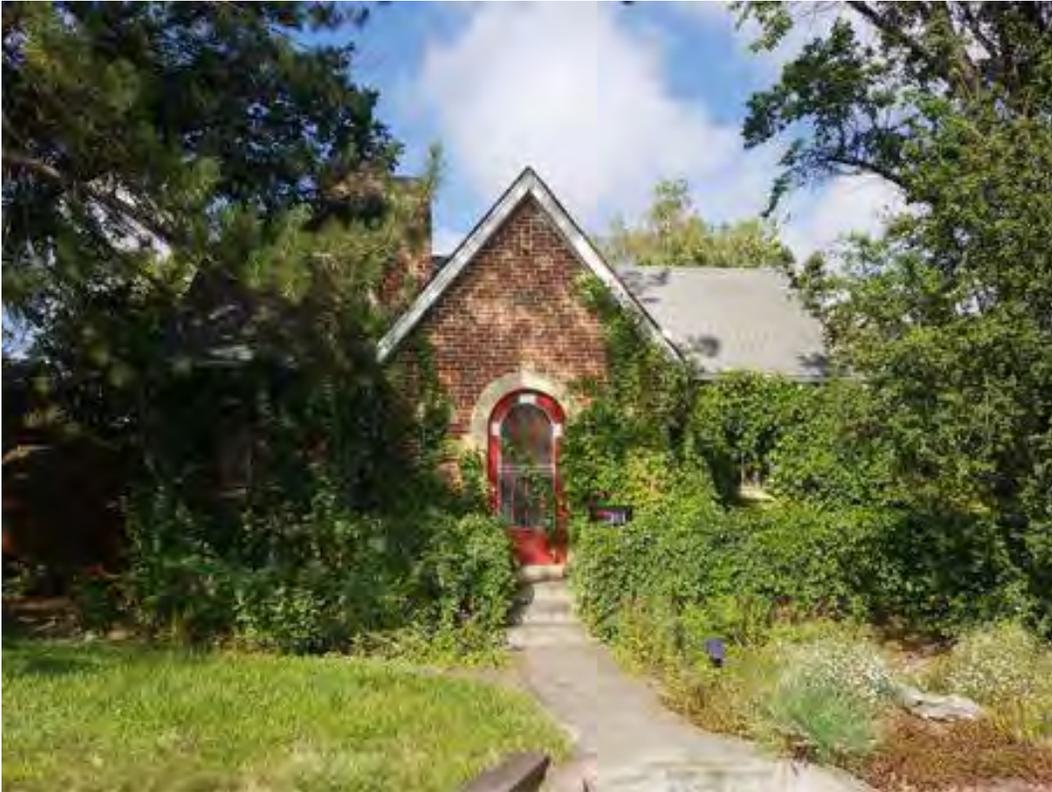
**Photo Number:** 5WL\_8935\_1

**Description:** Primary (east) elevation. Note the arched entrance and casement windows.

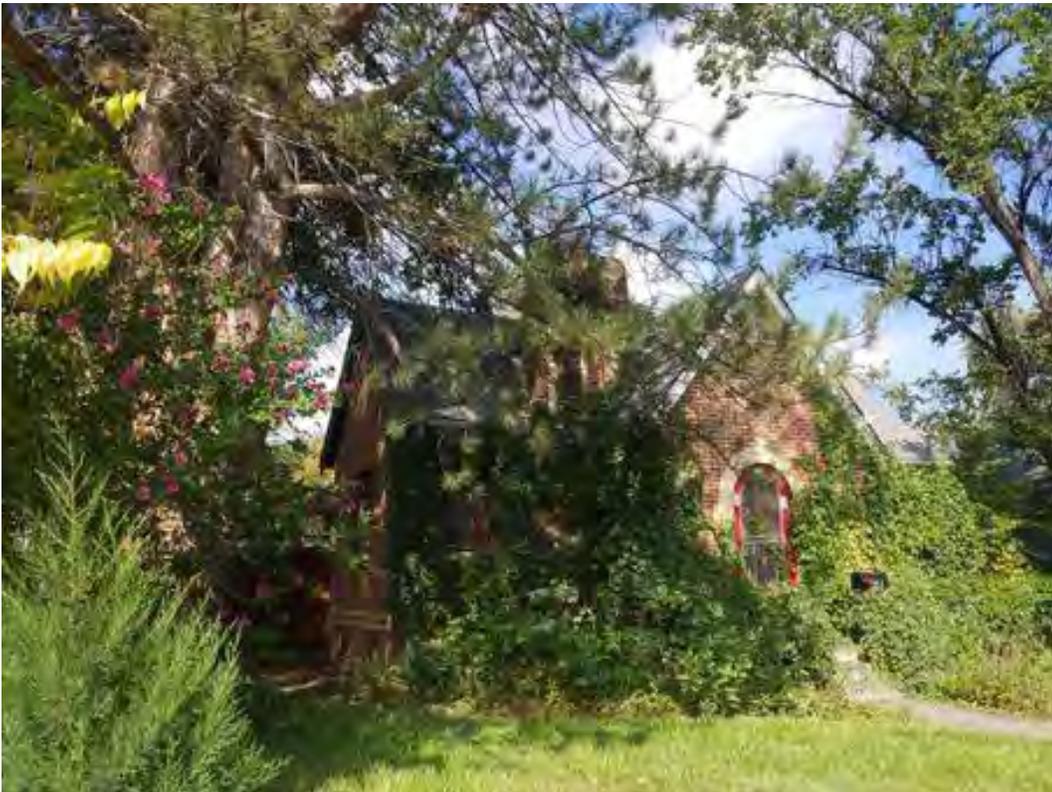
**Photo Number:** 5WL\_8935\_2

**Description:** Primary (east) and south elevations. Note the brick chimney and decorative brickwork. Rear addition is obscured from view.

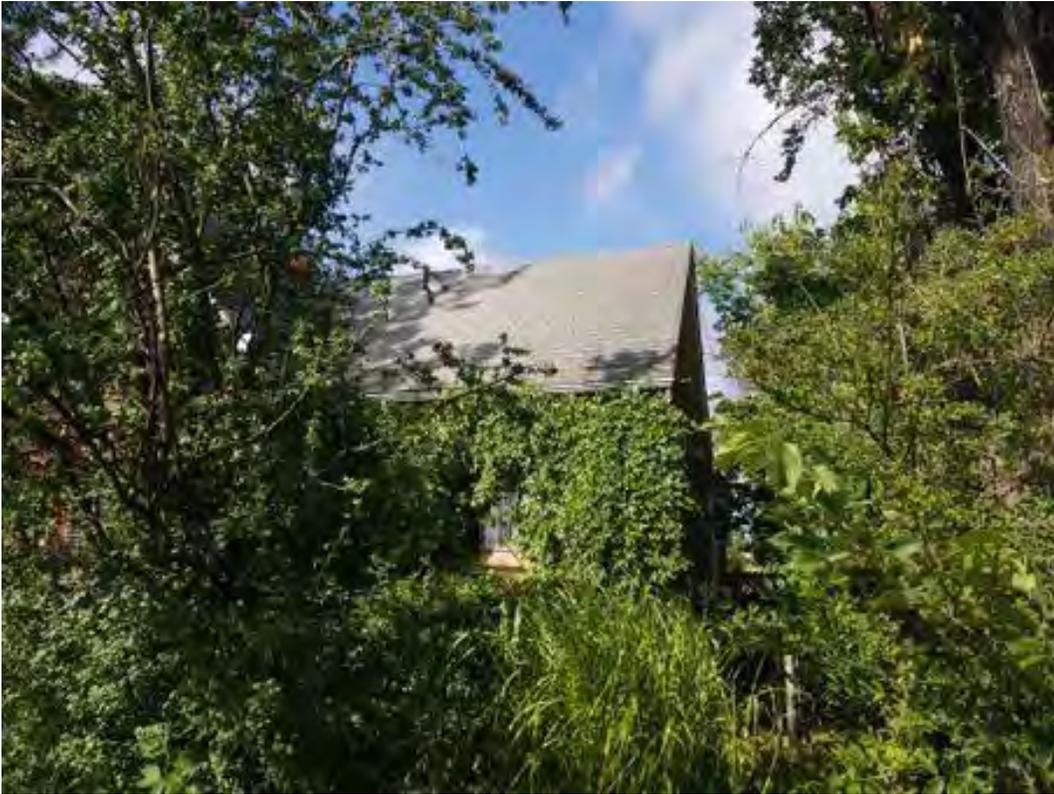
**Photo Number:** 5WL\_8935\_3

**Description:** South elevation. Note casement window.

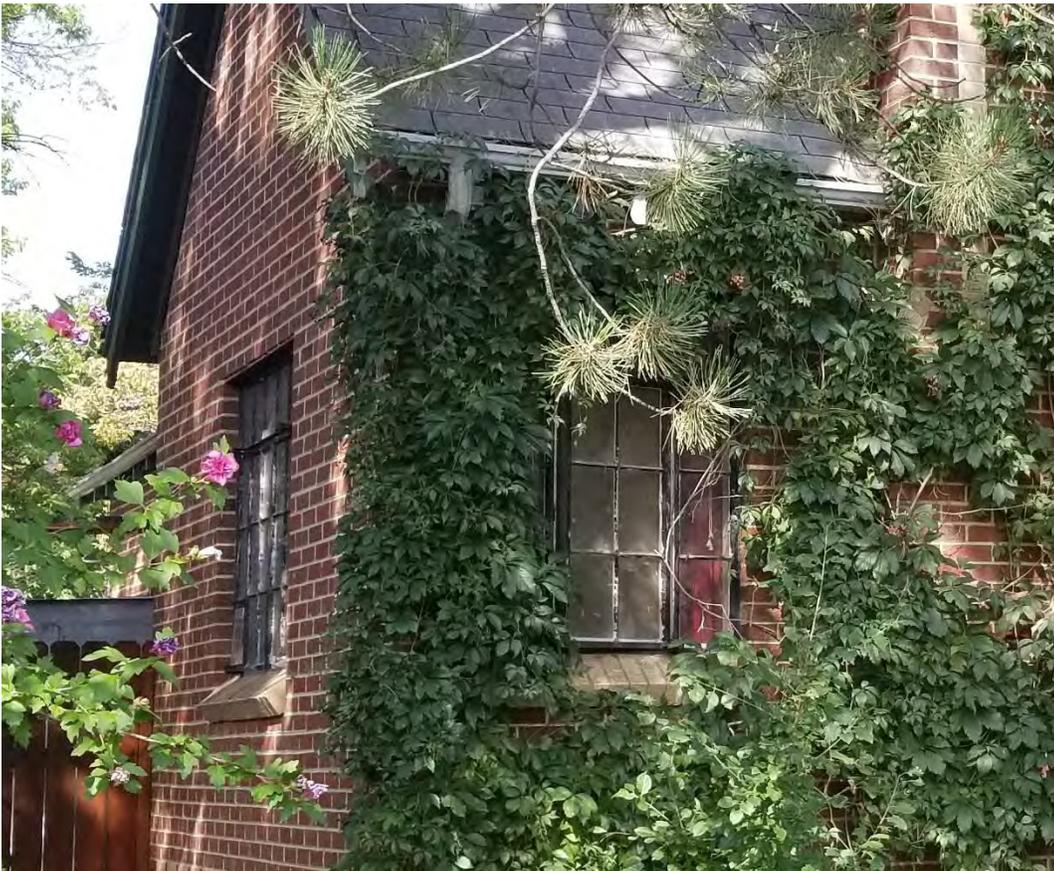
**Photo Number:** 5WL\_8935\_4

**Description:** Close up of north and south elevation windows. Note the wooden mullions and projecting blonde brick sill.

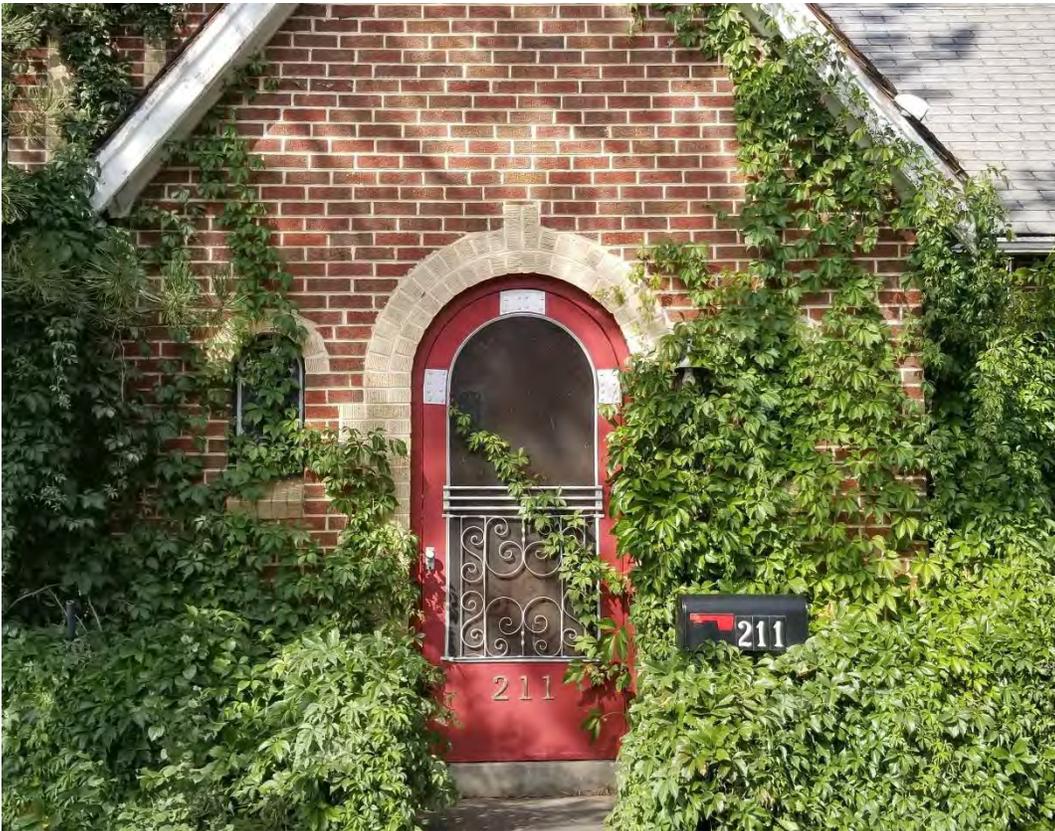
**Photo Number:** 5WL\_8935\_5

**Description:** East facing elevation and front door. Note the decorative blonde brick archway surrounding the doorway and windows flanking front door.

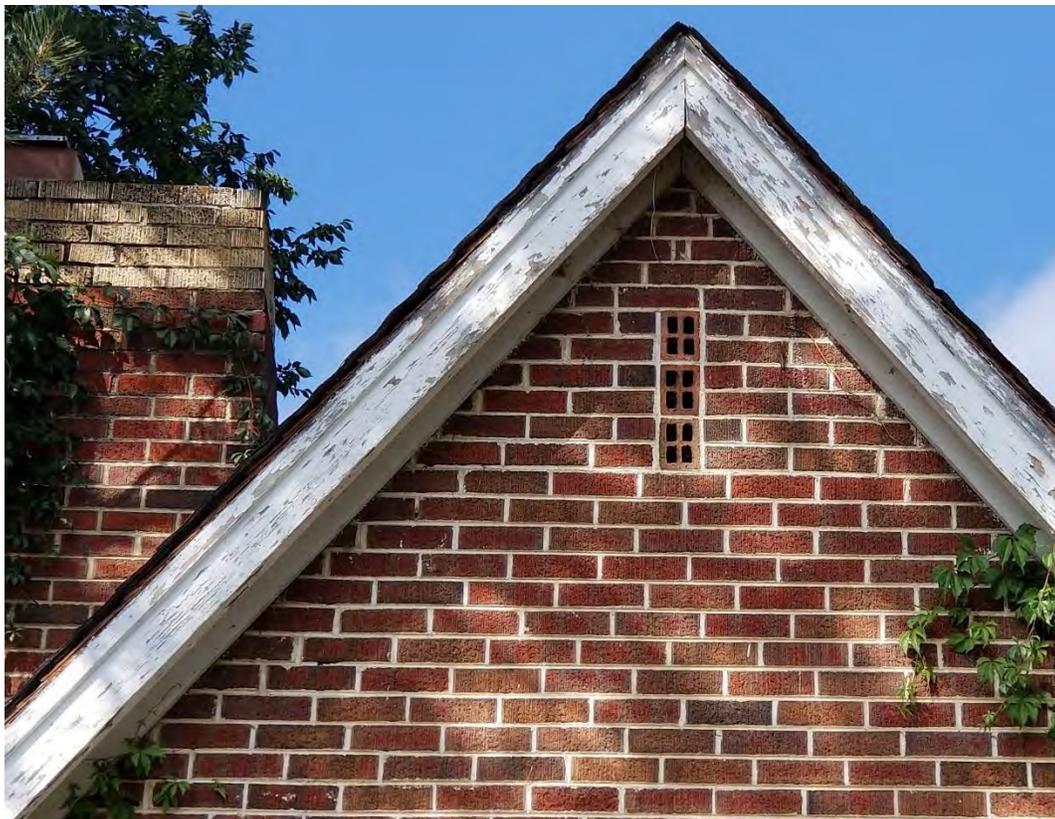
**Photo Number:** 5WL\_8935\_6

**Description:** East elevation roof peak with decorative brick.
